EDC 36: Torrance Meanders (River Kelvin)

Field surveyor: Strathclyde RIGS Group

Date visited: October 2009

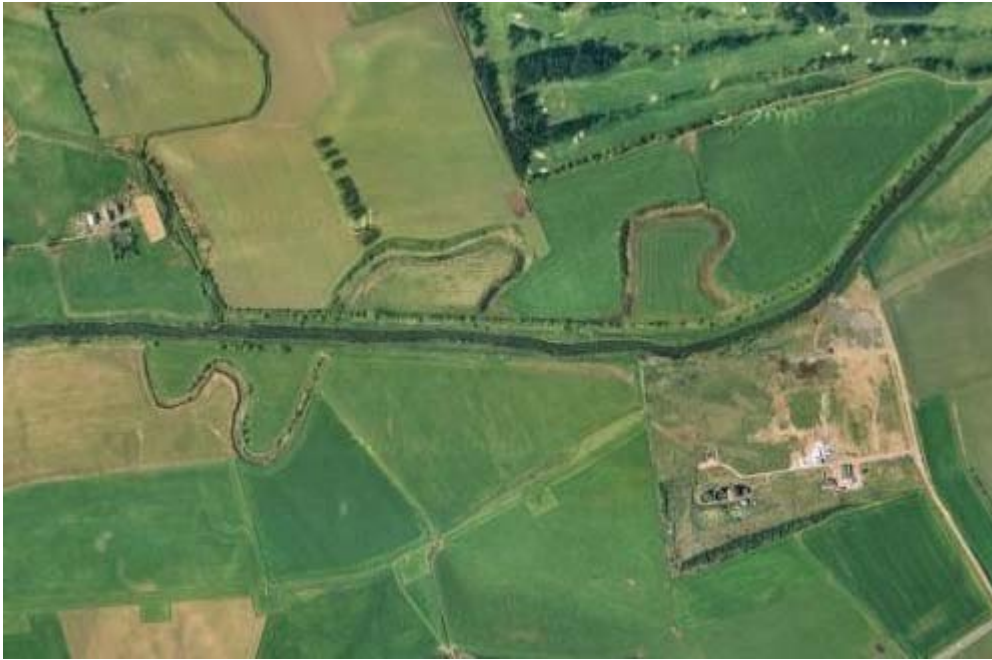
Inactive river channel remnants, interrupting arable fields and partially infilled with aquatic vegetation. They form three meanders (two with complex form) that are separated by the artificially straightened, deepened and leveed channel of the Kelvin, which is approximately 200 years old. The two meanders on the northern side have outer banks incised into a glacial fluvial terrace.

Current condition Only the overall channel planforms, and their (degraded) steep outer banks, survive.

Current conflicting activities Scrub growth partly obscures the steep channel banks in places.

(Photo 220) Aerial view of three remnant meanders, abandoned when the River Kelvin channel was artificially straightened.
