A26 D31 Leys Hill Bridge

Site information

Site description

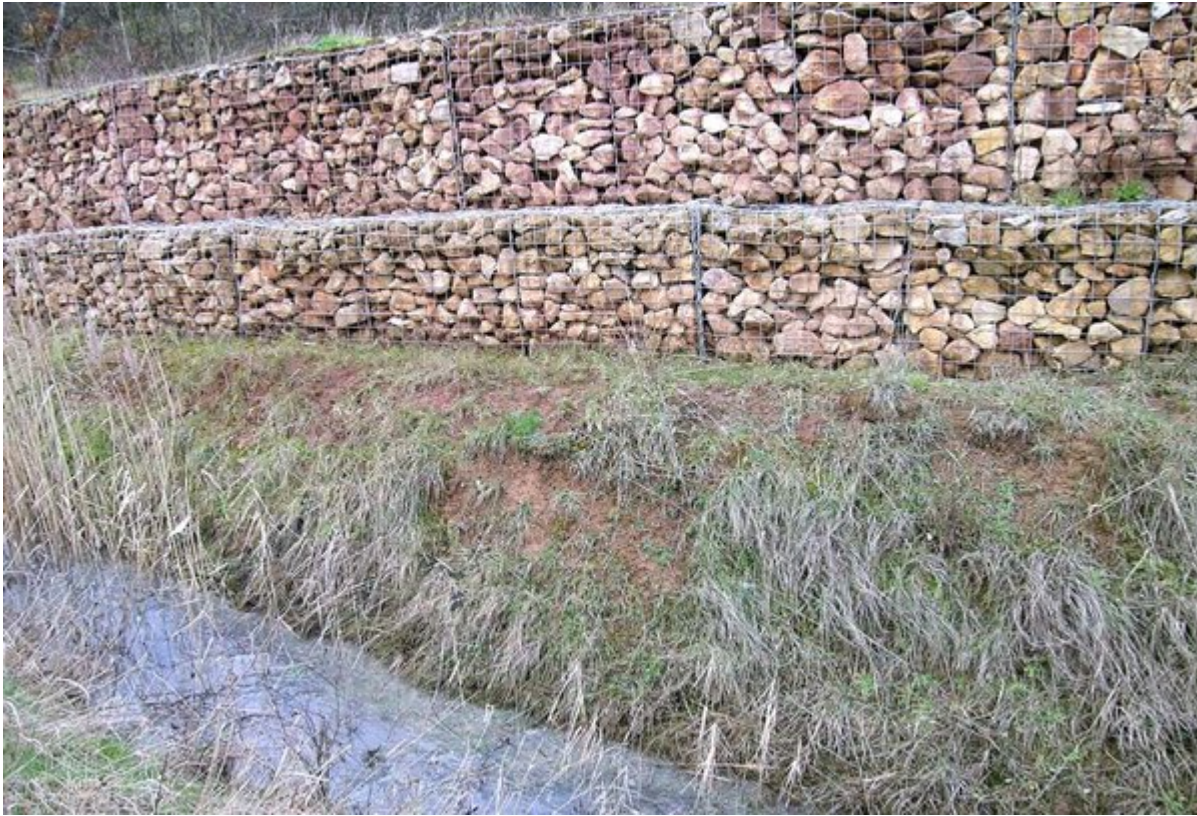
(Figure 125) Exposure of weathered red marl of the Edlington Formation. [SE 52280 06679].

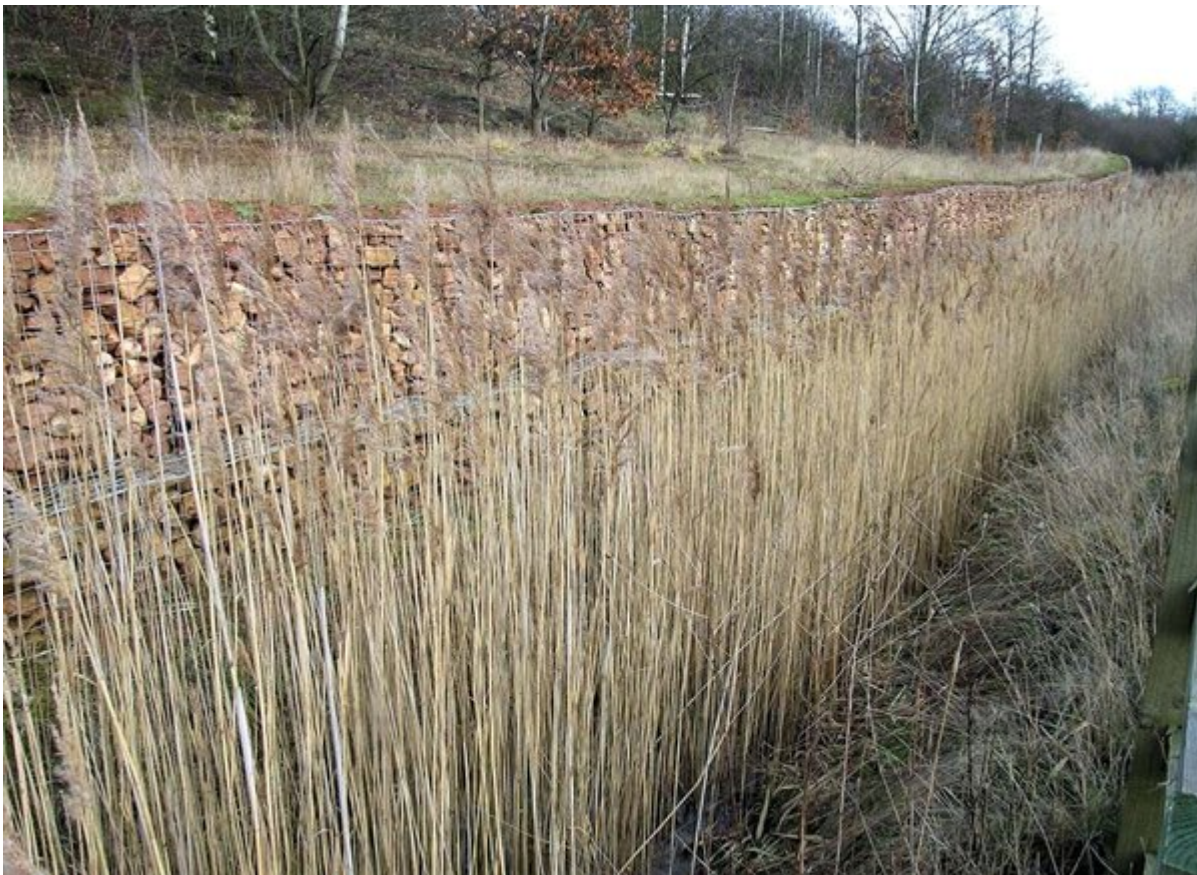
The ditch has been fenced off and planted with hawthorn and gabions have been erected to stabilise the slope. The ditch is now largely overgrown and obscured by osiers with only the occasional exposure of red weathered marl soil now visible. Along the bottom of the ditch and on man made waterfalls, there is a white/grey precipitate but this bears no obvious relationship with the marl exposures.

(Figure 126) View of osiers that largely obscure the exposures of marl in the drainage ditch. [SE 52280 06679].
