# A29 D99 Skelbrooke Quarry

**Site name:** Skelbrooke Quarry

**Field surveyor:** Scott Engering **Date:** 16/2/07

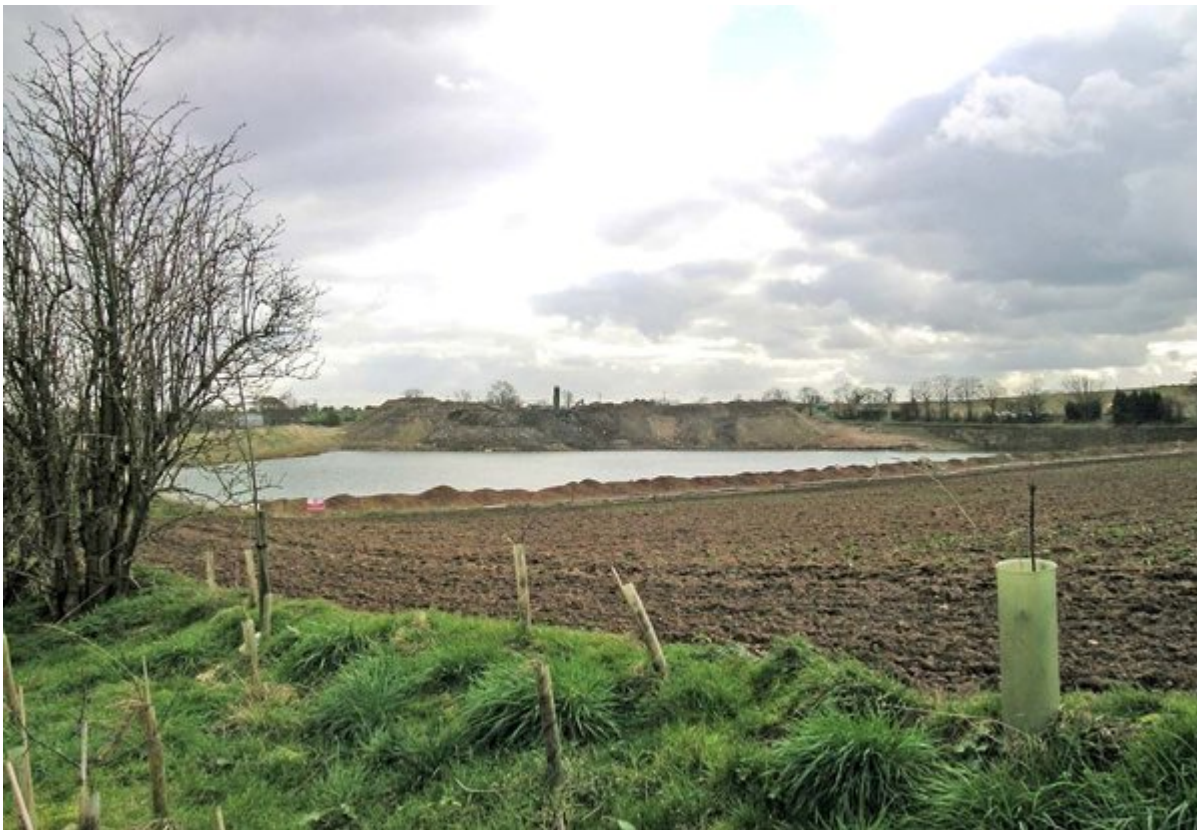
The site has ceased quarrying activities and is now full with water and is being progressively landfilled. The section of marl described in the 1997 survey has now been landscaped and at the date of the resurvey, a maximum section of 2-3 m of dolostone was still seen in the north-west face. No features of geological interest will remain.

*(Figure 134) General view of restoration and tree planting works. [SE 51116 11573].*

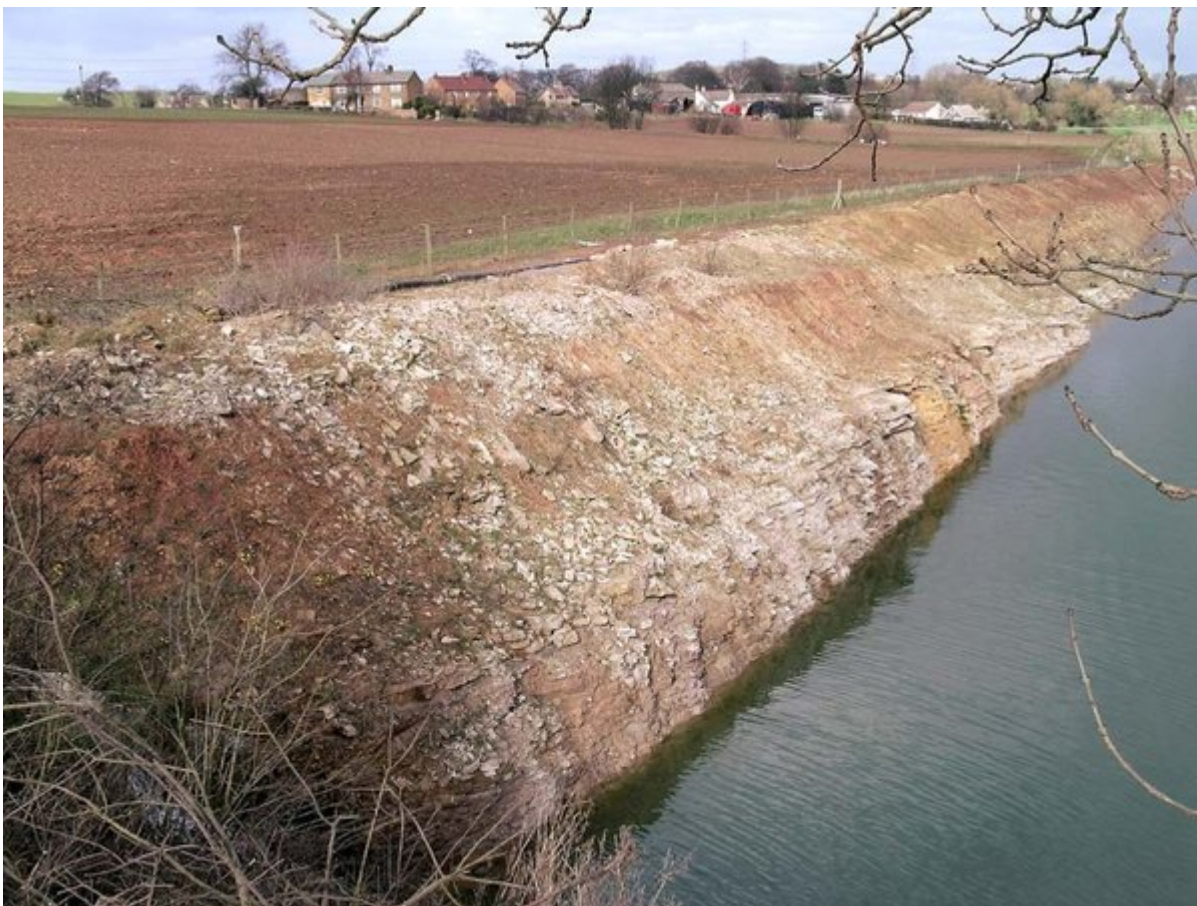
*(Figure 135) Last remaining exposure of limestones of the Brotherton Formation and overlying Roxby Formation. [SE 51116 11573].*
