Benvane (Beinn Bhàn), Stirling

[NN 533 122]

D. Jarman

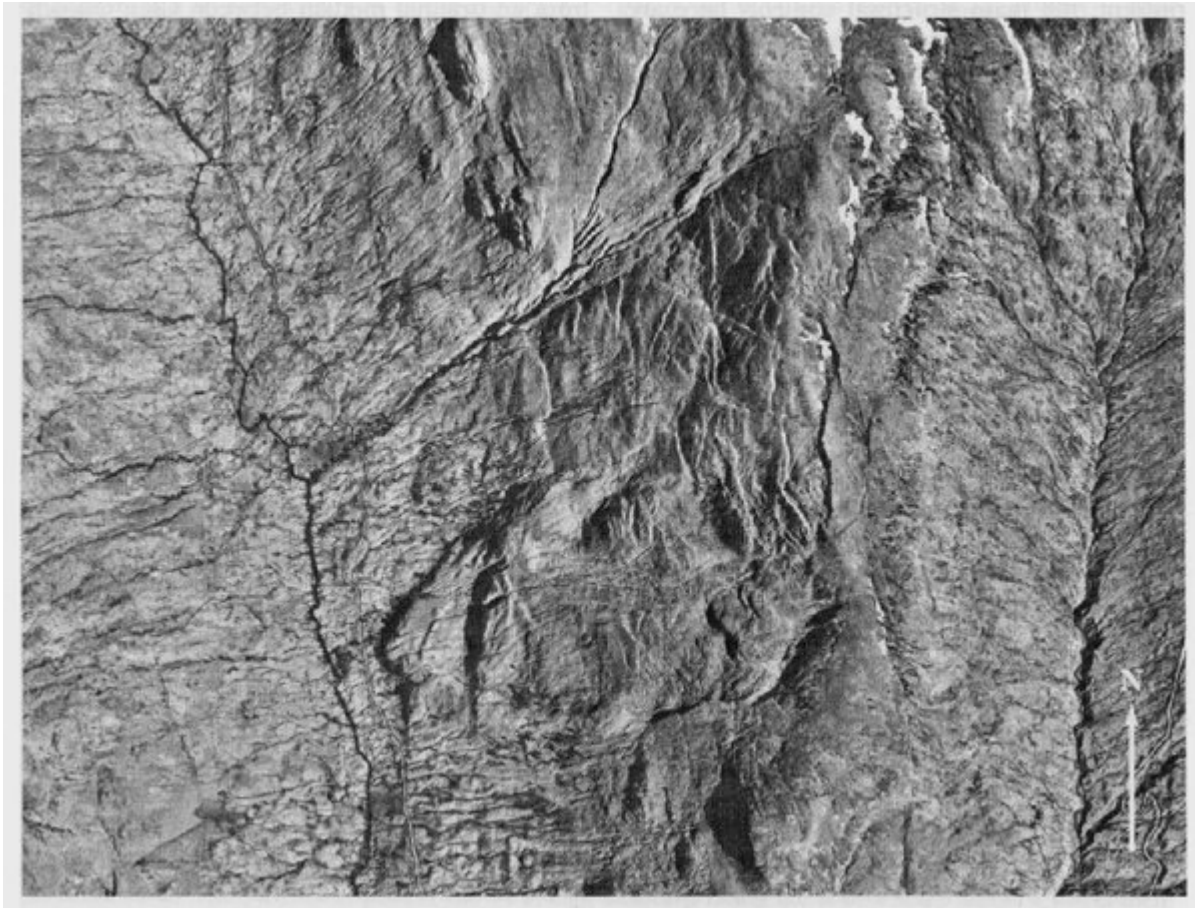
The northern half of the rock slope failure is a slope deformation which presents a remarkable network of antiscarps well seen on aerial photographs (Figure 2.33). They follow three alignments; contour parallel (NNW–SSE), gently diagonal (NNE–SSW), and a few more widely spaced on a steeper diagonal (WNW–ESE) which nears vertical lower down. By contrast with the Beinn Fhada antiscarp array which attains heights of 5–10 m, this array generally attains less than 1 m in height, with many elements merely being benches; the WNW–ESE set locally reaches 3 m. Some of the intersections are finely detailed, and suggest platy tilt-outs ((Figure 2.34) (inset); cf. An Sornach, Jarman 2003c). This area of virtually in-situ deformation extends down to a more pronounced (1.5 m) lowest antiscarp at 420 m OD, which steps across the slope within a broad area where springs issue. Below it, a smooth, steep slope split by a vertical dry rupture, and a subdued slump zone, may extend the failure down to 350 m OD. The northern margin of this deformation is defined by a deep gully complex that cuts off at least eight anti-scarps or benches.

(Figure 2.33) Vertical aerial photograph (1989) of Benvane, with sun from the east accentuating the array of anti-scarps, scarplets and benches. (Photo: Crown Copyright: RCAHMS (All Scotland Survey Collection).)

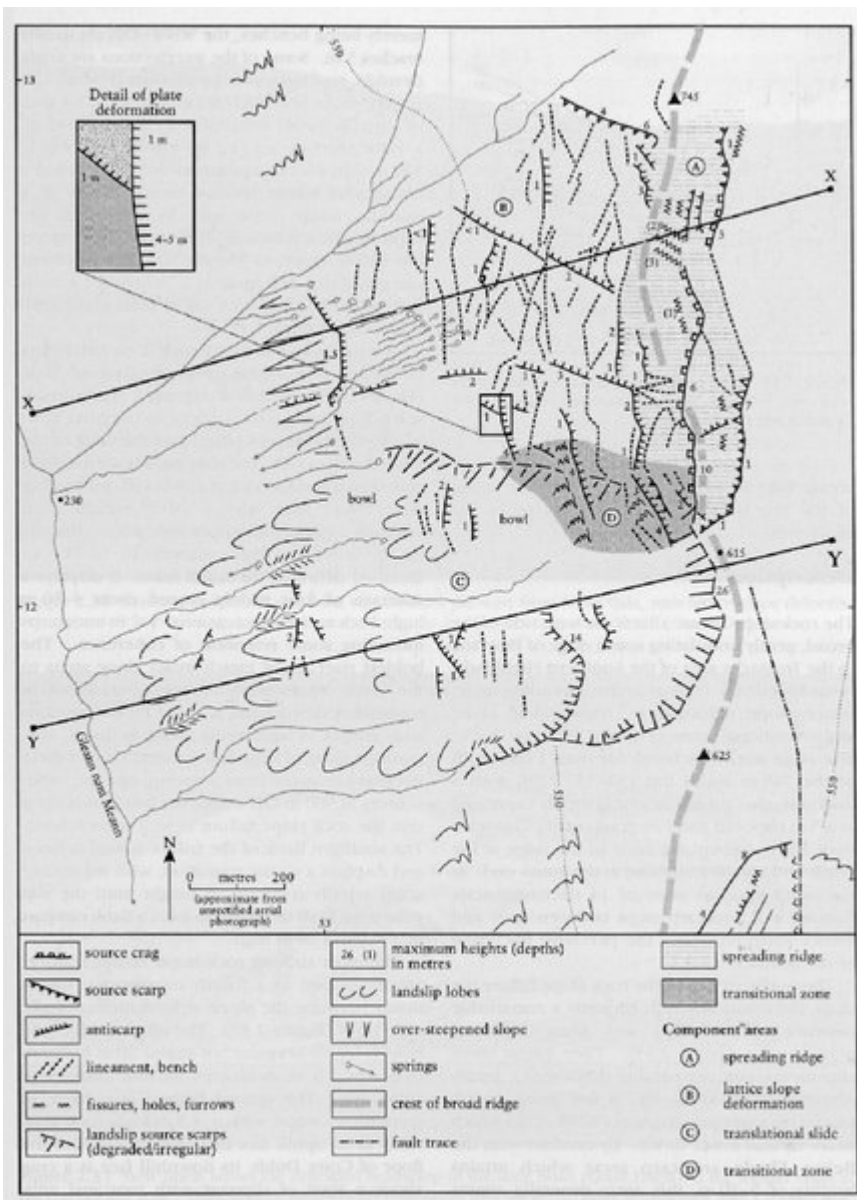
The rock slope failure affects the west side of the broad, gently undulating south ridge of Benvane in the Trossachs area of the Southern Highlands. It has four distinct components: spreading ridge, lattice slope deformation, translational slide, and transitional zone (Figure 2.34) and (Figure 2.35). The ridge itself has failed for over 1 km south of the 745 m south top [NN 537 129], with a discontinuous zig-zag headwall locally expressed as a 5 m rockwall and 7 m grass scarp. This is set back 120 m behind the crest of the ridge at the north end and 80 m behind at the south end. At the north end, an array of 14 decimetre-scale furrows and antiscarp steps between crest and source scarp illustrates the pervasive fracturing of the bedrock.

(Figure 2.34) Geomorphological interpretation of the Benvane rock slope failure complex. Based on unrectified aerial photograph with field verification.

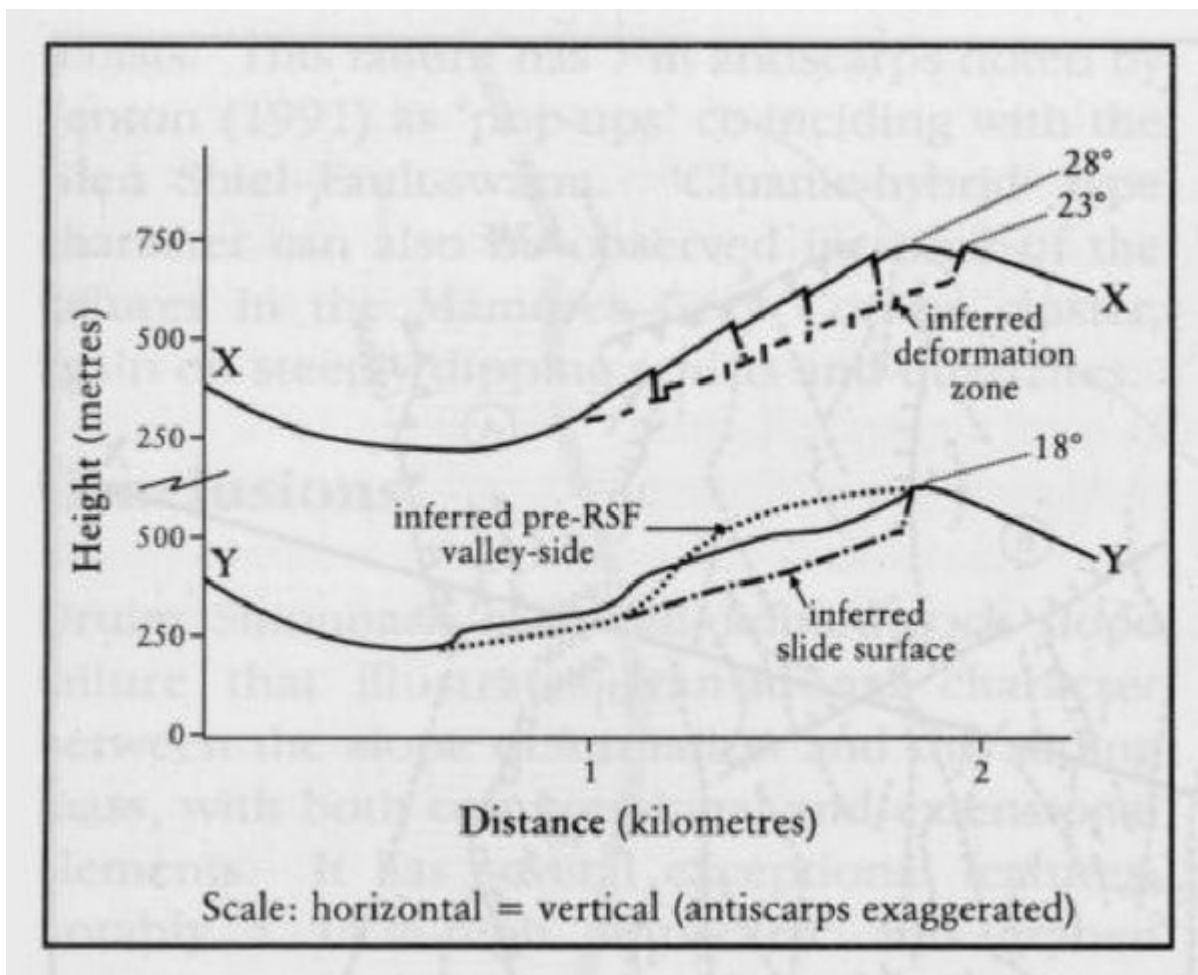
(Figure 2.35) Sections X-X through the deformation zone and Y-Y through the translational slide. For locations see (Figure 2.34).

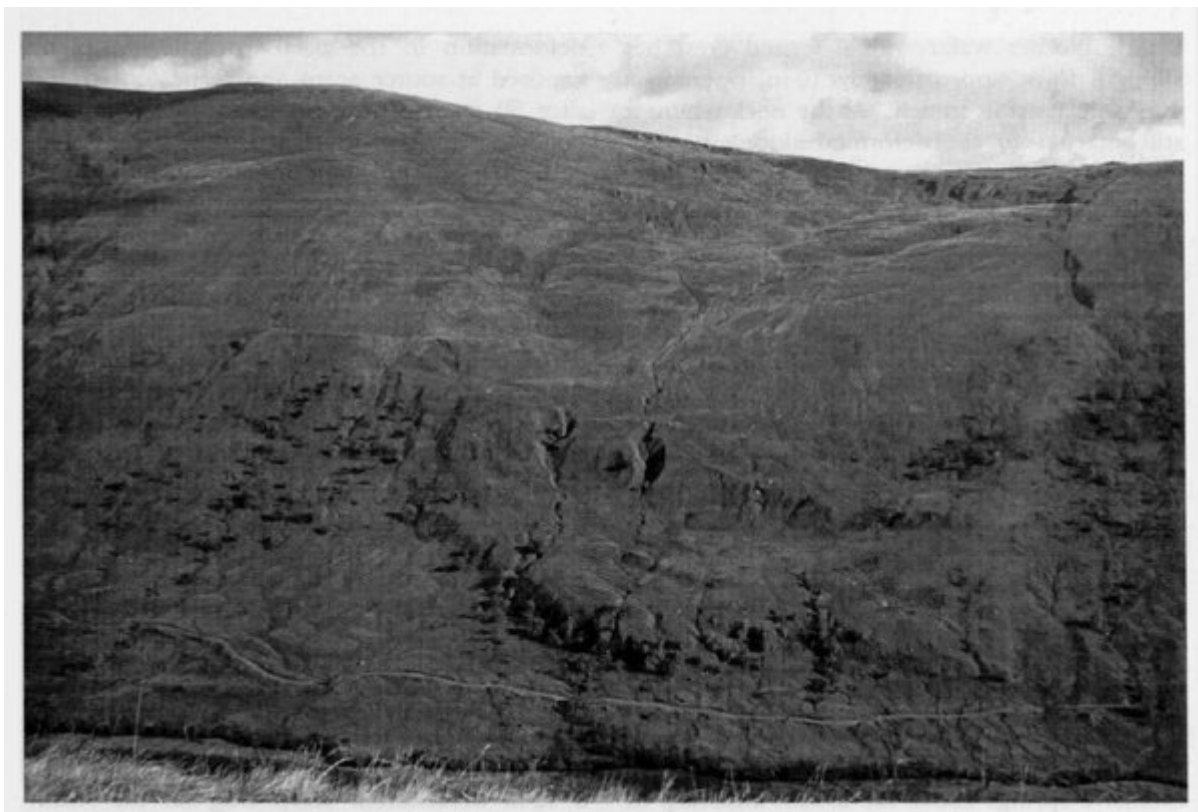
The southern half of the rock slope failure has developed into a long-travel translational slide (Figure 2.36). It has a degraded grassy head-scarp 26 m high at the apex of an irregular bowl (Coire Dubh) almost biting into the crest of the ridge at 610 m OD. The slide mass has descended almost to the slope foot at 230 m OD, protruding as a broad lobe with a 20–25 m-high basal rampart. Despite its viscous appearance, there is no evidence of disintegration to blocky or slumped debris in the failed mass. It displays a staircase of four widely spaced risers 4–30 m high; each tread has occasional 1–2 m antiscarps indicating some retention of coherence. The boldest riser could match intact slope steps to the south, representing an approximately 300 m translation downslope; it is cut by two streams with gorges in apparently intact bedrock, suggesting rafting of large failed slices. One of these streams emanates from a spring, but the other sources at 500 m OD within the bowl, indicating that the rock slope failure is well-consolidated. The southern flank of the failure is well defined and displays a classic transition, with the source scarp rapidly reducing in height until the slip protrudes from the slope to form a flank rampart that reaches 20 m high.

(Figure 2.36) Benvane slide bowl and lobe, viewed from the west from Meall Cala, with lattice slope deformation upper-left; extensive springs can be seen above the lowest anticarp centre-left. (Photo: D. Jarman.)

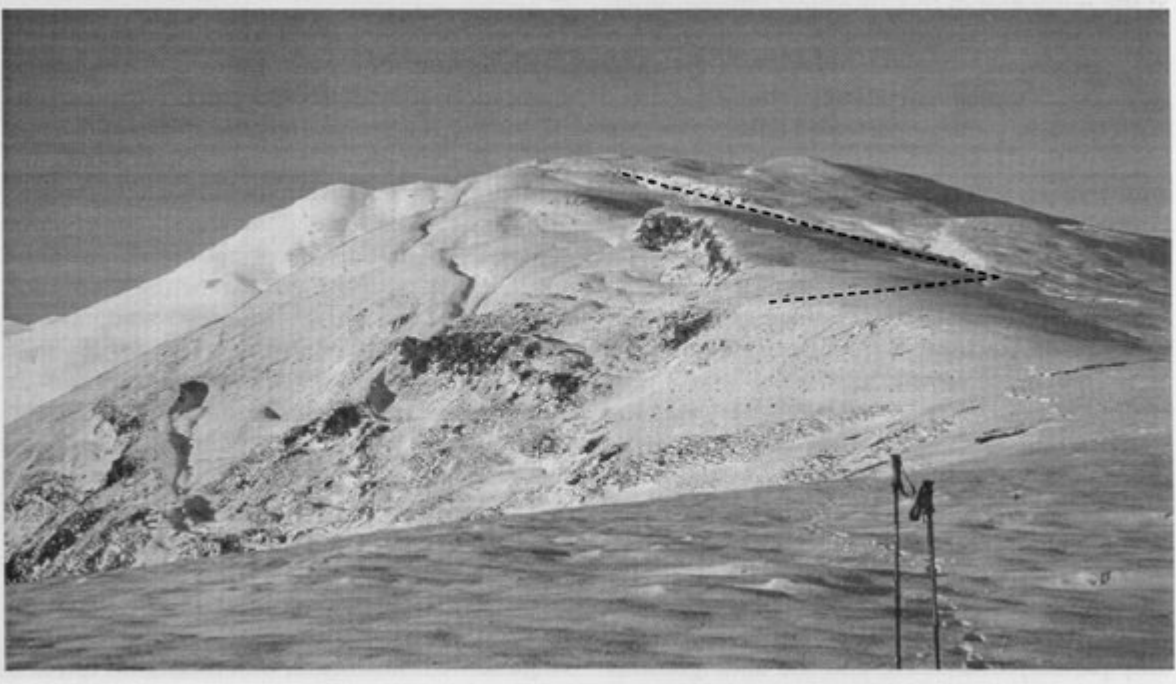
The most striking rock slope failure features are developed in a fourth component, transitional between the slope deformation and the slide bowl (Figure 2.37). The north flank of the bowl is highly irregular but attains 20 m in depth in

places. It is incised by four prominent antiscarps. The second highest is a wafer of quasi-intact slope with a 4.5 m-high rock anti-scarp as its uphill face that extends out into the floor of Coire Dubh; its downhill face is a crag above a zone of slippage with tensional anti-scarps. Adjacent to the headscarp of Coire Dubh, another wafer with a fretted crest has slipped down approximately 10 m, opening a 4 m-deep tension trench. At the neck where it still attaches to the deformed slope, it transmutes into trifurcating antiscarps 0.5–2 m high. At the head of this transitional sector, a short 10 m rock crag is the most pronounced feature of the rock slope failure. It breaks back to become an obtuse wedge source scarp to a subsided section of the spreading ridge, which is some 400 m long and extends 80 m in from the ridge crest (Figure 2.38). A series of tension trenches up to 2 m wide and deep occur above the north side of this subsided wedge, and in its floor, on the WNW–ESE orientation, with the sense of movement being southwards down-ridge as much as valley-wards (cf. Sgurr na Ciste Duibhe).

(Figure 2.37) View north across the degraded headscarp of the slide bowl (Coire Dubh to the fresher crags of the transitional zone. The extent of incipient encroachment into the broad ridge is indicated with a broken line. (Photo: D. Jarman.)

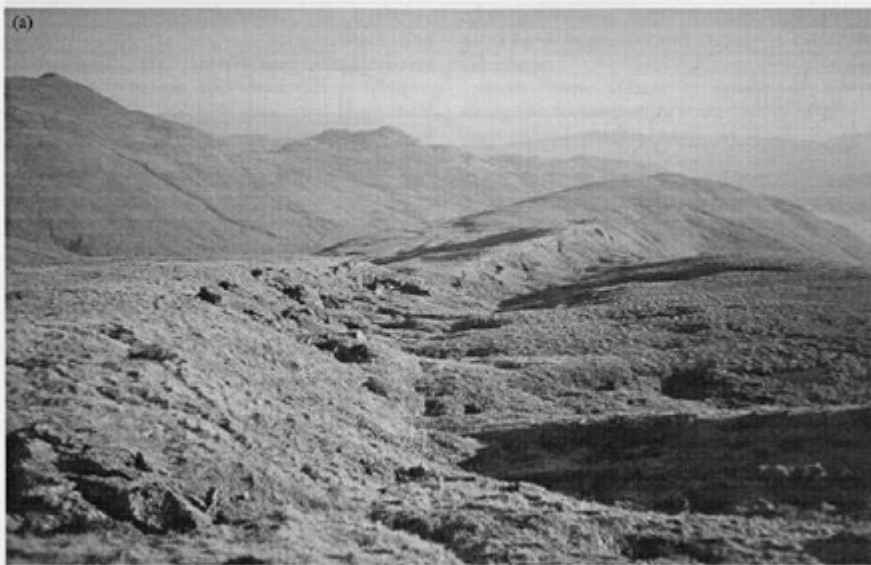
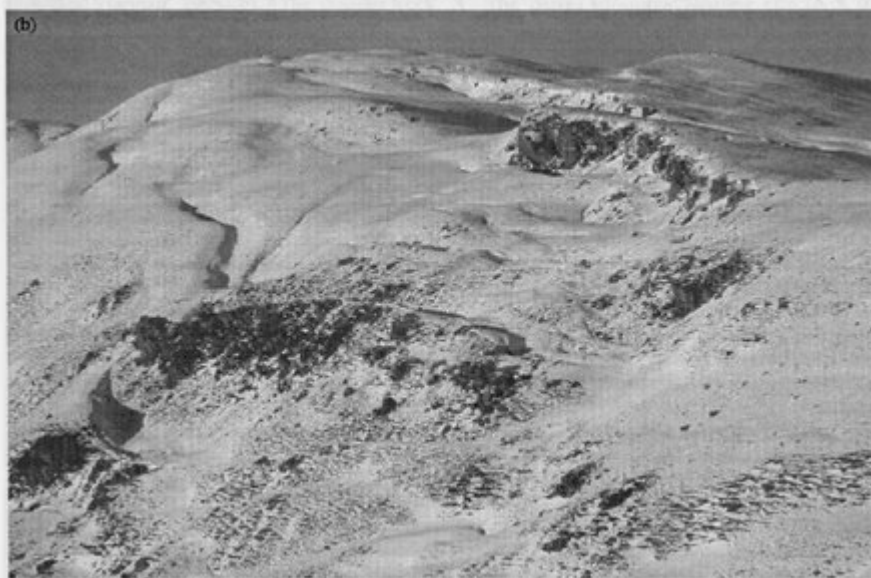
(Figure 2.38) (a) View south down the spreading ridge to the slide bowl. The 6 m-high source scarp to the subsidence graben is not the limit of encroachment in to the ridge, the true headscarp being just visible on the left edge. (b) A close-up view across the slide bowl of the transitional zone extending into the spreading ridge. (Photos: D. Jarman.)

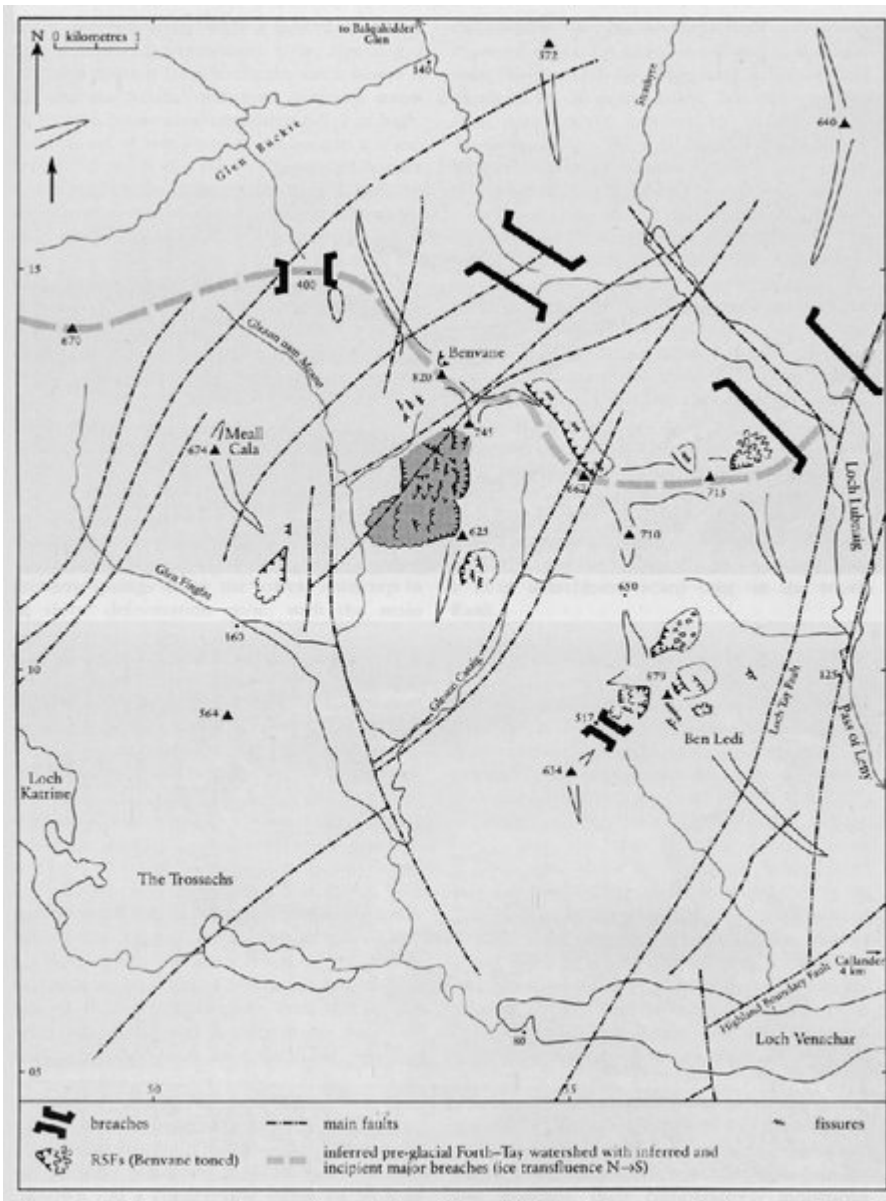
Benvane lies within a structurally related cluster of rock slope failures (Figure 2.39). The aerial photographs show its NNW–SSE ridge-splitting component continuing as an erosional lineament, which then controls a shallow, arrested 0.24 km² landslip on the east side of the ridge in Gleann Casaig. To the north of the deformation, the geological map shows similar features recurring sporadically for 2 km along the midslopes almost to the col above Glen Buckie. On the opposite side of Gleann nam Meann, the south ridge of Meall Cala is nicked by a small but striking failure which well represents the classic acute wedge form of rock slope failure. It has a 20–30 m-high source plane on the dip of the schists, and a 12 m detachment scarp crag on the south flank.

(Figure 2.39) Benvane and surrounding rock slope failures (RSFs) in their topographical context. This sub-cluster may be associated with glacial transfluence south-east across local watersheds, the breaches being at varying stages of development. Unlike the Glen Ample sub-cluster immediately to the north-east, there is no specific association with main faults.
