EDC 12: Barraston Quarry, Barraston Farm

Summary description

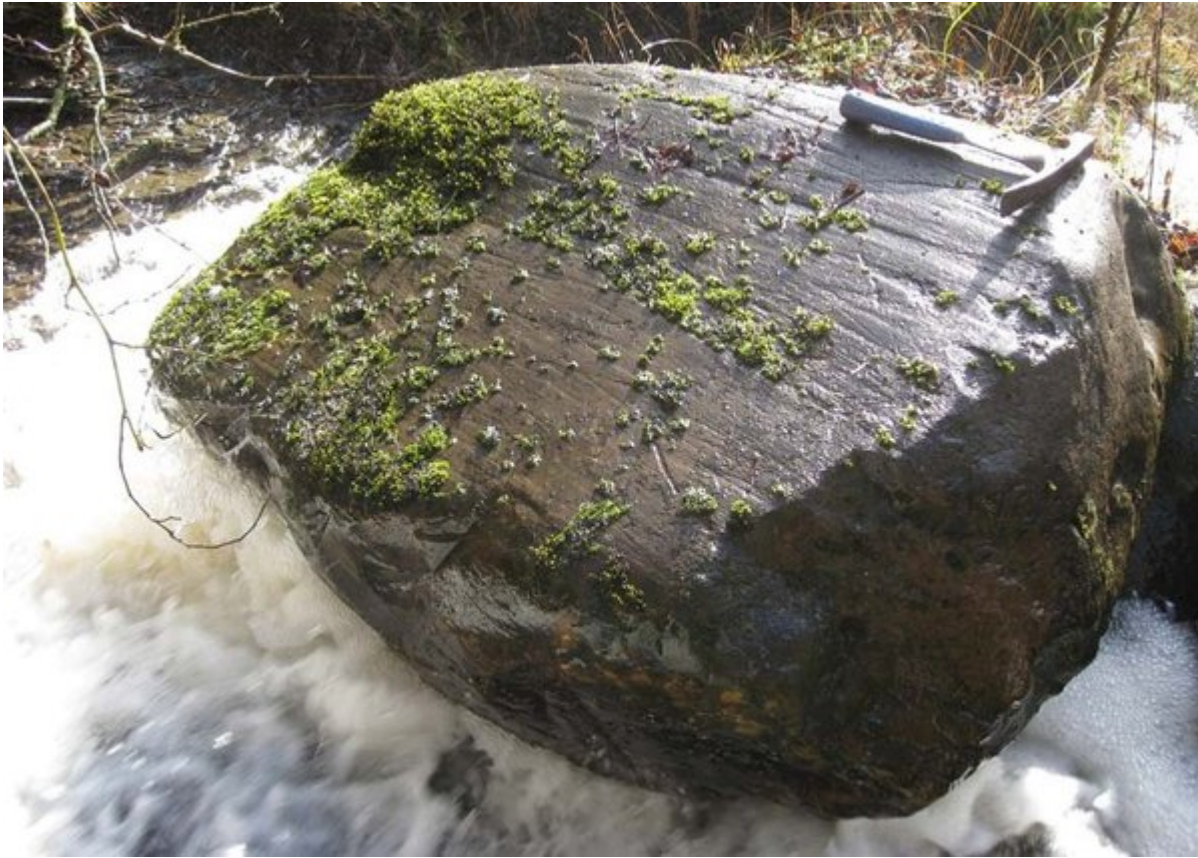
(Photo 61) A superb example of a striated (glacially scratched) boulder, found in the burn entering Barraston quarry from the northwest. It has probably been washed out of a glacial till deposit. Looking SE.
