Spireslack Locality 10: View of major fault

NGR: [275188 630710] [NS 75188 30710]

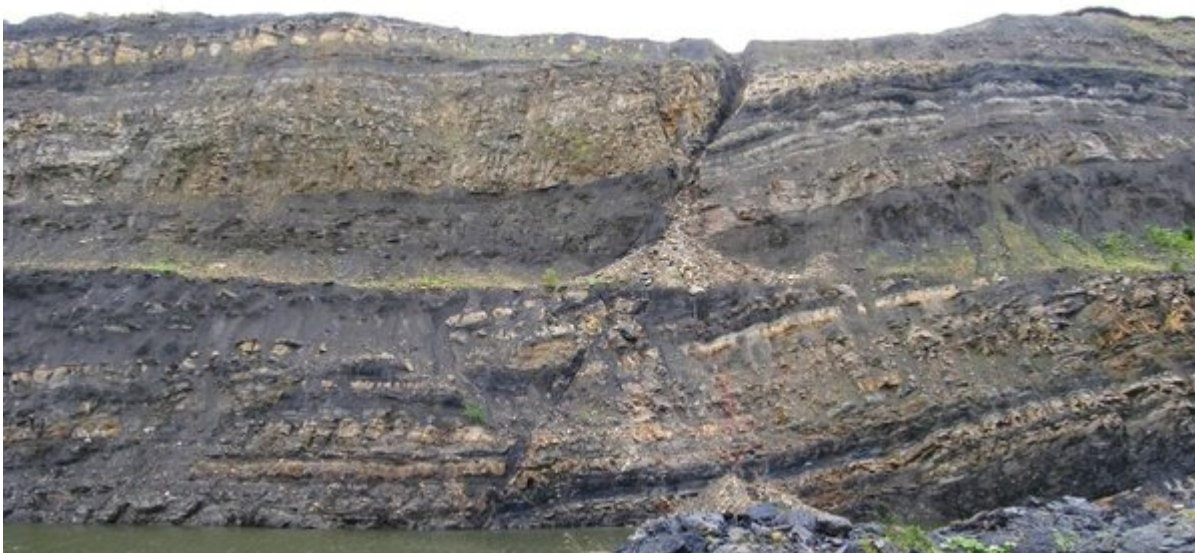
(Spireslack_10 P1): Fault in the south wall, displacing rocks in an apparent normal sense down to the east (left of the image), but also to the north in an oblique sinistral fashion. The weaker fault rocks have been eroded along the fault plane, leaving a cleft marking the position of the fault. Sandstone tends to fracture when faulted — the fractured sandstone has washed out of the fault plane to form a localised debris cone half way up the scarp. Photo facing south. ©

(Spireslack_10 P1) Fault in the south wall, displacing rocks in an apparent normal sense down to the east (left of the image), but also to the north in an oblique sinistral fashion. The weaker fault rocks have been eroded along the fault plane, leaving a cleft marking the position of the fault. Sandstone tends to fracture when faulted — the fractured sandstone has washed out of the fault plane to form a localised debris cone half way up the scarp. Photo facing south. © BGS, NERC.
