Spireslack Locality 11: Section through old mine workings with in-situ pit prop

NGR: [274976 630578]–[274923 630554] [NS 74976 30578]–[NS 74923 30554]

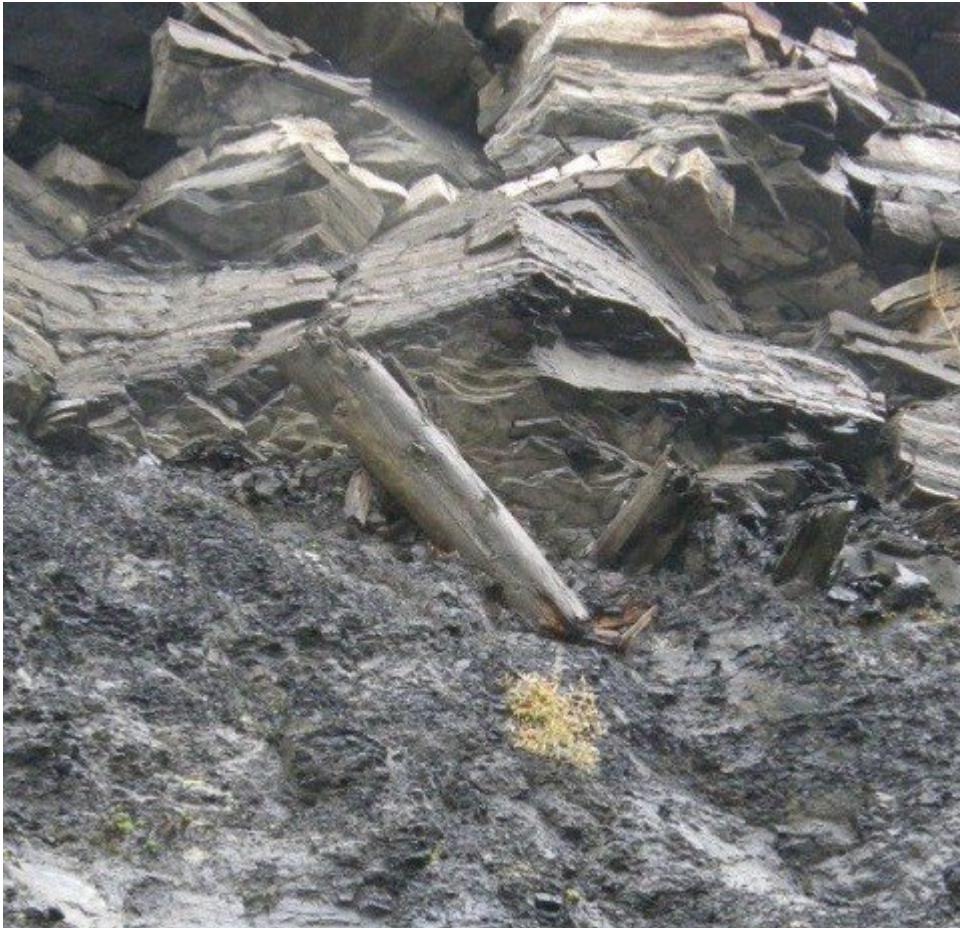
(Spireslack_11 P2) Wooden pit prop in situ within the coal workings. The wooden props were used to hold up the roof of the workings as the coal was extracted. The prop, sitting above packed mine waste in the photo, has since collapsed due to the overlying weight of rock (sandstone) above. © BGS, NERC.
