A18 D94 Warmsworth Quarry

Site information

Field surveyor: Scott Engering **Date:** 16/2/07

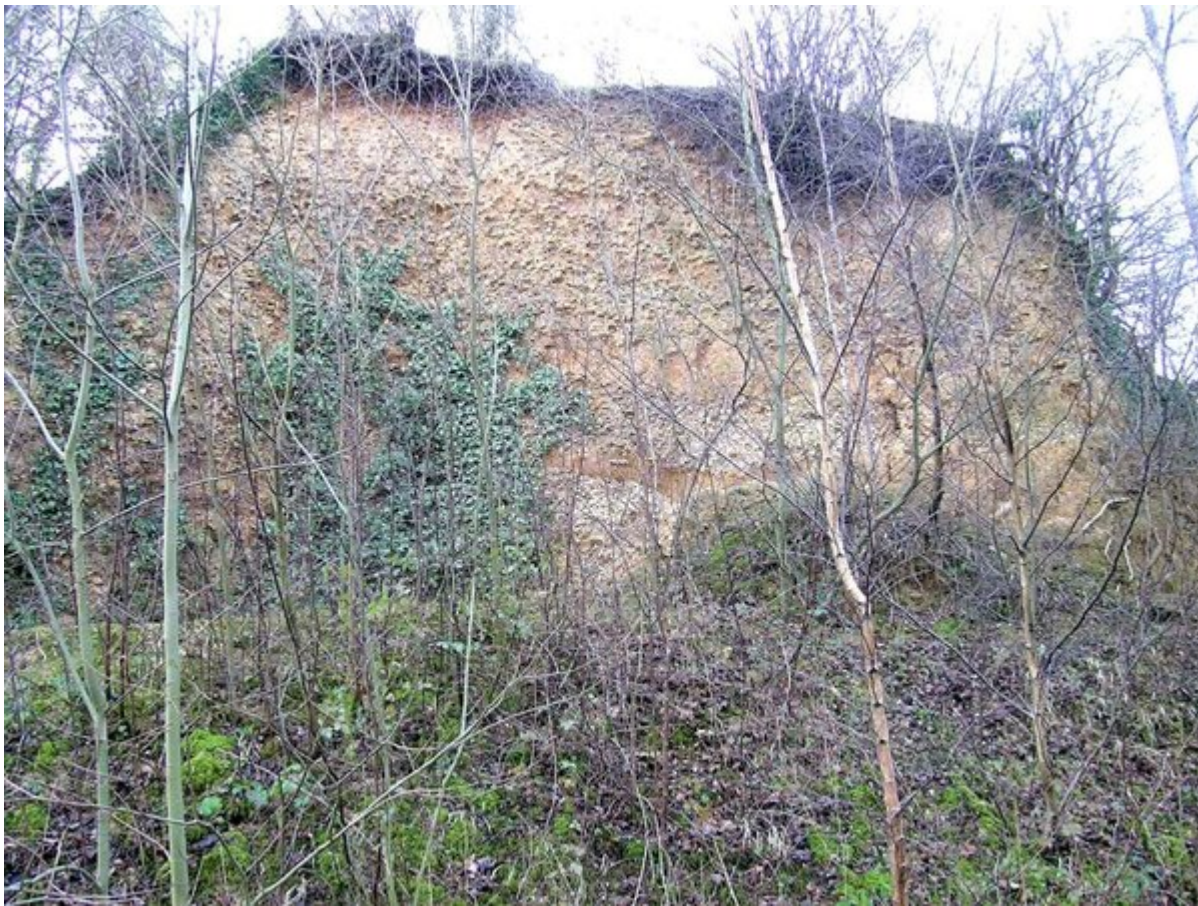
(Figure 91) General view of north face of breccia stump. [SE 53458 00455].

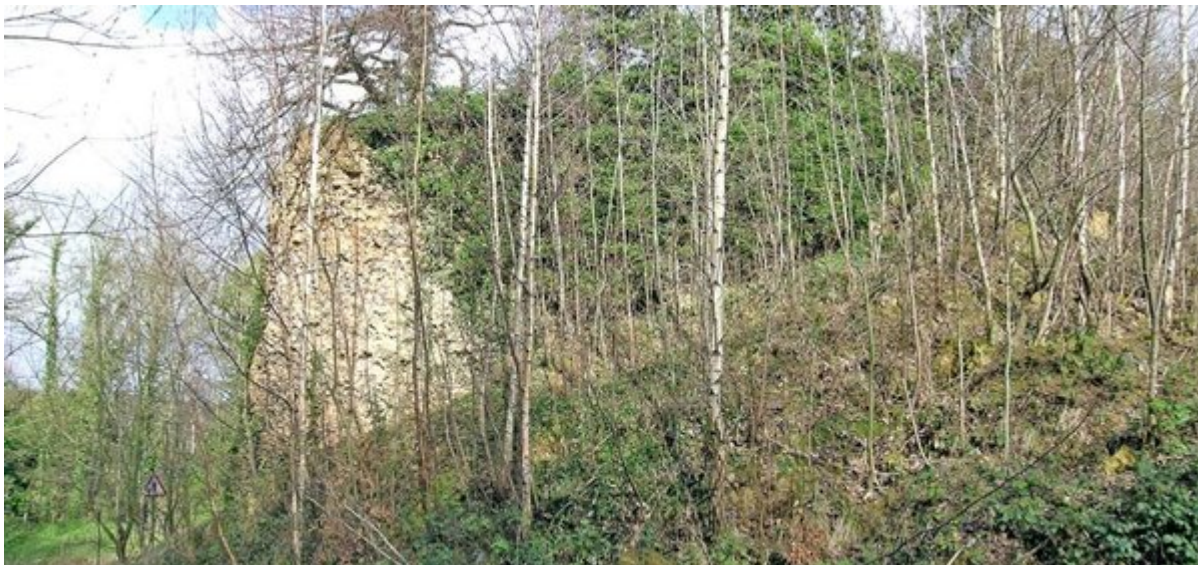
(Figure 92) General view of south face of breccia stump. [SE 53457 00488].

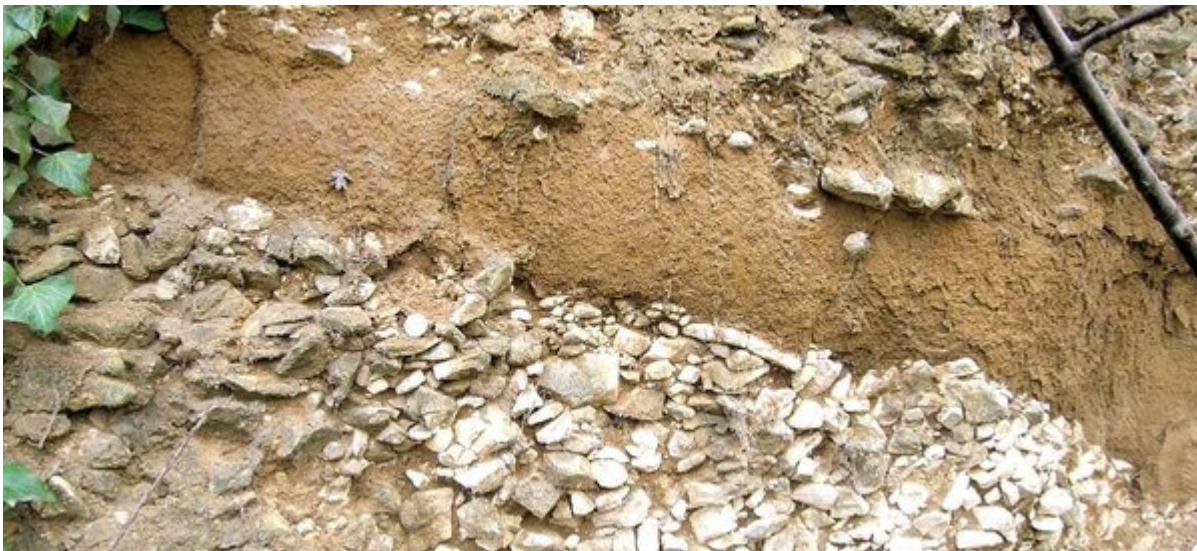
An isolated stump comprising a breccia of angular and in places sub-rounded limestone generally less than 100 mm in size with an orange-brown sandy matrix. The south side contains lenses where there is a large proportion of sandy material and to the north side, there are two beds 300-400 mm thick that are essentially composed of cemented sand and form a sharp boundary with the underlying breccia but coarsen upwards into the overlying breccia.

(Figure 93) Detail of sandstone and limestone layers in south face of breccia stump. [SE 53457 00488].

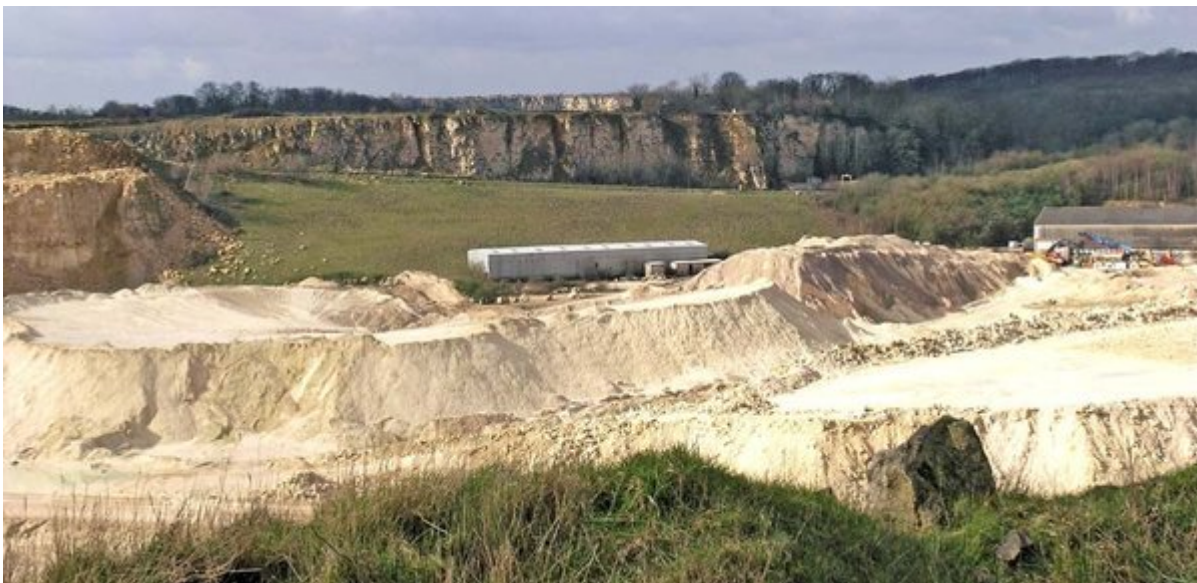
(Figure 94) General view of quarry looking to the west. [SE 53900 00400].
