A18 D94 Warmsworth Quarry

Site information

Site photographs D94 Warmsworth Quarry

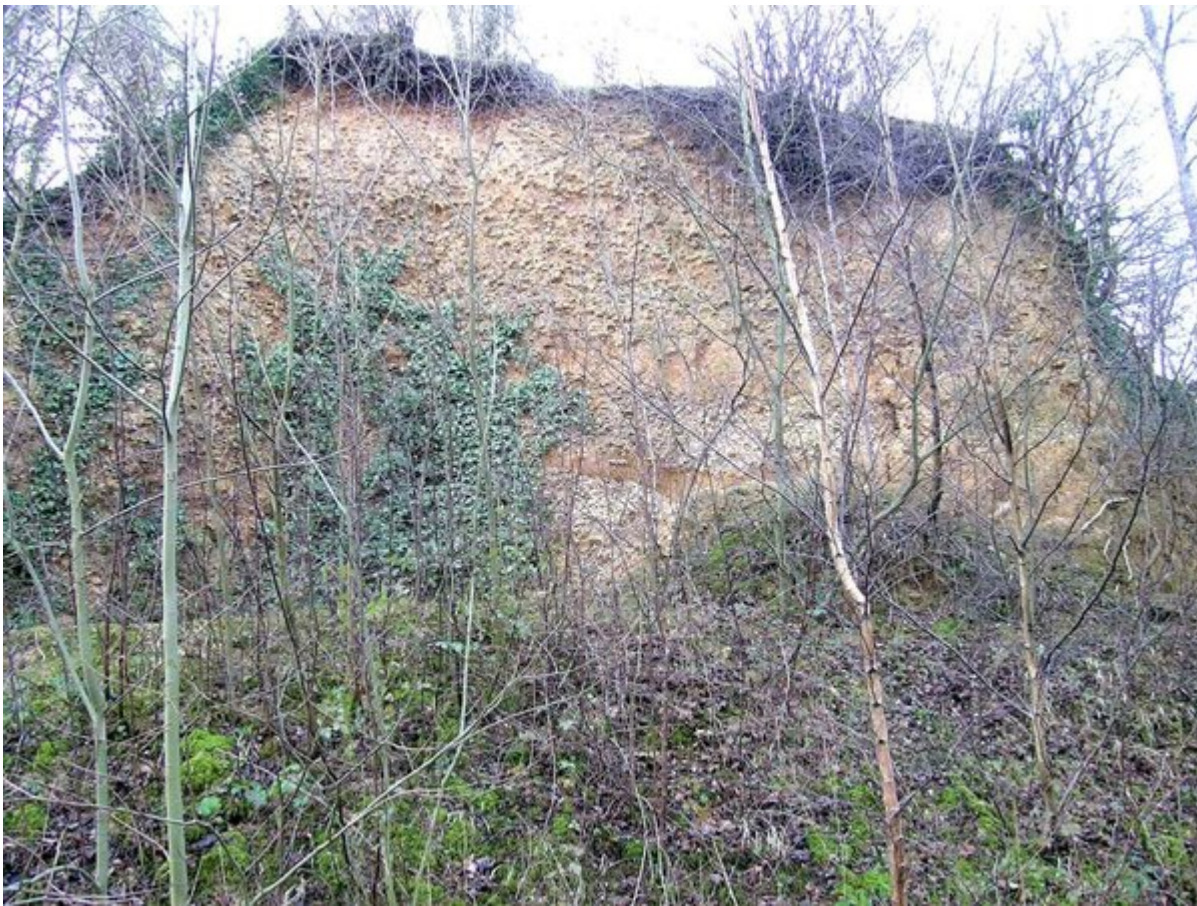
(Figure 91) General view of north face of breccia stump. [SE 53458 00455].

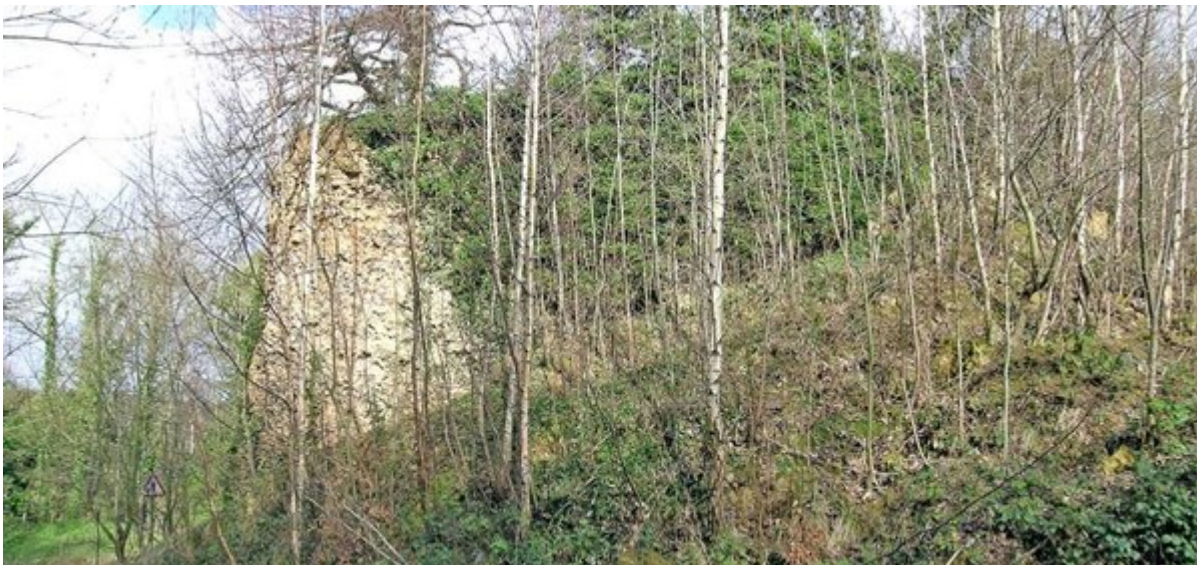
(Figure 92) General view of south face of breccia stump. [SE 53457 00488].

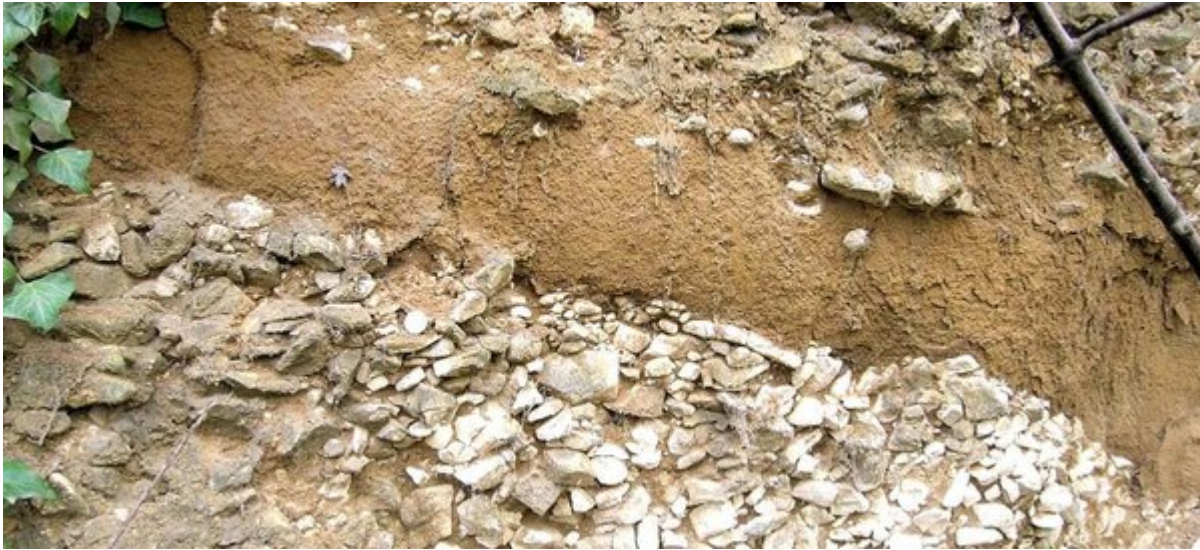
(Figure 93) Detail of sandstone and limestone layers in south face of breccia stump. [SE 53457 00488].

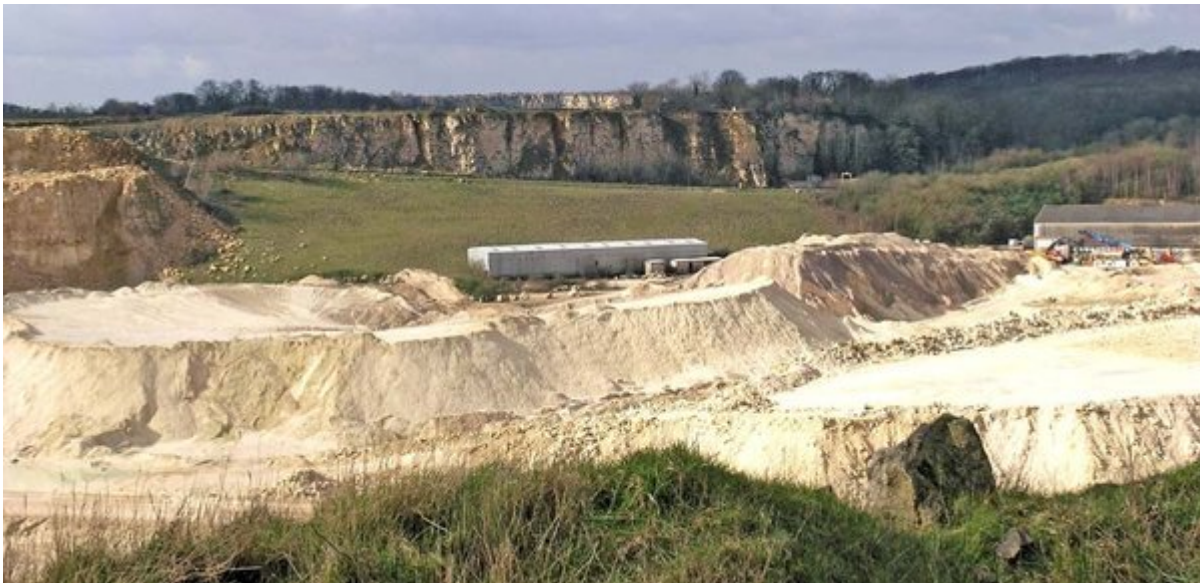
(Figure 94) General view of quarry looking to the west. [SE 53900 00400].
