A19 D78 Warmsworth Park

Site information

Site name: Warmsworth Park

Site key: D78

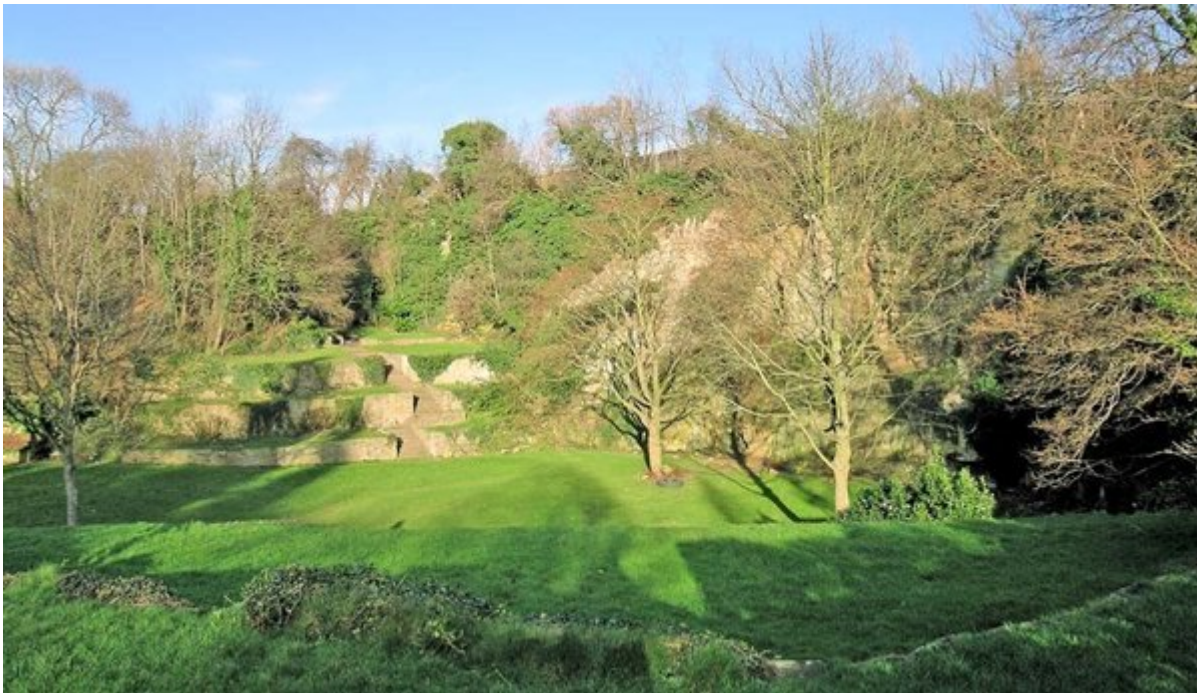
(Figure 96) General view of landscaping of the old quarry benches looking to the north. [SE 54460 00300].

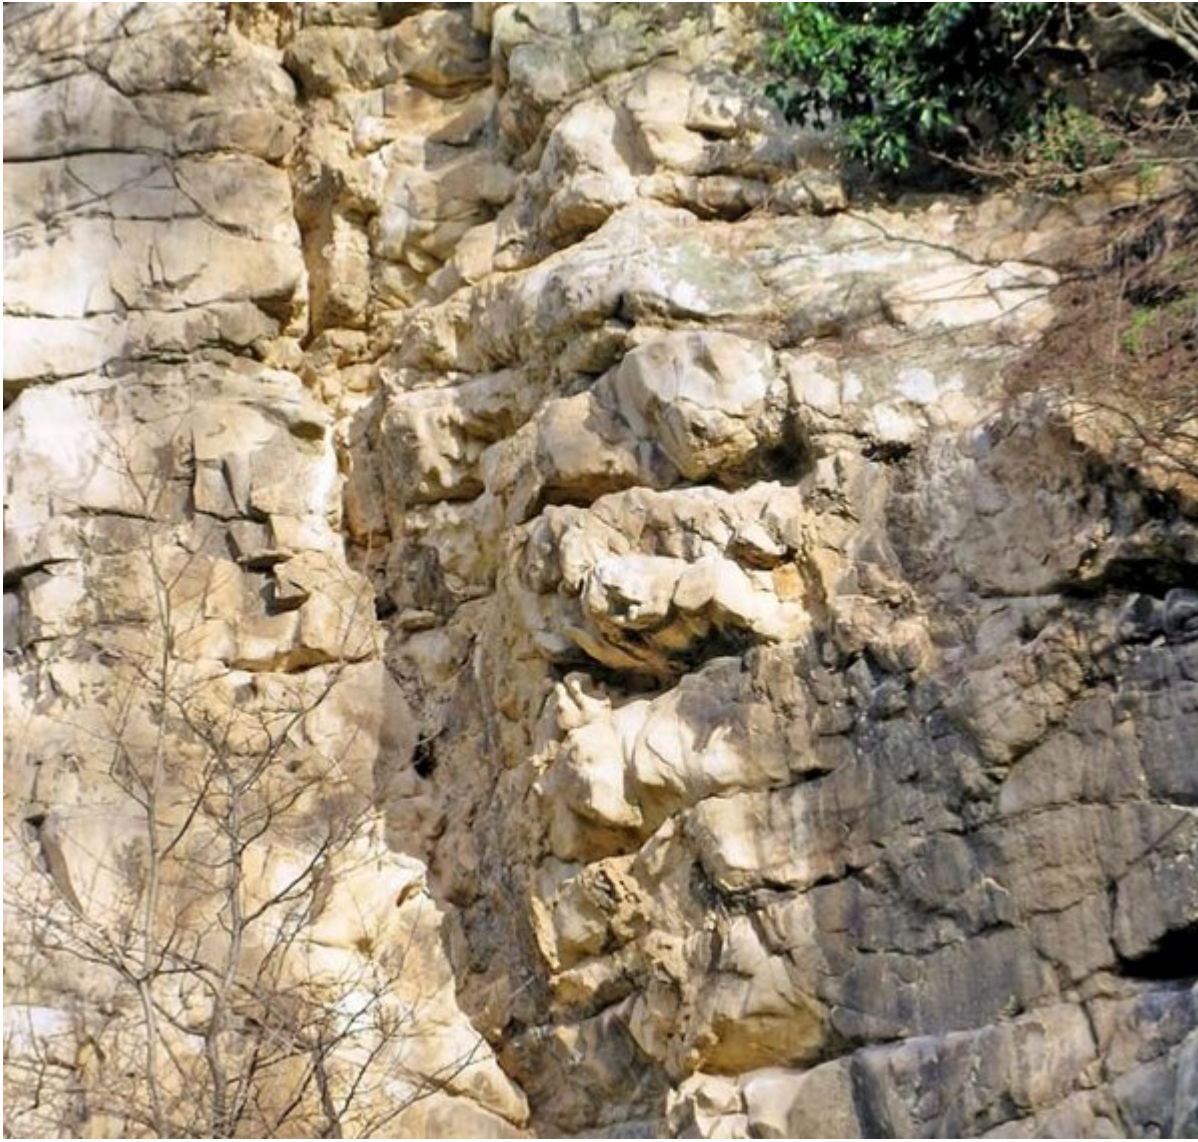
One particularly interesting feature is a vertical joint in a quarry face that shows widening and solution of the limestone by percolating groundwater and is possibly associated with the formation of Karst topography on a once exposed and weathered surface.

(Figure 98) Development of a sink hole and solution features along a joint in the eastern face of the quarry. [SE 54470 00370].
