A19 D78 Warmsworth Park

Site information

Site photographs D78 Warmsworth Park

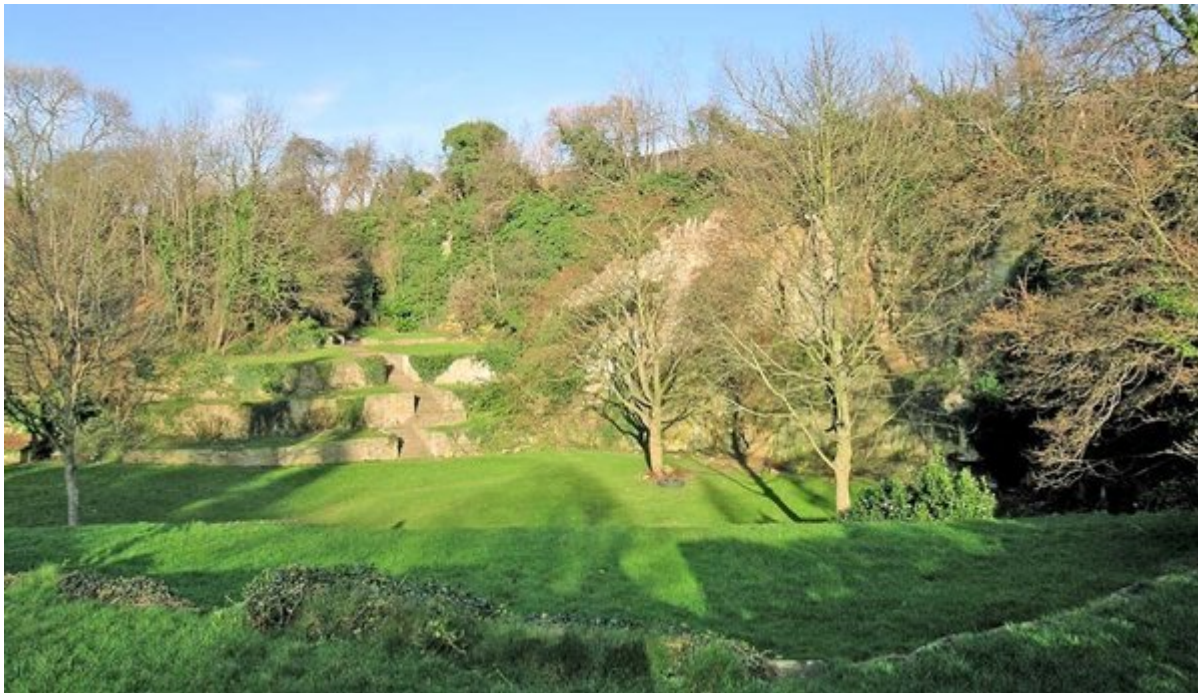
Many of the quarry faces are obscured with vegetation but where exposed in the high quarry benches, the uppermost beds are flaggy in nature, a feature that is highlighted by weathering and the formation of soil horizons.

(Figure 96) General view of landscaping of the old quarry benches looking to the north. [SE 54460 00300].

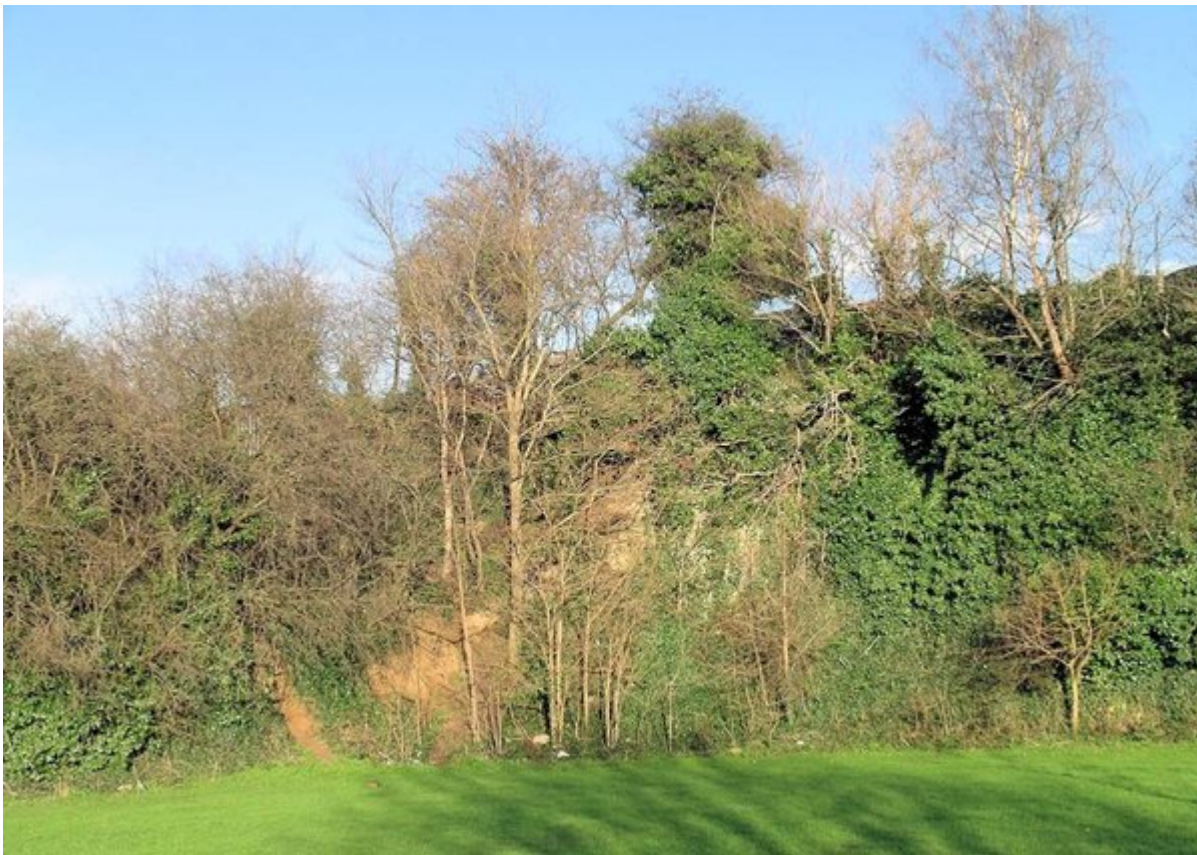
At one location on the eastern side of the quarry, there is a mass of poorly consolidated red/brown sandy material up to 6.5 m thick with angular and sub-rounded fragments which is probably till similar to that seen at Hexthorpe Flatts, Cedar Road Quarry and New Edlington Brick Pit. However, here it occurs at the same level as an 8 m high limestone quarry face. Junctions with the limestone are not exposed and it is not clear if this is a natural deposit in a fault bound rift within the limestone or relates to the former quarrying activities.

(Figure 97) General view of till (left) and limestones of the Sprotbrough Member (right). [SE 54470 00305].

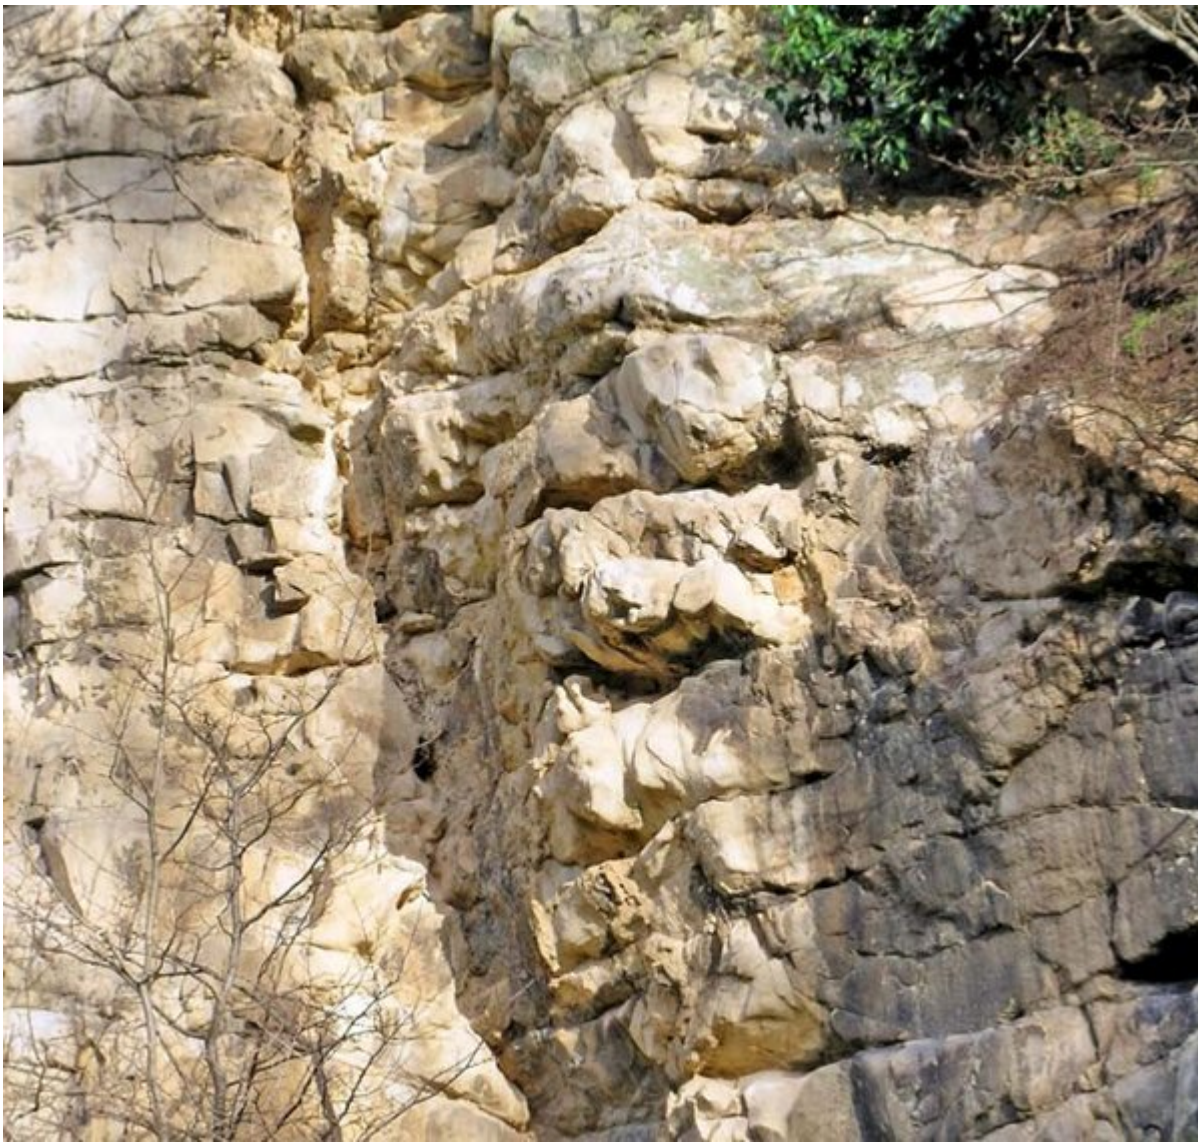
One particularly interesting feature is a vertical joint in a quarry face that shows widening and solution of the limestone by percolating groundwater and is possibly associated with the formation of Karst topography on a once exposed and weathered surface.

(Figure 98) Development of a sink hole and solution features along a joint in the eastern face of the quarry. [SE 54470 00370].
