A25 D61 New Edlington Brick Pit

Site name: New Edlington Brick Pit

Site key: D61

Field surveyor: Scott Engering **Date:** 19/1/07

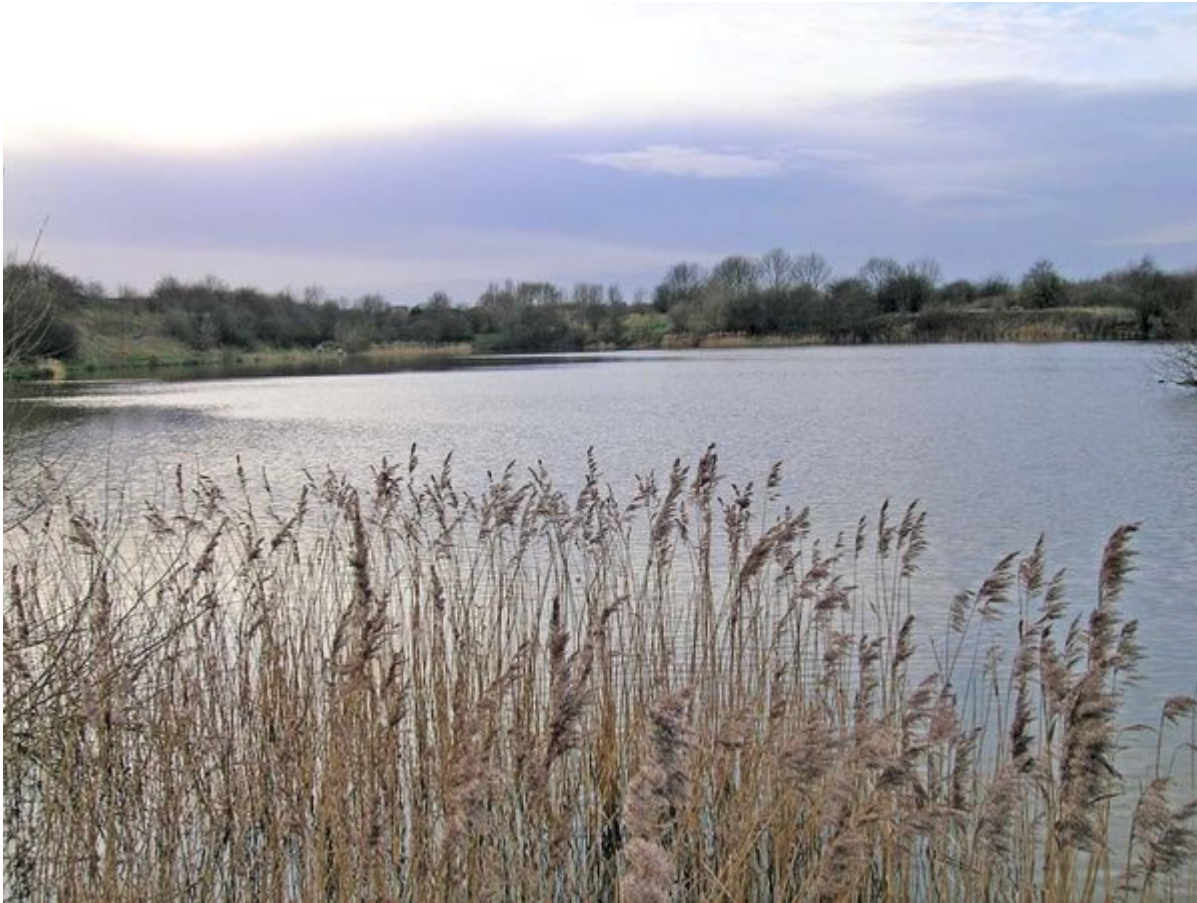
Disused brick pit, now filled with water and used for angling and nesting site for birds. Located behind allotments to rear of Dixon Road.

(Figure 119) General view across the old flooded brick pit to the south-west. [SK 53320 98610].

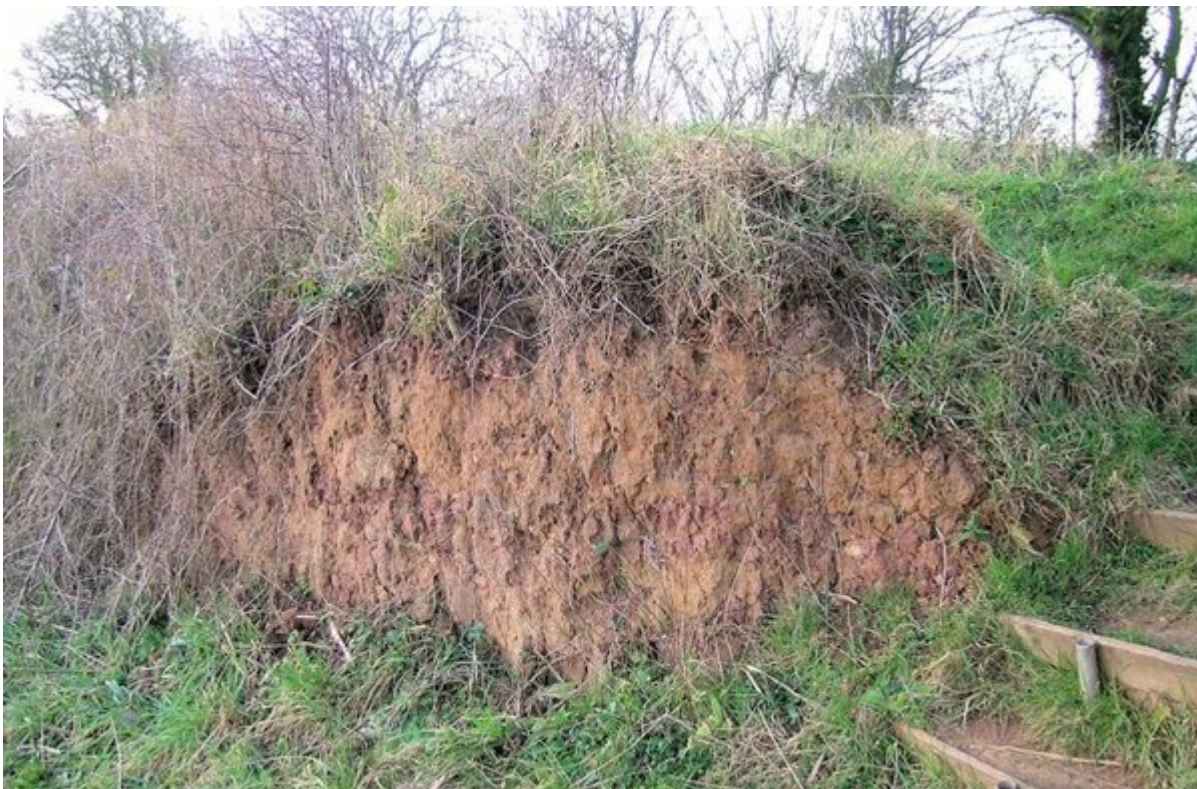
Current condition Gypsum and marl not visible at time of survey. Till has limited exposures that are susceptible to vegetation growth. Rating: 4

(Figure 120) Exposure of weathered till to the north side of the flooded brick pit. [SK 53140 98550]

(Figure 120) Exposure of weathered till to the north side of the flooded brick pit. [SK 53140 98550].

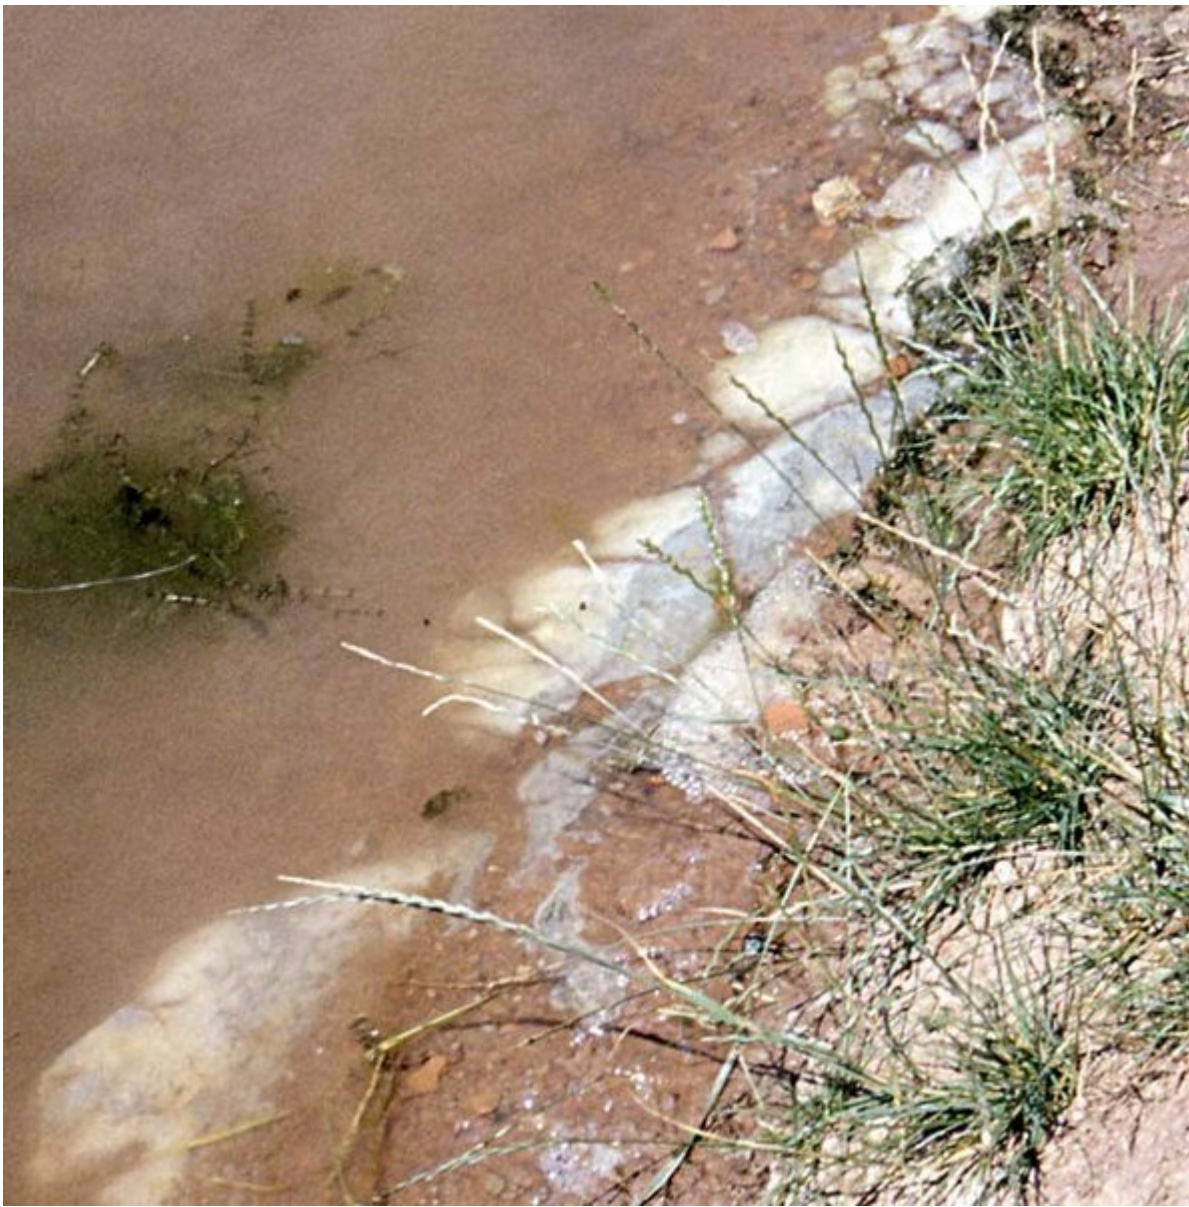
Green and red marls with gypsum bands exposed at water level around the edge of the pit. To the northern edge of the pond, occasional exposures of red, sandy boulder clay can be seen, similar to that seen at Warmsworth Park, Hexthorpe Flatts and Cedar Road Quarry. At the date of survey, there were no exposures of marl and gypsum visible due to rise in water level of approximately 4 feet after recent heavy rains. Current water level approximately 4.3 m, with minimum of about 2.5 m feet in summer. The pond is normally drained at regular intervals with a sluice but this had not been done for some time.

(Figure 121) Detail of gypsum outcrop within the Edlington Formation, as seen during the 1997 RIGS survey. [SK 53250 98500].
