A25 D61 New Edlington Brick Pit

Site name: New Edlington Brick Pit

Site key: D61

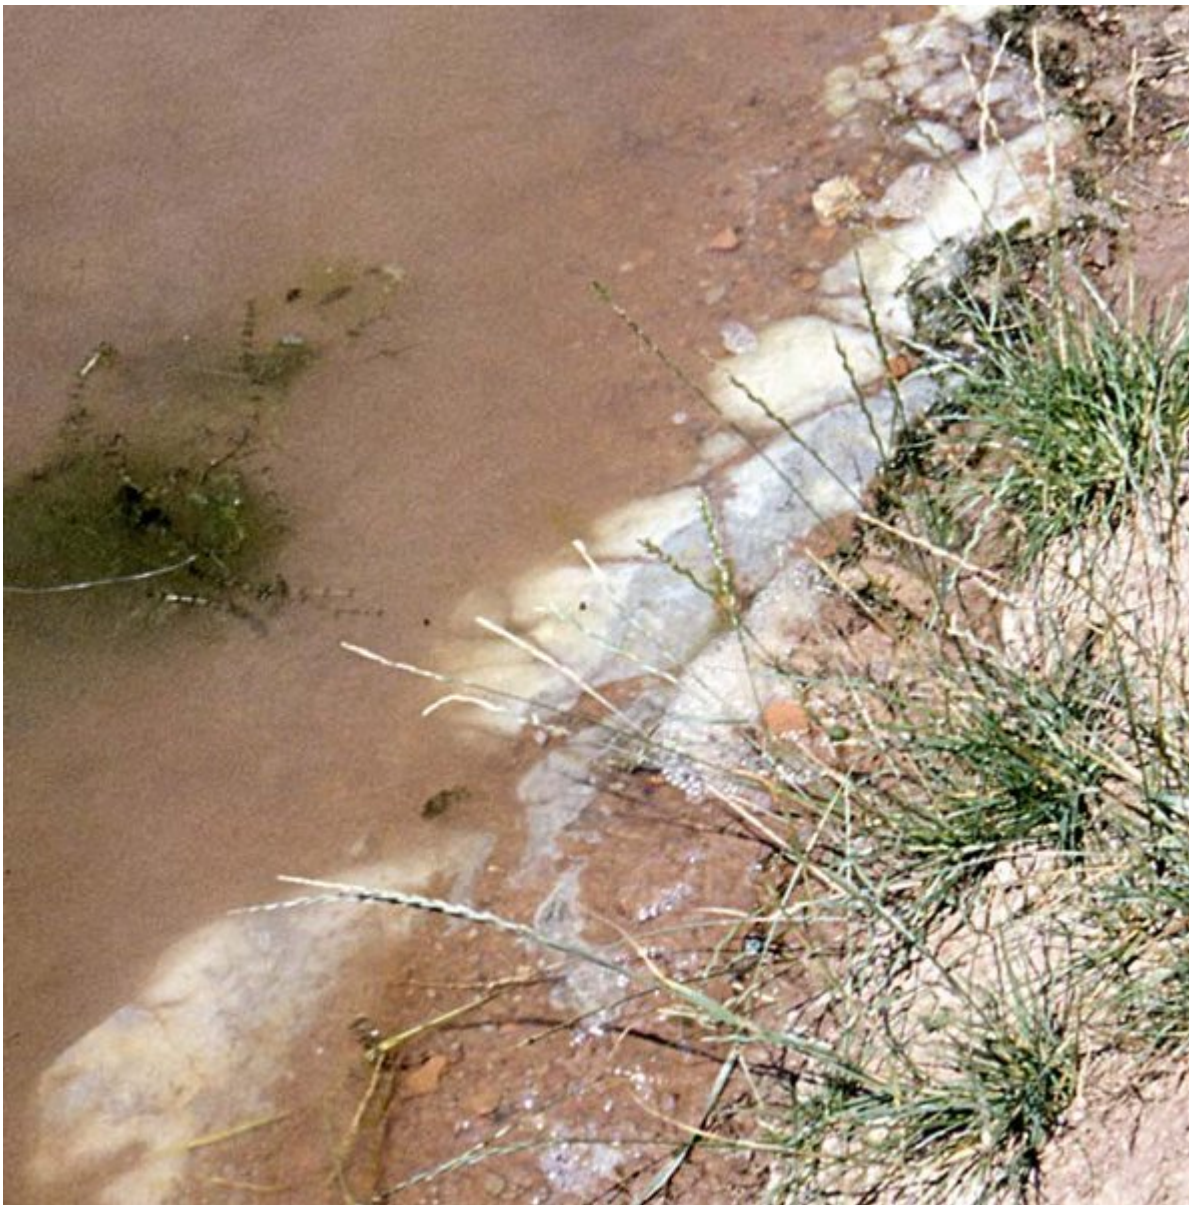
Sedimentary Rare exposure of gypsum in Edlington Formation. Till provides evidence of distribution of this deposit in the district. Rating: 6

Minerals Rare occurrence of gypsum. Rating: 6

(Figure 121) Detail of gypsum outcrop within the Edlington Formation, as seen during the 1997 RIGS survey. [SK 53250 98500].
