A33 D190–192 Blaxton Common

Site information

Field surveyor: Scott Engering **Date:** 16/2/07

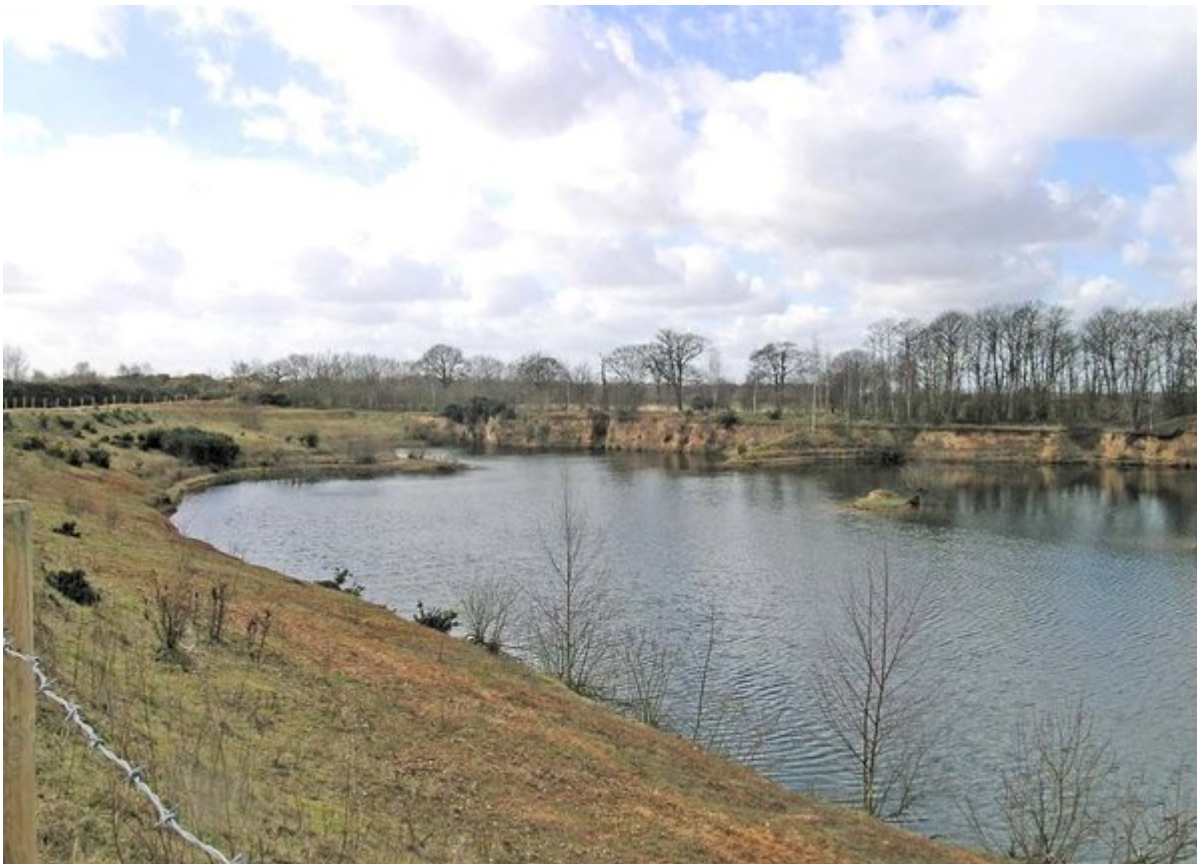
Large area of old sand and gravel pits that have long since been disused. The site is understood to be in multiple ownership but the only known owner is Tarmac, whose representative accompanied me on the visit to the Levels Lane Quarry. The principal feature of interest here is a large flooded pit with an exposure of up to 6 m of Sherwood Sandstone along the entire length of its western side. Photos taken from [SE 68716 02029]. The pit has been fenced off since the date of the last survey in 1997 and old bits of plant and machinery etc have been cleared away.

(Figure 156) General view of old sand and gravel workings. [SE 68716 02029].

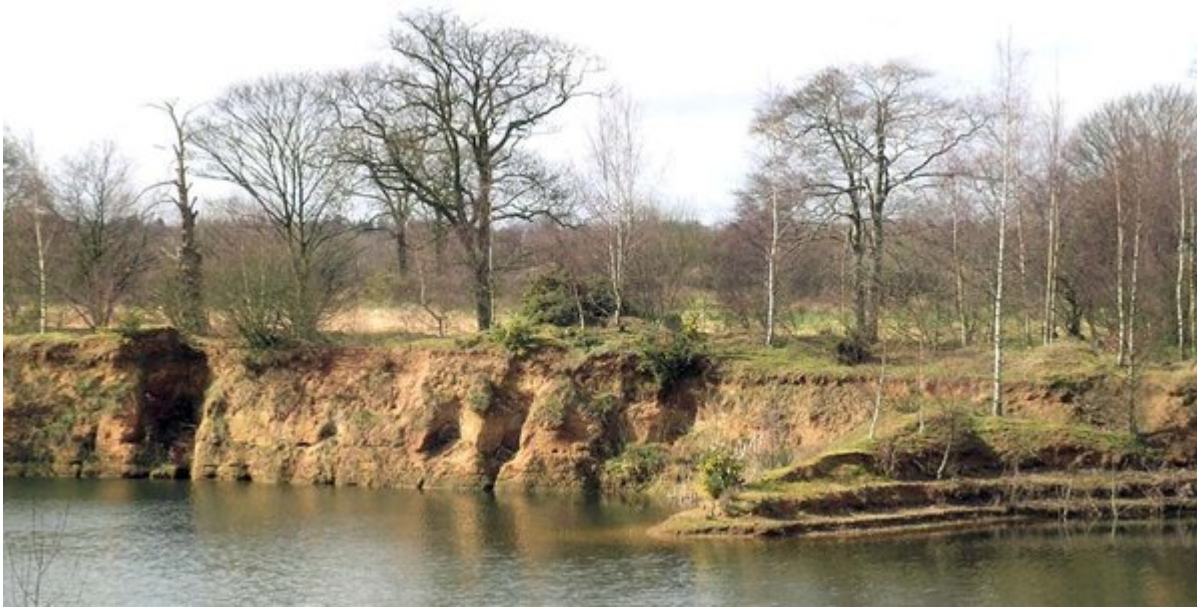
The exposure is in effect now inaccessible. The entrance to the quarry is gated and is used by a farmer on adjoining land. Waterside exposure limits safe access to study rock.

(Figure 157) Detail of Sherwood Sandstone in old sand and gravel workings. [SE 68716 02029].

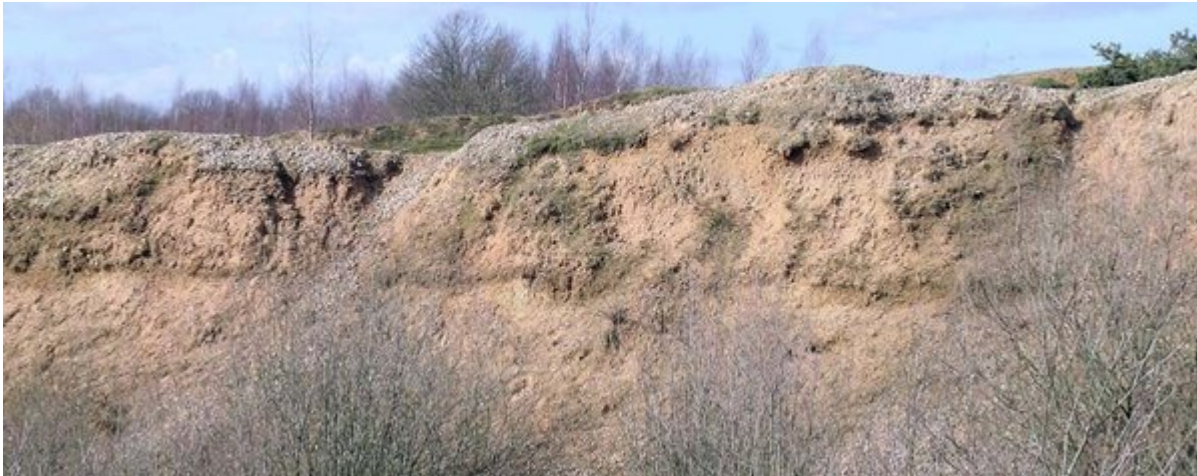
The site is now much more overgrown than in the 1997 survey and exposures of the Older River Gravel are not easy to find. Many exposures are adjacent to flooded parts of the site and are thickly vegetated and are not generally safely accessible. Occasional exposures can be seen beneath tree roots as at [SE 66879 01714] or larger expanses as seen at [SE 68491 01742] but detailed assessments of the potential value of these exposures was not ascertained due to access problems.

(Figure 158) Residual exposure of sand and gravel. [SE 68491 01742].

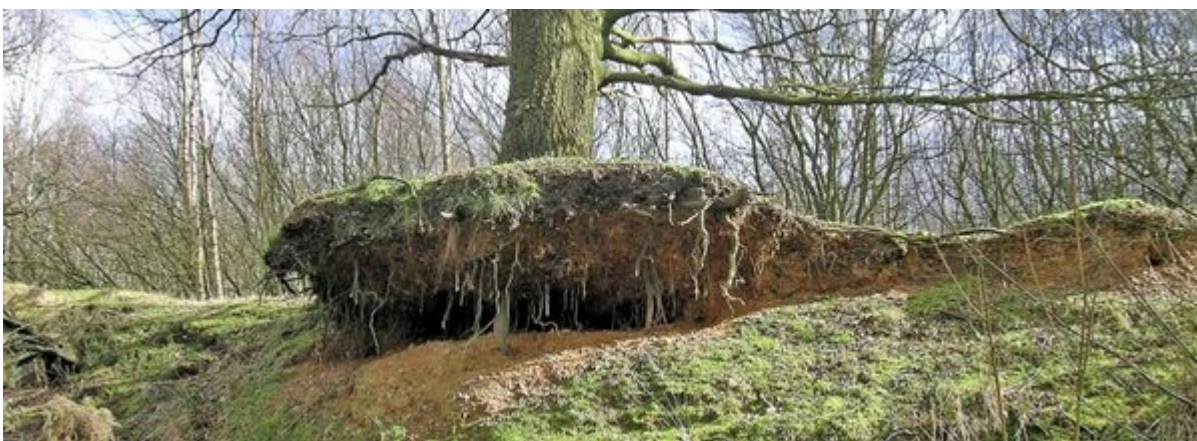
(Figure 159) Detail of sand and gravel beneath tree roots. [SE 66879 01704].
