## A33 D190–192 Blaxton Common

### Site information

**Field surveyor:** Scott Engering **Date:** 16/2/07

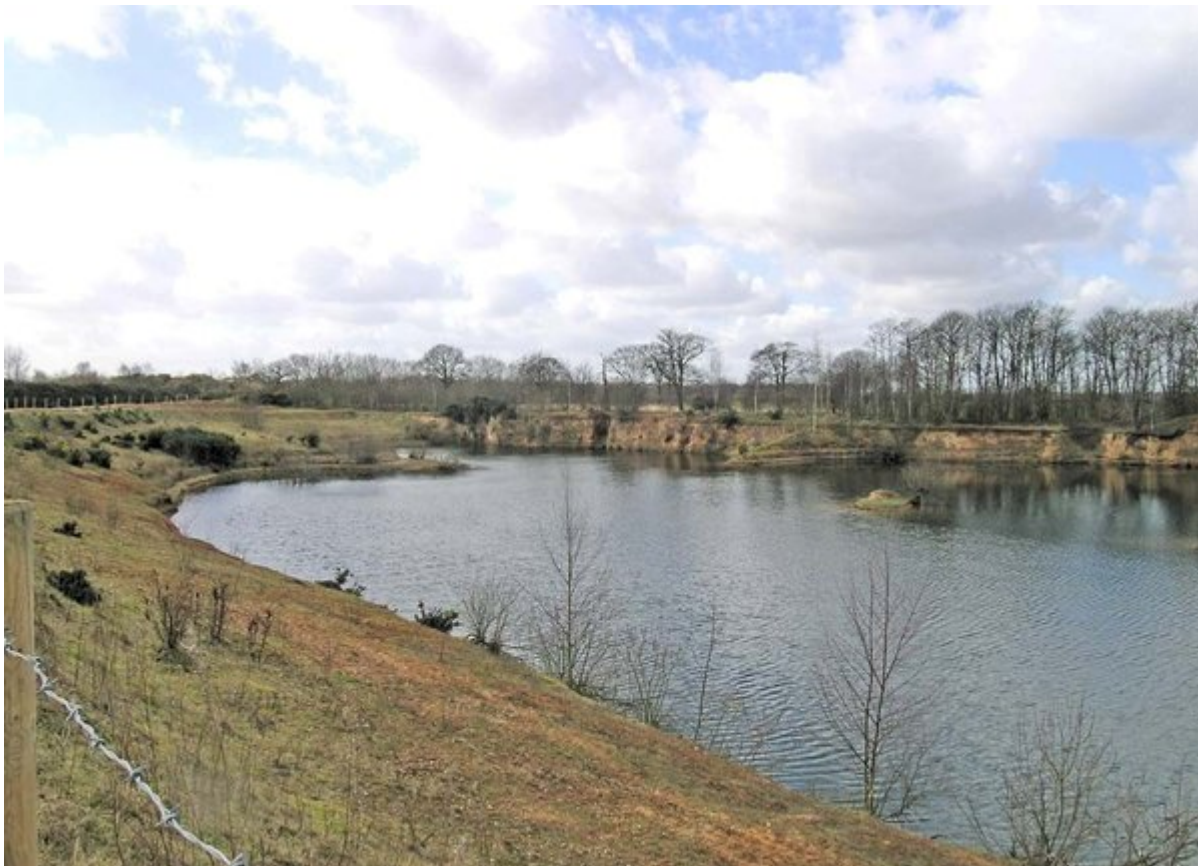
Large area of old sand and gravel pits that have long since been disused. The site is understood to be in multiple ownership but the only known owner is Tarmac, whose representative accompanied me on the visit to the Levels Lane Quarry. The principal feature of interest here is a large flooded pit with an exposure of up to 6 m of Sherwood Sandstone along the entire length of its western side. Photos taken from [SE 68716 02029]. The pit has been fenced off since the date of the last survey in 1997 and old bits of plant and machinery etc have been cleared away.

(Figure 156) General view of old sand and gravel workings. [SE 68716 02029].

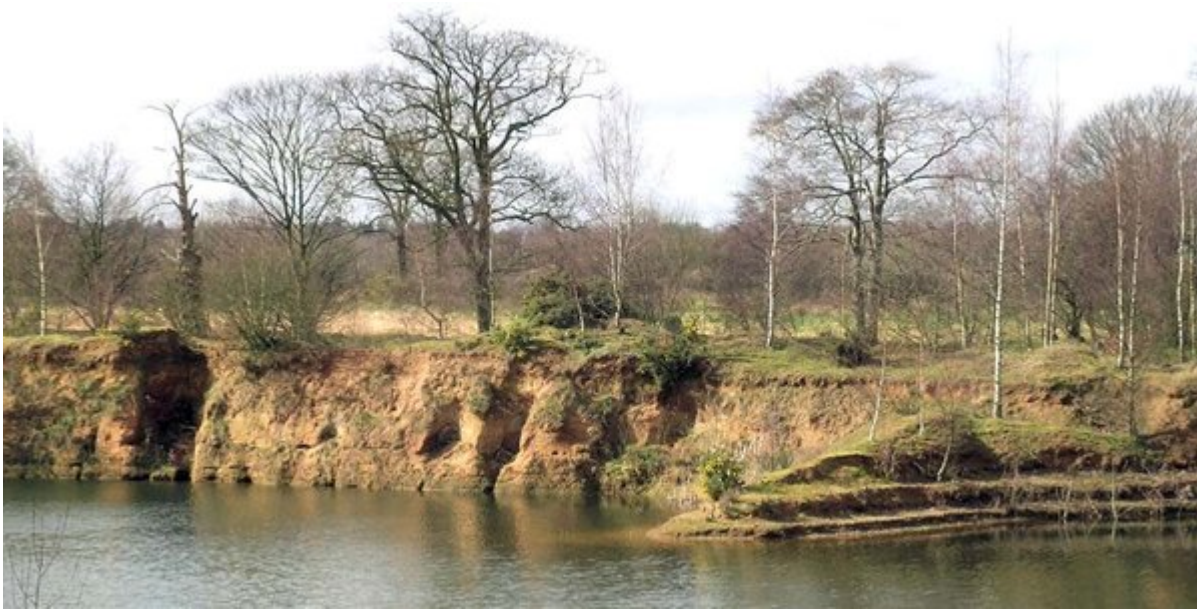
The exposure is in effect now inaccessible. The entrance to the quarry is gated and is used by a farmer on adjoining land. Waterside exposure limits safe access to study rock.

(Figure 157) Detail of Sherwood Sandstone in old sand and gravel workings. [SE 68716 02029].

*(Figure 157) Detail of Sherwood Sandstone in old sand and gravel workings. [SE 68716 02029].*

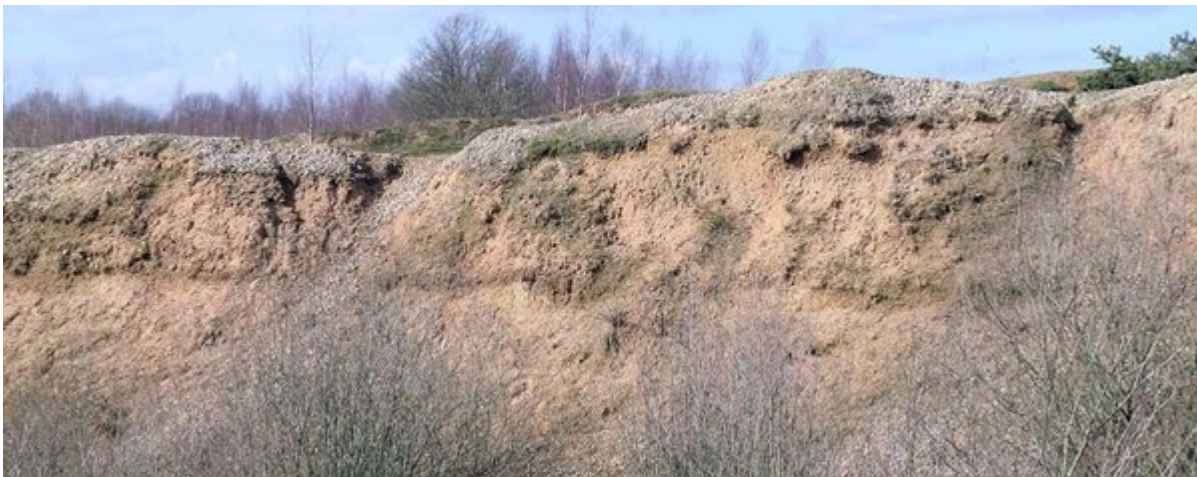
(Figure 158) Residual exposure of sand and gravel. [SE 68491 01742].

*(Figure 158) Residual exposure of sand and gravel. [SE 68491 01742].*

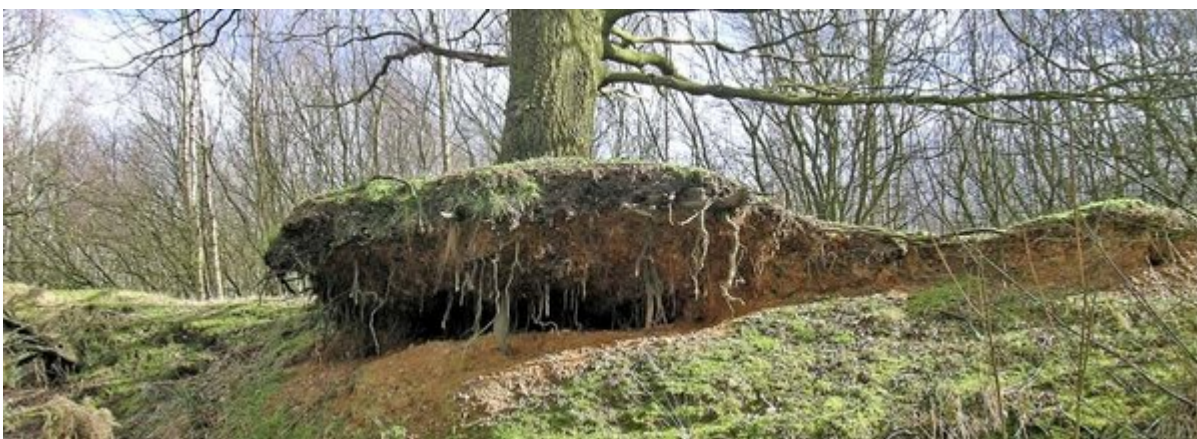
The site is now much more overgrown than in the 1997 survey and exposures of the Older River Gravel are not easy to find. Many exposures are adjacent to flooded parts of the site and are thickly vegetated and are not generally safely accessible. Occasional exposures can be seen beneath tree roots as at [SE 66879 01714] or larger expanses as seen at [SE 68491 01742] but detailed assessments of the potential value of these exposures was not ascertained due to access problems.

(Figure 159) Detail of sand and gravel beneath tree roots . [SE 66879 01704].

*(Figure 159) Detail of sand and gravel beneath tree roots. [SE 66879 01704].*
