# A1 D6 Denaby Lane

## Site information

## **RIGS assessment of site value**

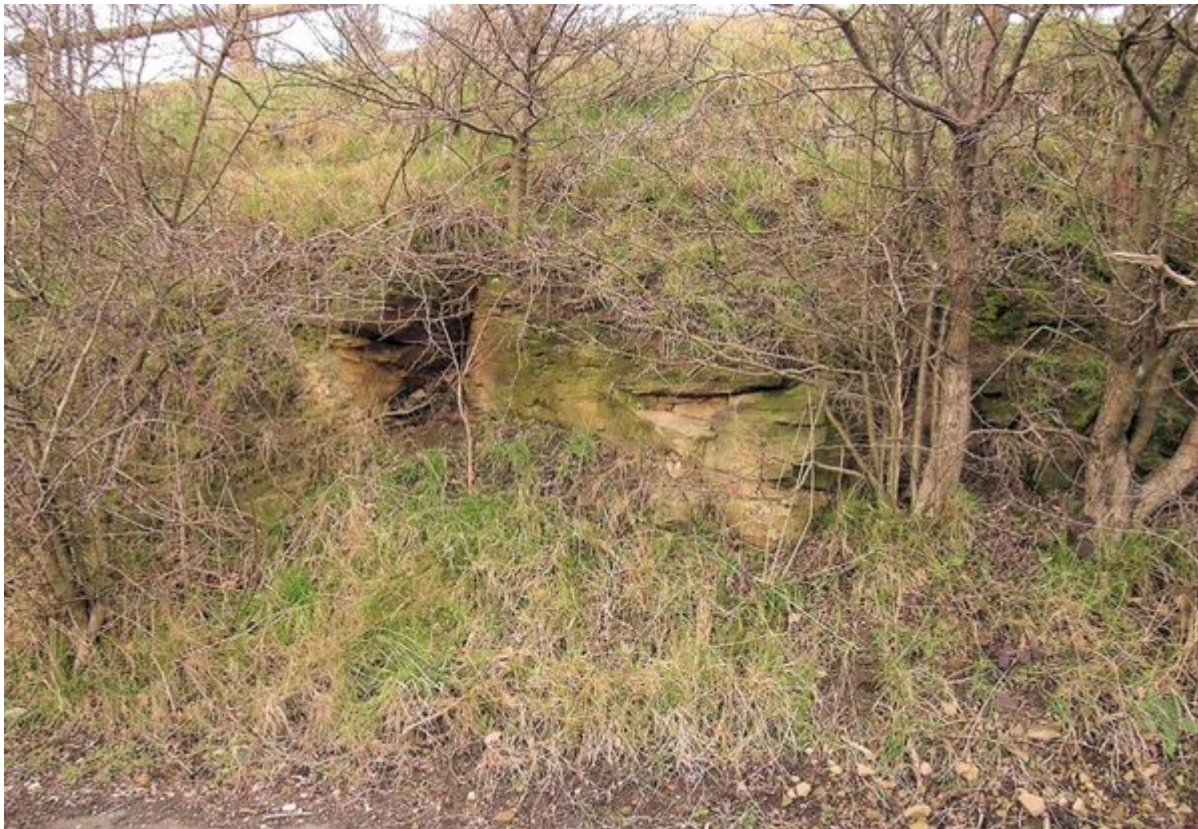
Limited outcrop of Mexborough Rock in roadside cutting [SK 48974 99510], with maximum section of 3 m. Exposure is sporadic along the length and is often largely overgrown. Where exposed, it comprises cross bedded, fine to medium grained flaggy sandstone with iron staining, especially to the surfaces of the joints. The highest levels of the exposed sections show advanced disruption by roots and the processes of soil formation.

**Current condition** Much of the section is overgrown and would be improved by selective clearance and removal of large shrubs/small trees. Rating: 5

(Figure 15) Road cutting exposure of Mexborough Rock with vegetation overgrowth.[SK 48974 99510].

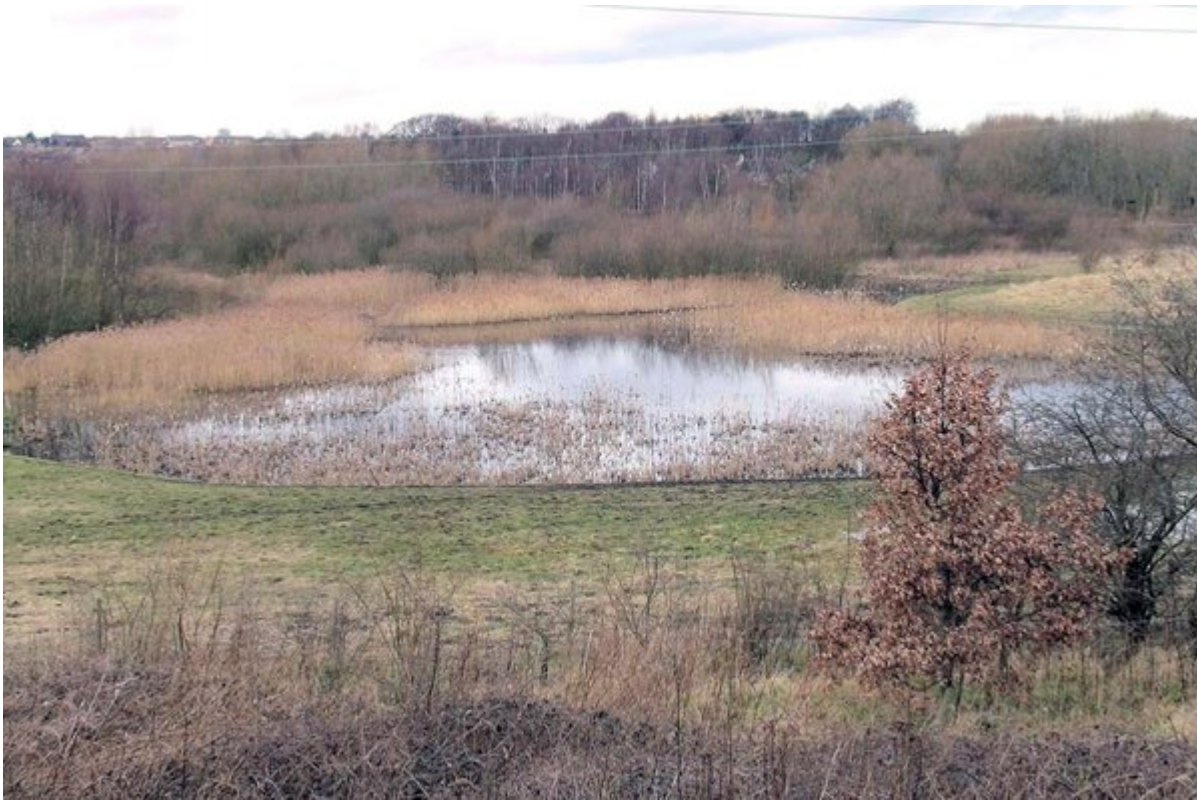
*(Figure 16) Wetlands associated with the former course of the River Don. [SK 48894 99473].*

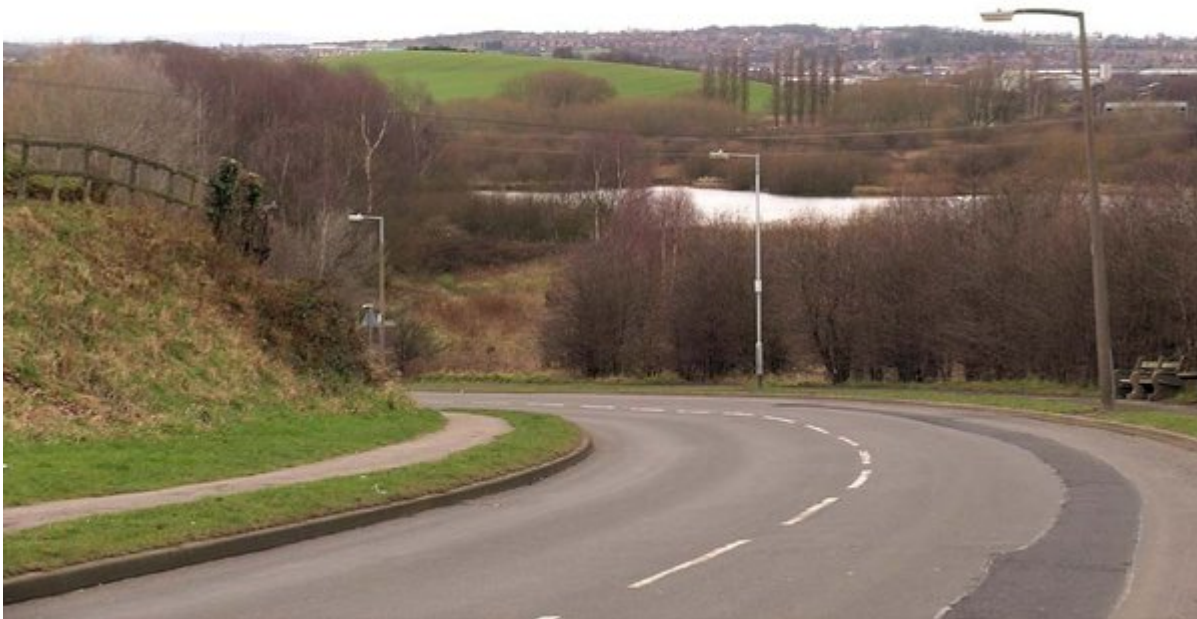
The position of the roadside exposure coincides with a steep drop in the road down an escarpment that is formed by a south-west trending fault line, with a down throw to the north. The fault is part of the South and North Don Fault system and contributes to the topography of the Mexborough Rock, which forms a prominent ridge alongside the Hooton Roberts road. Where the rock mainly outcrops opposite Coalpit Road, there are good views of this topography and further down the hill at [SK 48894 99501] and [SK 48848 99473], the wetlands associated with a former meander of the River Don is seen. From this site, at [SK 4855 9865] to the north of the River Don and [SK 47859 99511] (Ferryboat Farm Fisheries), where there is part of an oxbow lake, a good appreciation of the geological structure and geomorphology of the area may be obtained.

*(Figure 17) View to the Don Valley over a fault and down the escarpment. [SK 48870 99500].*
