Mam Tor, Derbyshire

[SK 130 836]

R.G. Cooper and D. Jarman

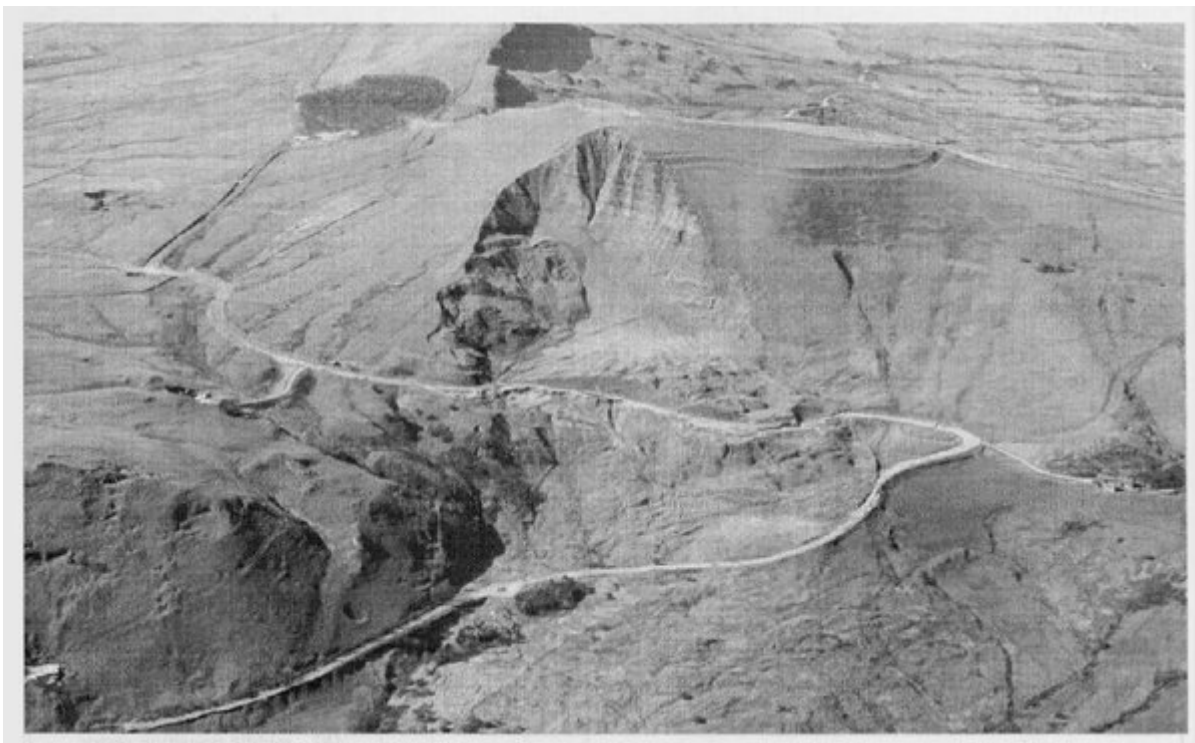
(Figure 5.27) Oblique aerial photograph of the Mam Tor area, showing the old road which was closed in 1979 owing to repeated slippage. The scar of the landslip is clearly visible, as well as a slumped mass. (Photo: © National Trust/High Peak.)

It is unusual for an inland slide in Britain to interfere with important communication routes. Here, the original direct road between Manchester and Sheffield (A625) became so affected by repeated slippage (Figure 5.27) that it was closed in 1979, necessitating unprecedentedly lengthy detours for trunk traffic. This has prompted a series of detailed geotechnical studies including Lounsbury (1962), Brown (1966, 1977), Stevenson and Gaunt (1971), Lant (1973), Lupini (1980), Al-Dabbagh (1985), and notably Skempton *et al.* (1989), making Mam Tor probably the best understood mass movement of natural origin in inland Britain. It provides an invaluable point of reference for interpreting similar and contrasting sites. It also has the benefit of a guide for visitors interested in its geology (Cripps and Hird, 1992), while Derbyshire County Council has placed an informative board at the foot of the closed road.

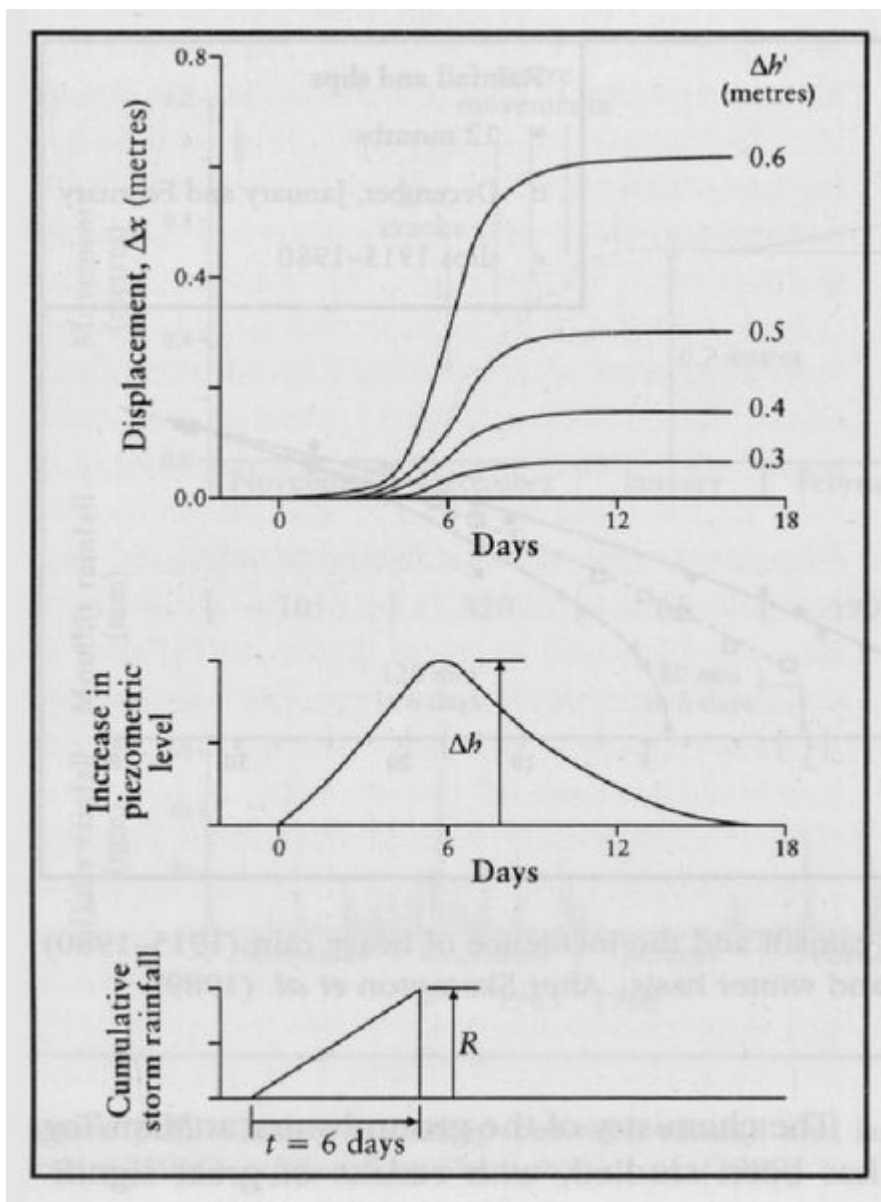
(Figure 5.36) Displacements at Mam Tor caused by winter rainstorms. Note: movement begins at a piezometric level that is lower than the level at which movement ceases. This may imply that there has been a strength gain that may be of chemical origin in which movement releases cations. After Skempton et al. (1989).

Observations from piezometers installed at or near the shear zone for short periods in 1977 and 1978 give an indication of the seasonal response of the landslide's groundwater levels to rainfall (Figure 5.35) and (Figure 5.36). In winter months, when the soil moisture deficit is effectively zero, the greater part of the rainfall not lost as runoff penetrates to augment groundwater. Under such conditions the 'storm response' in groundwater level is more or less directly proportional to the rainfall. While the ratio may vary locally with permeability, slope angle, depth to water table and intensity of rainfall, in uniform strata the response, seasonal as well as short term, is practically the same at different depths. Thus for winter rainstorms capable of causing substantial movements, the corresponding transient groundwater rise in the lower sector is about 0.5 m. In the upper sector, permeability is higher, where broken sandstone exists in the debris, and winter groundwater is at a greater depth; the average slope is steeper, but runoff from the scarp face will contribute a throughflow component. Therefore storm response in this part of the landslide is not very different from that in the lower sector, and in any case it is unlikely, even as an upper limit, to exceed the seasonal response of 0.7 m measured in a borehole in the upper sector.

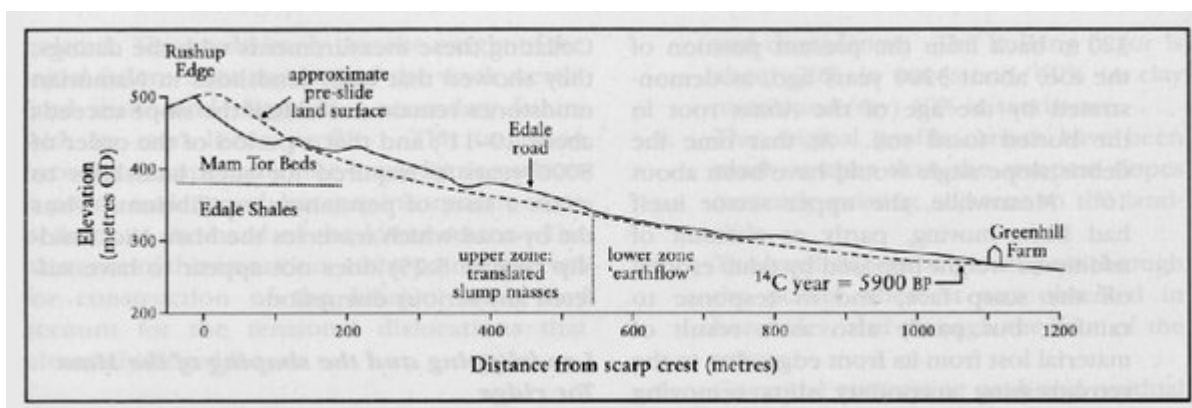
(Figure 5.40) Landslide profiles at Mam Nick, where $\theta = 10^\circ$. After Skempton et al. (1989).

1. Mam Nick (0.60 km²): this landslide has twice the extent of the Mam Tor event, and narrows the crest of Rushup Edge to a half-arête for 500 m (Figure 5.40). The source configuration is an obtuse wedge. In its south-east corner, it breaks through the ridge to create the 'Nick' followed by the minor road over to Edale. Here it has lowered the ridge by about 40 m, and truncates the west flank of Mam Tor, including its hillfort rampart (Figure 5.41). The main headscarp is of steep grass approximately 25 m high, with a clutch of short-travel sharp-crested slip masses having bold anti-scarps 3–5 m high. Beneath these, the apron of the main failed mass is crossed by the road, below which an amorphous 'earth-flow' extends at a lesser gradient for 500 m down to an 8–15 m-high toe bank above Greenhill Farm (Figure 5.40). This two-tier configuration is very similar to Mam Tor.
