EDC 9: Craighdu Burn, Bearsden

Field surveyor: Sarah Arkley & Luis Albornoz-Parra

Date visited: 6th March 2009

Summary description

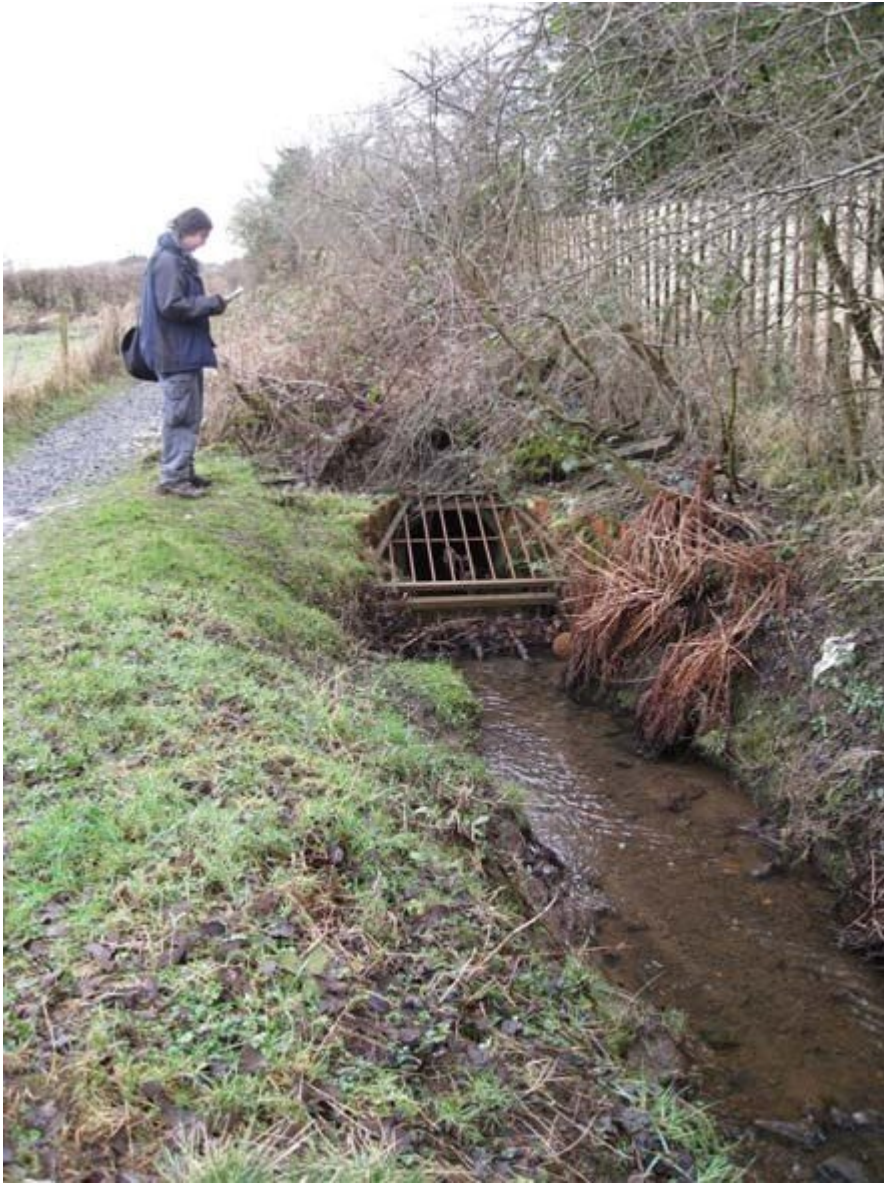
Current condition No geology sections exist anymore – burn is now piped underground

(Photo 37) Craigdhu Burn channelled underground. Looking SE.
