## EDC 9: Craighdu Burn, Bearsden

**Site type:** Natural exposure

**Date visited:** 6th March 2009

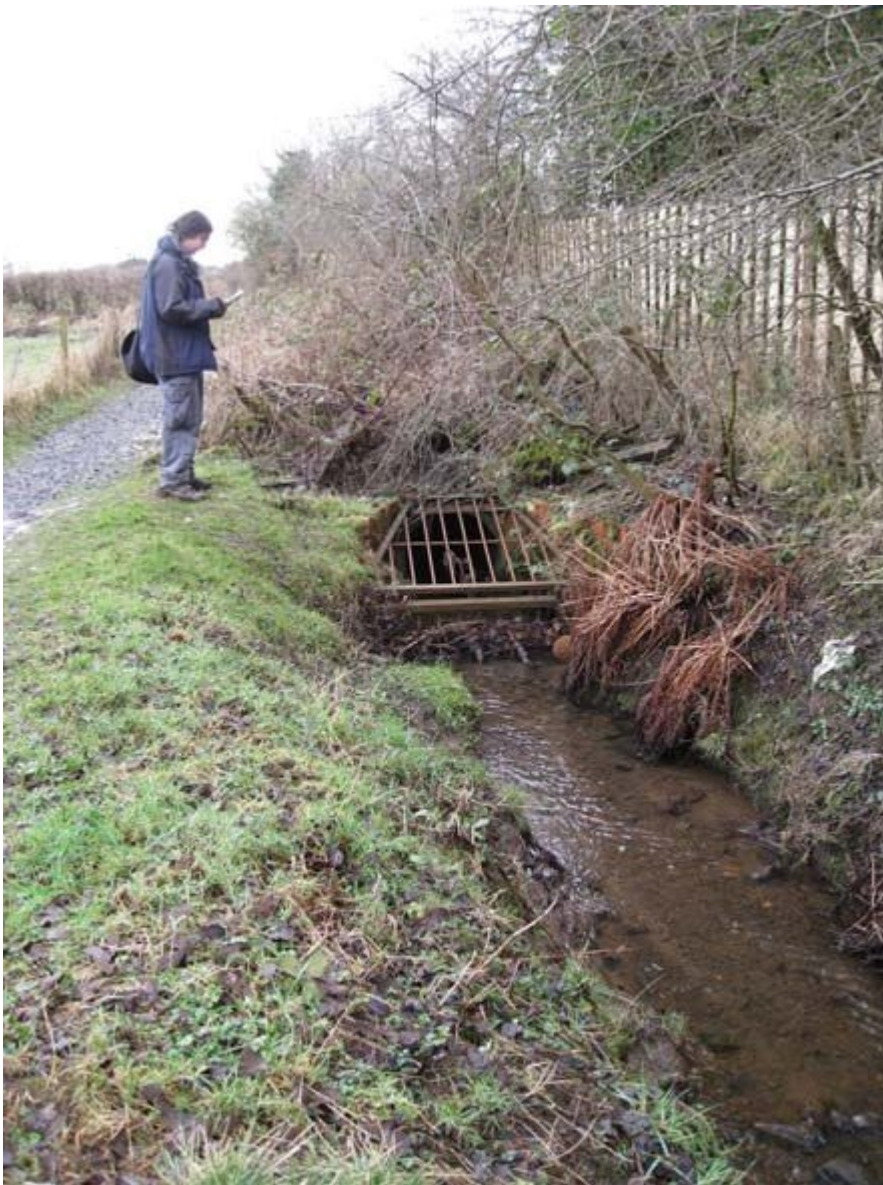
(Photo 37) Craigdhu Burn channelled underground. Looking SE.

*(Photo 37) Craigdhu Burn channelled underground. Looking SE.*

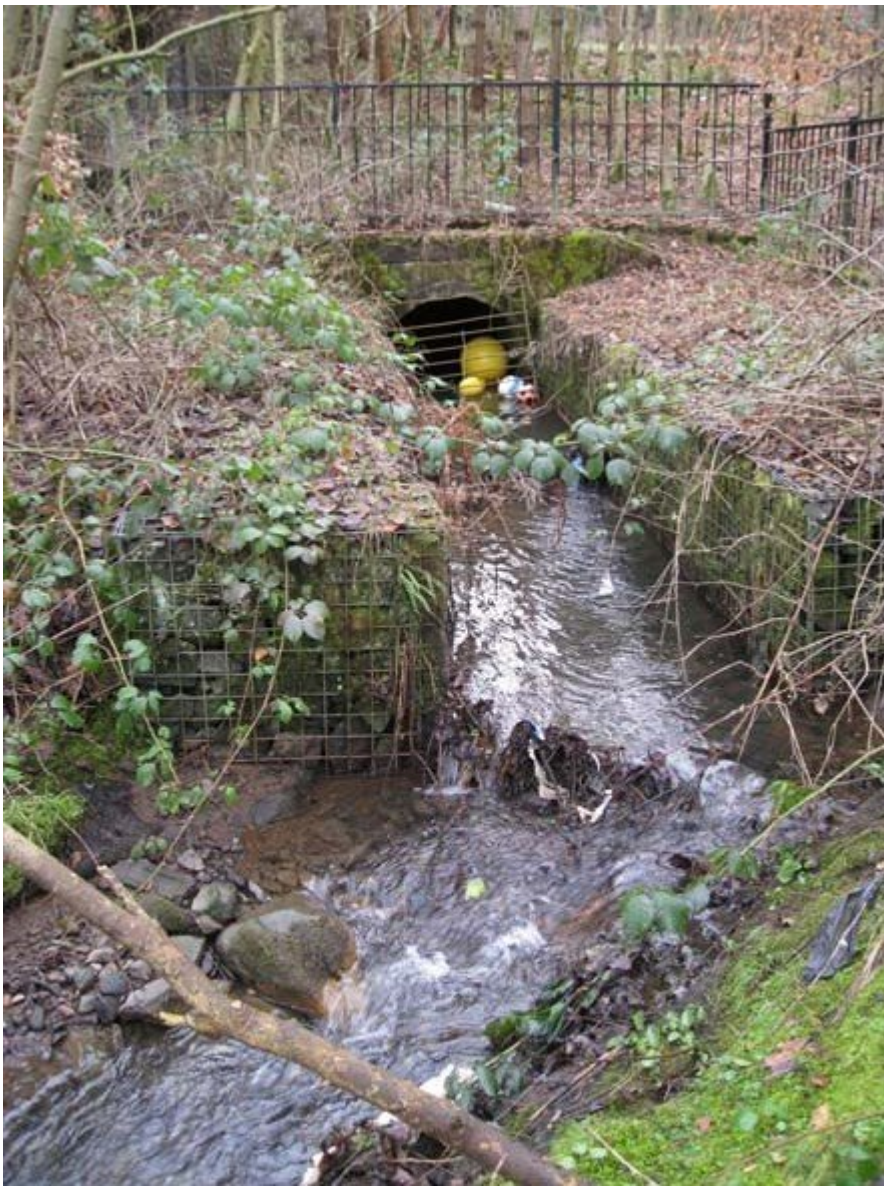
(Photo 38) Craigdhu Burn re-emerging. Looking WSW.

*(Photo 38) Craigdhu Burn re-emerging. Looking WSW.*

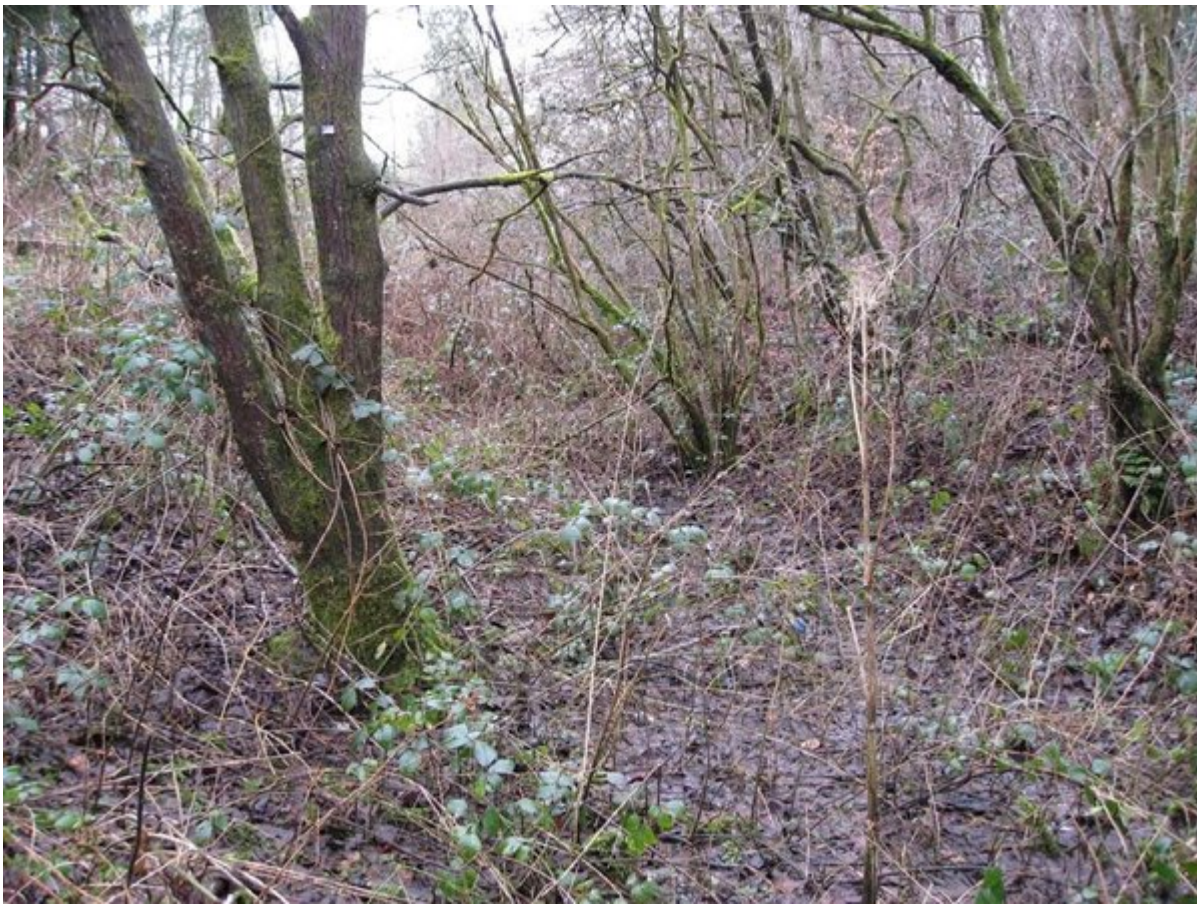
**Current condition** No geology sections exist anymore – burn is now piped underground

(Photo 39) View W along the course of Craigdhu Burn which is now piped underground. Previous geological maps have recorded exposures of sedimentary rocks belonging to the Limestone Coal Formation containing 'Lingula' shell fossils,

but these have now been landscaped and lost.

*(Photo 39) View W along the course of Craigdhu Burn which is now piped underground. Previous geological maps have recorded exposures of sedimentary rocks belonging to the Limestone Coal Formation containing 'Lingula' shell fossils, but these have now been landscaped and lost.*
