## EDC 29: Inchbelle Quarry, Kirkintilloch

**Site type:** Artificial quarry works

**Date visited:** 2nd April 2009

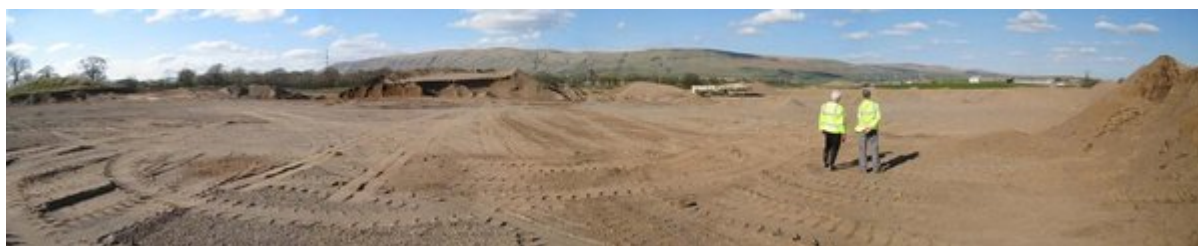
(Photo 179) Panorama across the active area of the quarry, with the Campsie Fells and Kilsyth Hills in the distance. The quarry is exploiting the glaciofluvial sand and gravels belonging to the Broomhouse Formation. Across the area the deposit is only a few metres thick and is generally composed of gravels overlying a unit of sand.

(Photo 179) Panorama across the active area of the quarry, with the Campsie Fells and Kilsyth Hills in the distance. The quarry is exploiting the glaciofluvial sand and gravels belonging to the Broomhouse Formation. Across the area the deposit is only a few metres thick and is generally composed of gravels overlying a unit of sand.

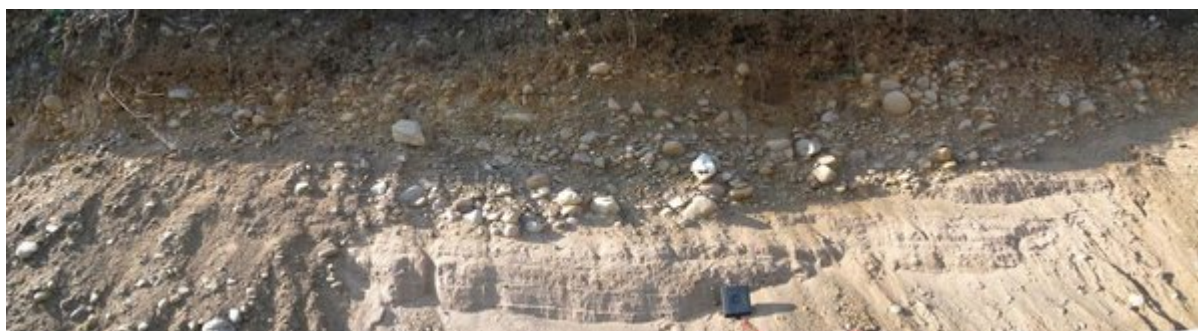
(Photo 180) The contact between the gravel and underlying sand unit can be clearly seen in small sections at the north-eastern edge of the quarry (partly infilled). The sand is generally medium- to coarse-grained and displays very gently dipping layers to the east. These layers are seen to be truncated by the erosive base of the gravels. Approx 70 cm of gravel is seen in this section, and the ill-defined bedding suggests a transport direction towards the east. Looking NW.

(Photo 180) The contact between the gravel and underlying sand unit can be clearly seen in small sections at the north-eastern edge of the quarry (partly infilled). The sand is generally medium- to coarse-grained and displays very gently dipping layers to the east. These layers are seen to be truncated by the erosive base of the gravels. Approx 70 cm of gravel is seen in this section, and the ill-defined bedding suggests a transport direction towards the east. Looking NW.

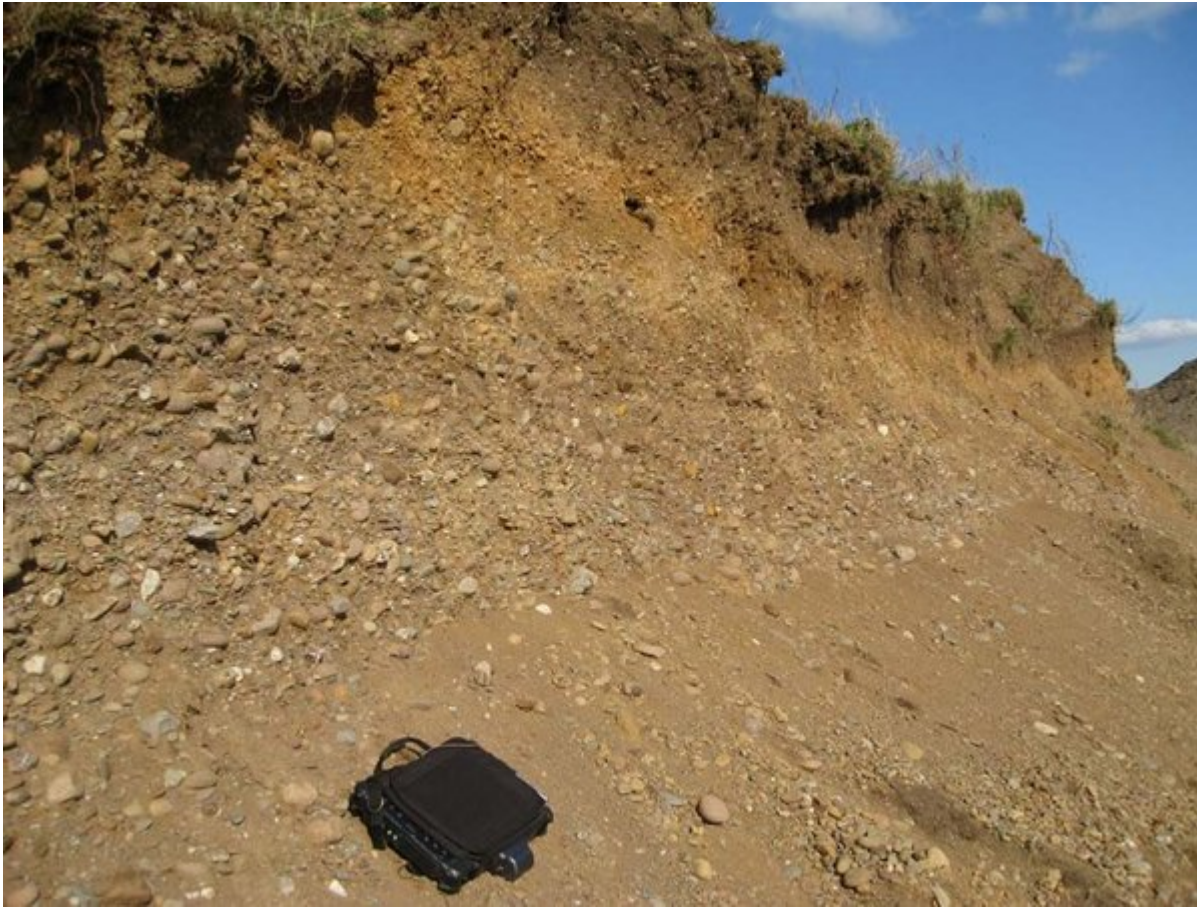
*(Photo 181) Exposures in the upper gravel unit, seen along the north eastern edge of an area which is partly infilled. The section displays up to 4 m of sandy gravel. Looking ENE.*

(Photo 181) Exposures in the upper gravel unit, seen along the north eastern edge of an area which is partly infilled. The section displays up to 4 m of sandy gravel. Looking ENE.

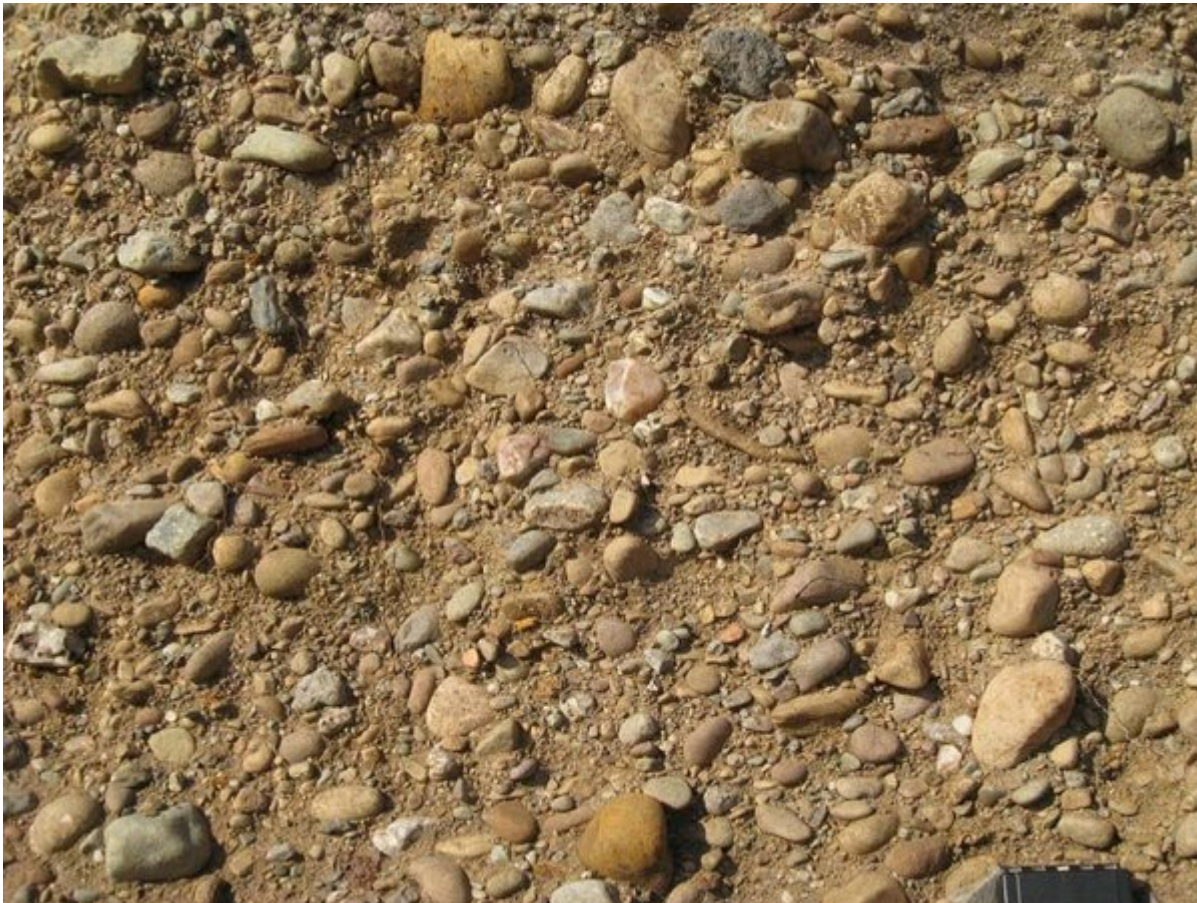
*(Photo 182) Close-up of the gravel unit seen in the figure above. The gravels are fairly poorly sorted, generally ranging between 5 cm and 15 cm in diameter mixed with medium- to coarse-grained sand. All the clasts are rounded to well*

rounded and are of various lithologies. Looking NNW.

(Photo 182) Close-up of the gravel unit seen in the figure above. The gravels are fairly poorly sorted, generally ranging between 5 cm and 15 cm in diameter mixed with medium- to coarse-grained sand. All the clasts are rounded to well rounded and are of various lithologies. Looking NNW.

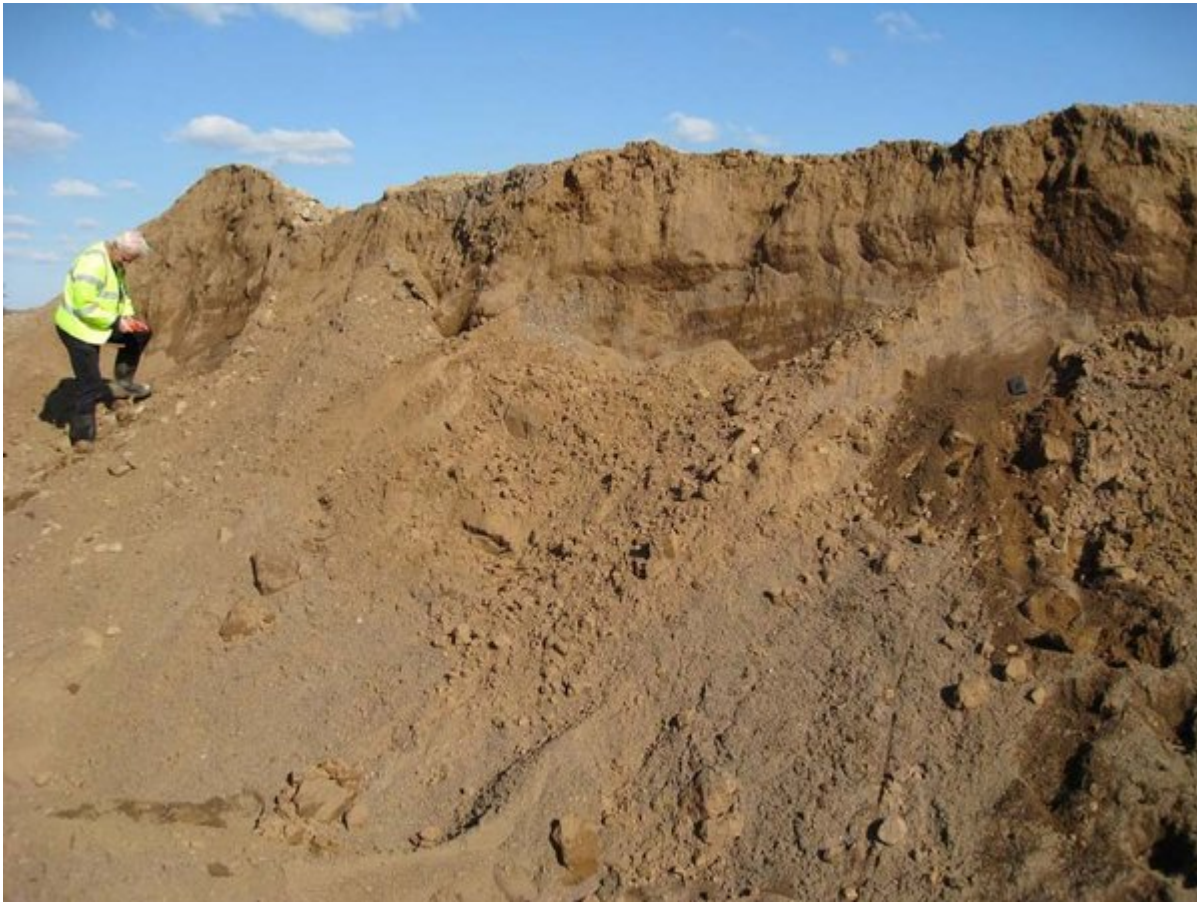
(Photo 183) Exposure in the lower sand unit at the southern edge of the active quarry (the upper gravel unit has been removed). On this visit approximately 1m of bedded medium- to coarse-grained sand with fine gravel was exposed. Looking east.

(Photo 183) Exposure in the lower sand unit at the southern edge of the active quarry (the upper gravel unit has been removed). On this visit approximately 1m of bedded medium- to coarse-grained sand with fine gravel was exposed. Looking east.

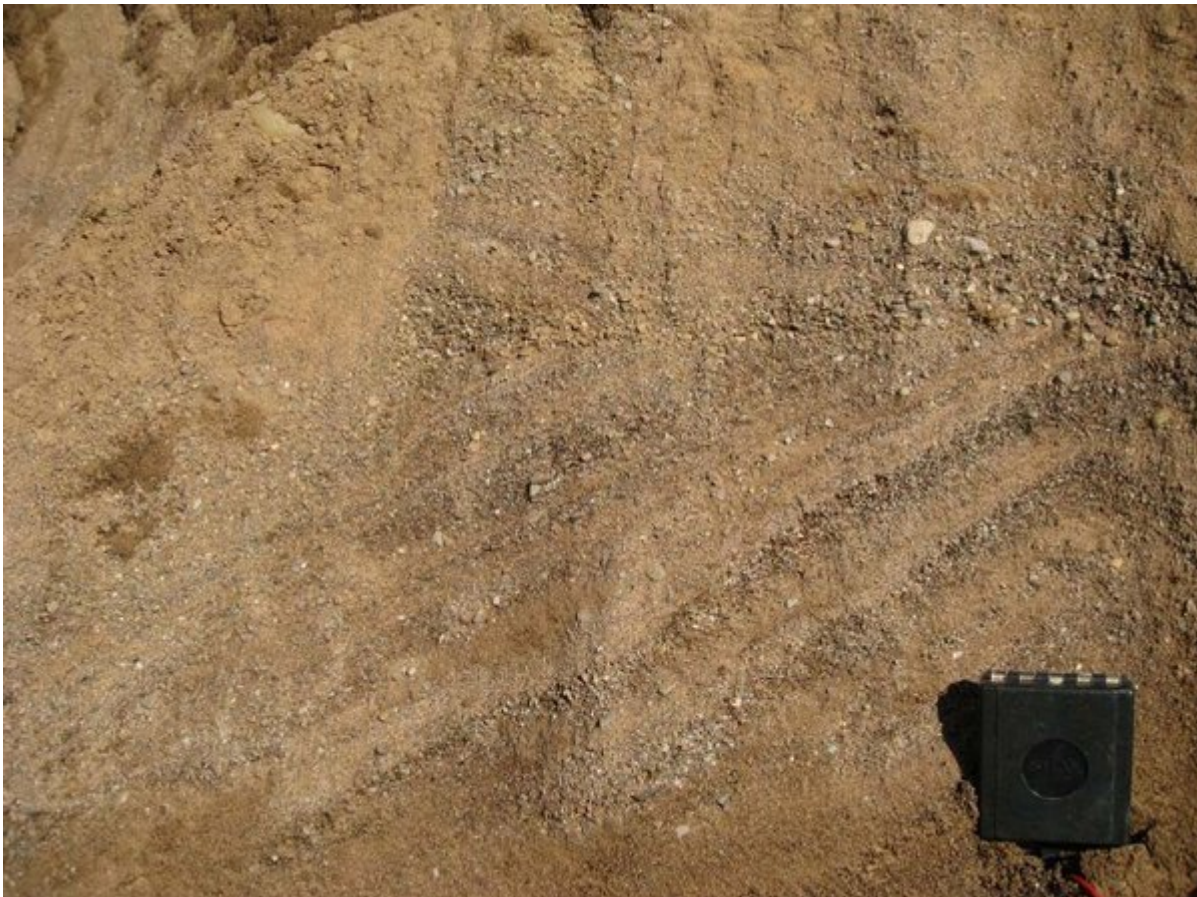
*(Photo 184) Close-up of the lower sand unit, displaying the structure in the sand. The cross-sets suggest an easterly transport direction. Looking south.*

(Photo 184) Close-up of the lower sand unit, displaying the structure in the sand. The cross-sets suggest an easterly transport direction. Looking south.

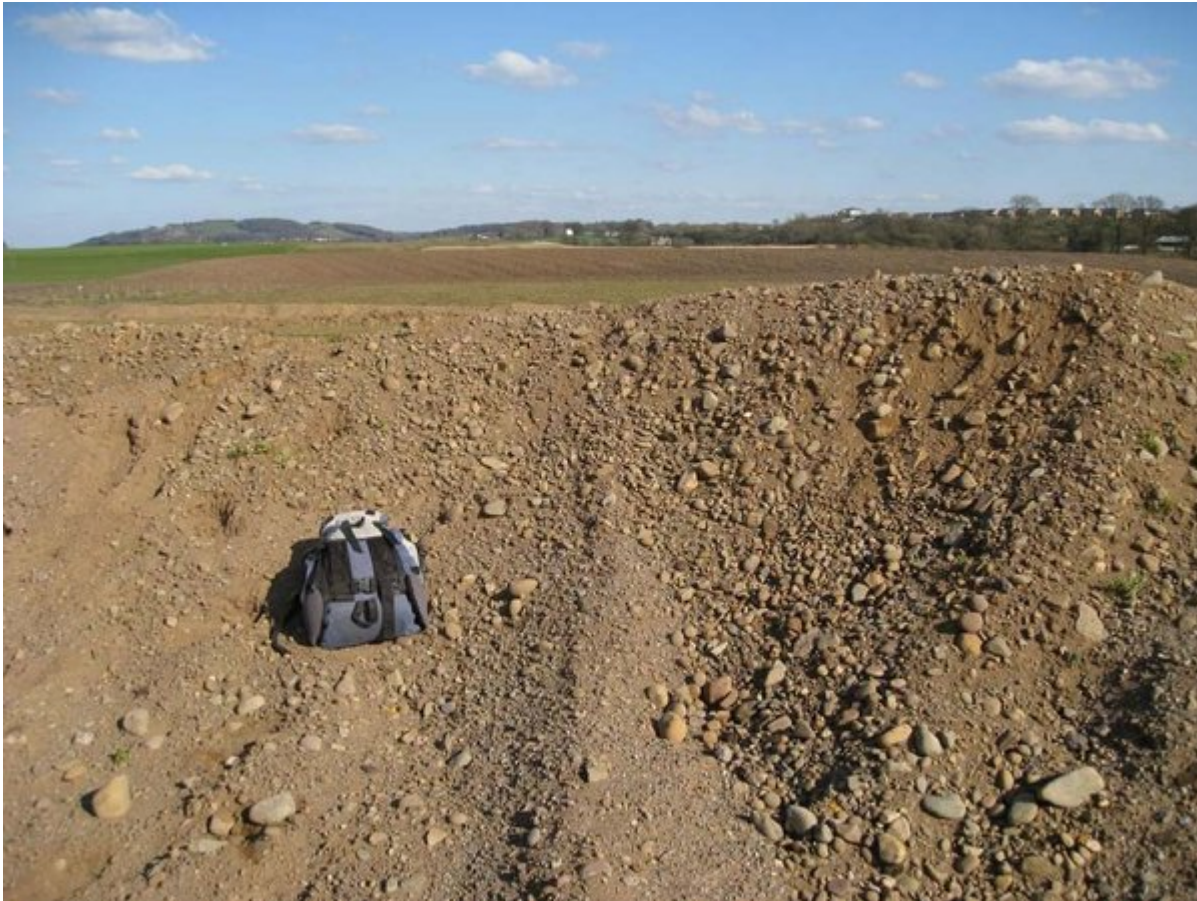
*(Photo 185) View looking ENE towards Bar Hill. As the sand and gravel is only a few metres thick here, areas become worked-out fairly quickly. The quarry owners, thinking ahead, have plans to expand to the area southeast of Inchbelle Farm (middle distance). The superficial geological map suggests there are further sand and gravel deposits here. Worked areas will be landfilled or landscaped accordingly, although will probably leave no exposures for future reference.*

Tarmac have plans to expand to the east, it would be good if a representative face could remain exposed for future generations to observe.

(Photo 185) View looking ENE towards Bar Hill. As the sand and gravel is only a few metres thick here, areas become worked-out fairly quickly. The quarry owners, thinking ahead, have plans to expand to the area southeast of Inchbelle Farm (middle distance). The superficial geological map suggests there are further sand and gravel deposits here. Worked areas will be landfilled or landscaped accordingly, although will probably leave no exposures for future reference.

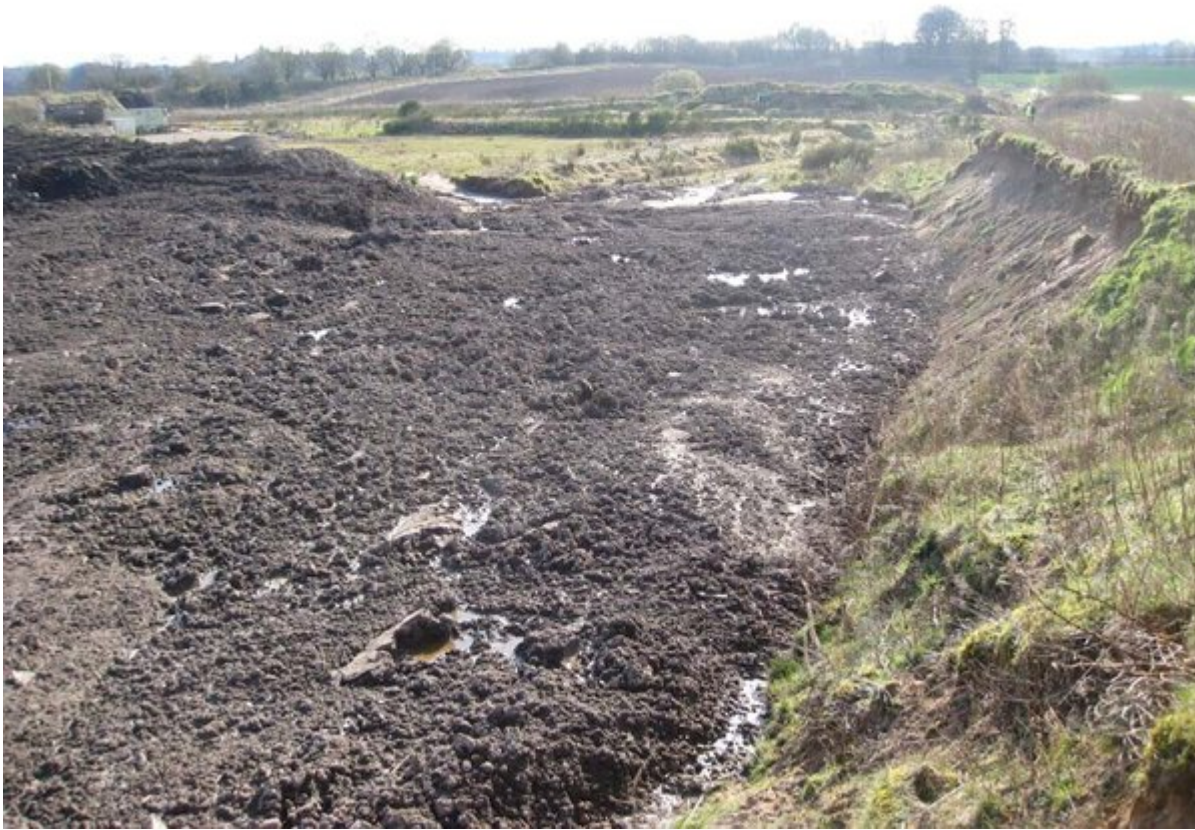
*(Photo 186) Areas previously quarried are now being infilled, and remaining sections at the edges will be permanently covered. Preserving these sections would allow people to see a rarely exposed part of the stratigraphy, which is part of the glacial history of the area. Looking SE.*

(Photo 186) Areas previously quarried are now being infilled, and remaining sections at the edges will be permanently covered. Preserving these sections would allow people to see a rarely exposed part of the stratigraphy, which is part of the glacial history of the area. Looking SE.
