Spireslack Locality 17: Devonian strata

NGR: [276090 630849] [NS 76090 30849]

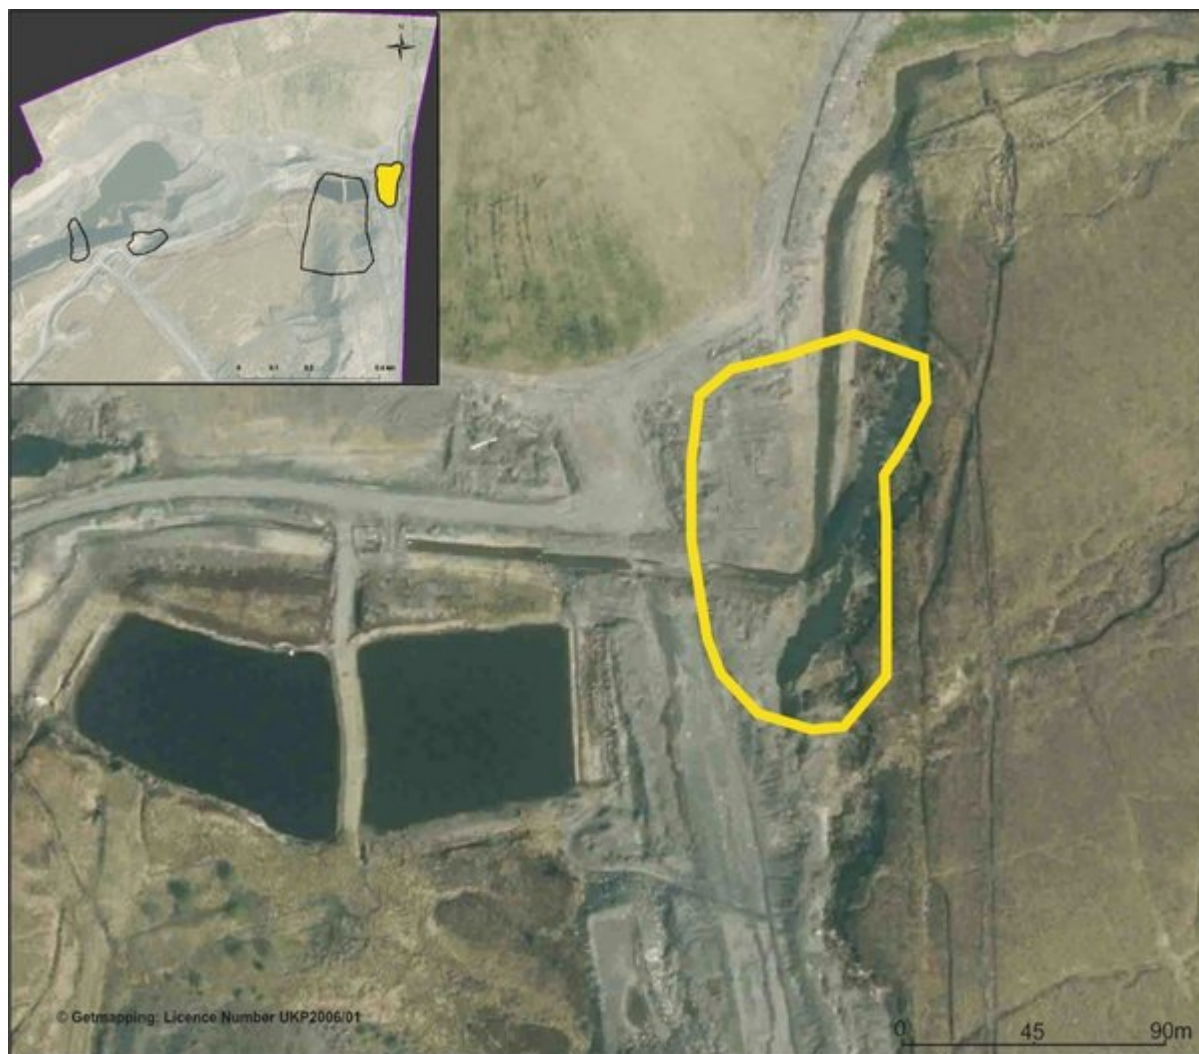
Photograph overview with polygon boundary

Aerial (Overview of Locality 17). Site boundary includes key rock exposures, immediate access to site and viewpoints to the site.

(Overview of Locality 17). Site boundary includes key rock exposures, immediate access to site and viewpoints to the site.

Measures to enhance site: Create bridge over pond and even out surfaces to allow easier access. Create viewing platform in front of pond.
