Spireslack Locality 18: 'Area B1'—sedimentary architecture

NGR: [274991, 629637]–[275347, 629657] [NS 74991 29637]–[NS 75347 29657]

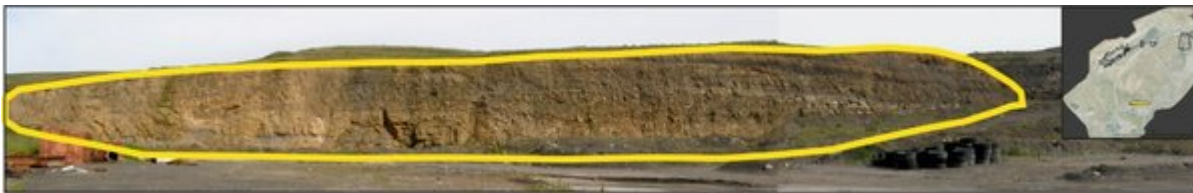
(Overview of Locality 18). Site boundary includes key rock exposures, immediate access to site and viewpoints to the site. View looking toward the north from the old car park levelled area at the south of the Spireslack SCM.

(Overview of Locality 18). Site boundary includes key rock exposures, immediate access to site and viewpoints to the site. View looking toward the north from the old car park levelled area at the south of the Spireslack SCM.

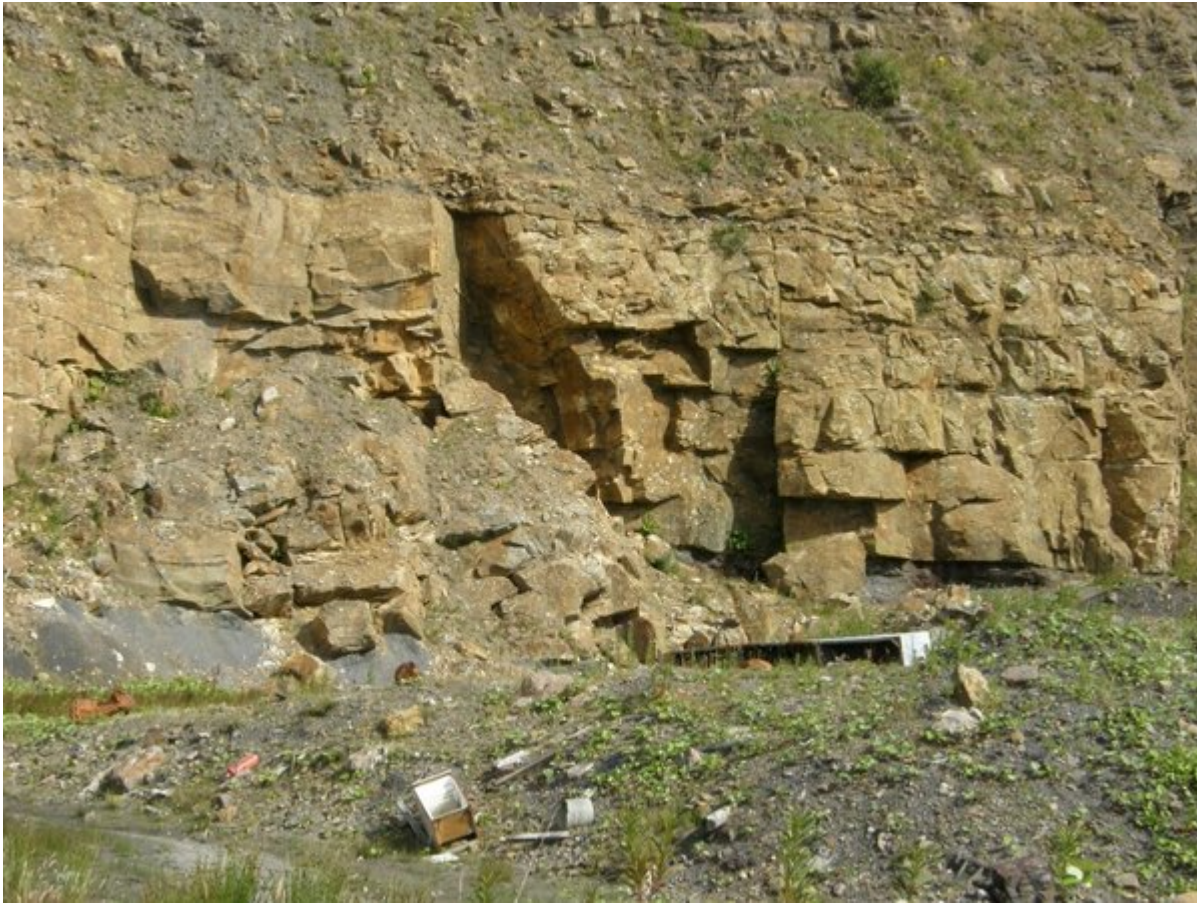
(Spireslack_18 P1) Stacked sandstone bodies within Area B1 at Spireslack. These thick tabular massive bodies of sandstone represent stacked bars formed as part of a channel complex. Closer inspection reveals cross- bedding within these stacked bars which can be used for palaeocurrent analysis. To improve access, spoil heap in front section should be levelled and the section cleared of loose material. © BGS, NERC.

Level area in front of the face and clean up section of loose material and dust to highlight sedimentary features.

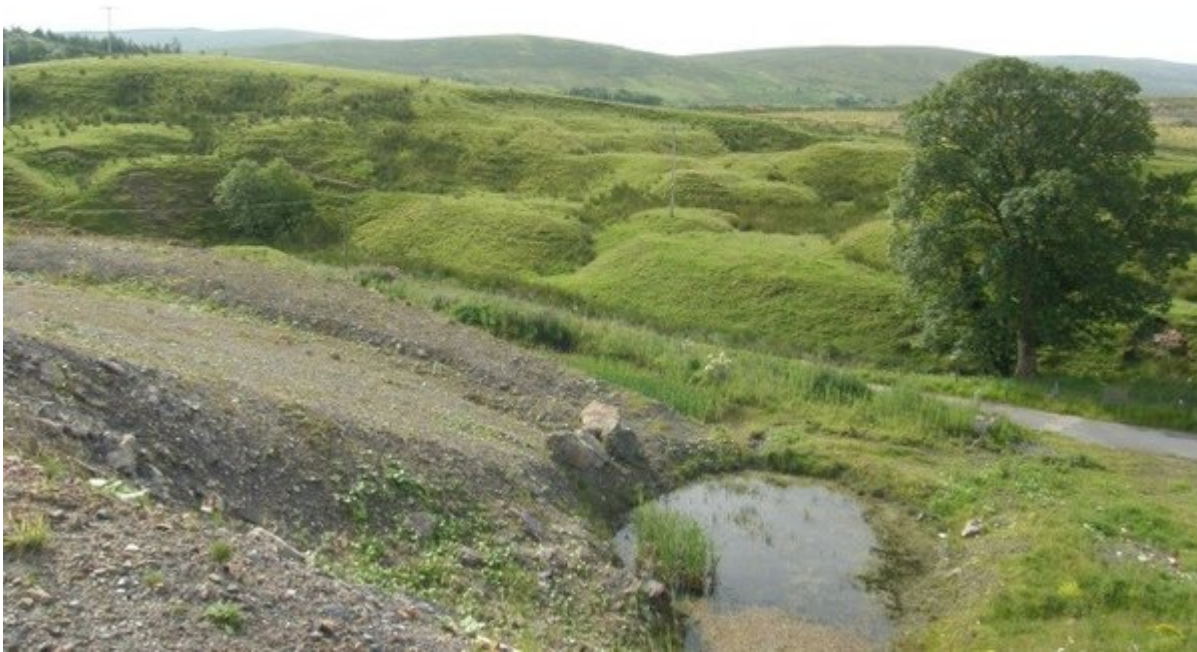
(Figure 8) Bell-pits at southern edge of Spireslack SCM. View looking toward the south-west. These disused bell-pits were historically associated with ironstone and limestone mining. © BGS, NERC

(Figure 8) Bell-pits at southern edge of Spireslack SCM. View looking toward the south-west. These disused bell-pits were historically associated with ironstone and limestone mining. © BGS, NERC

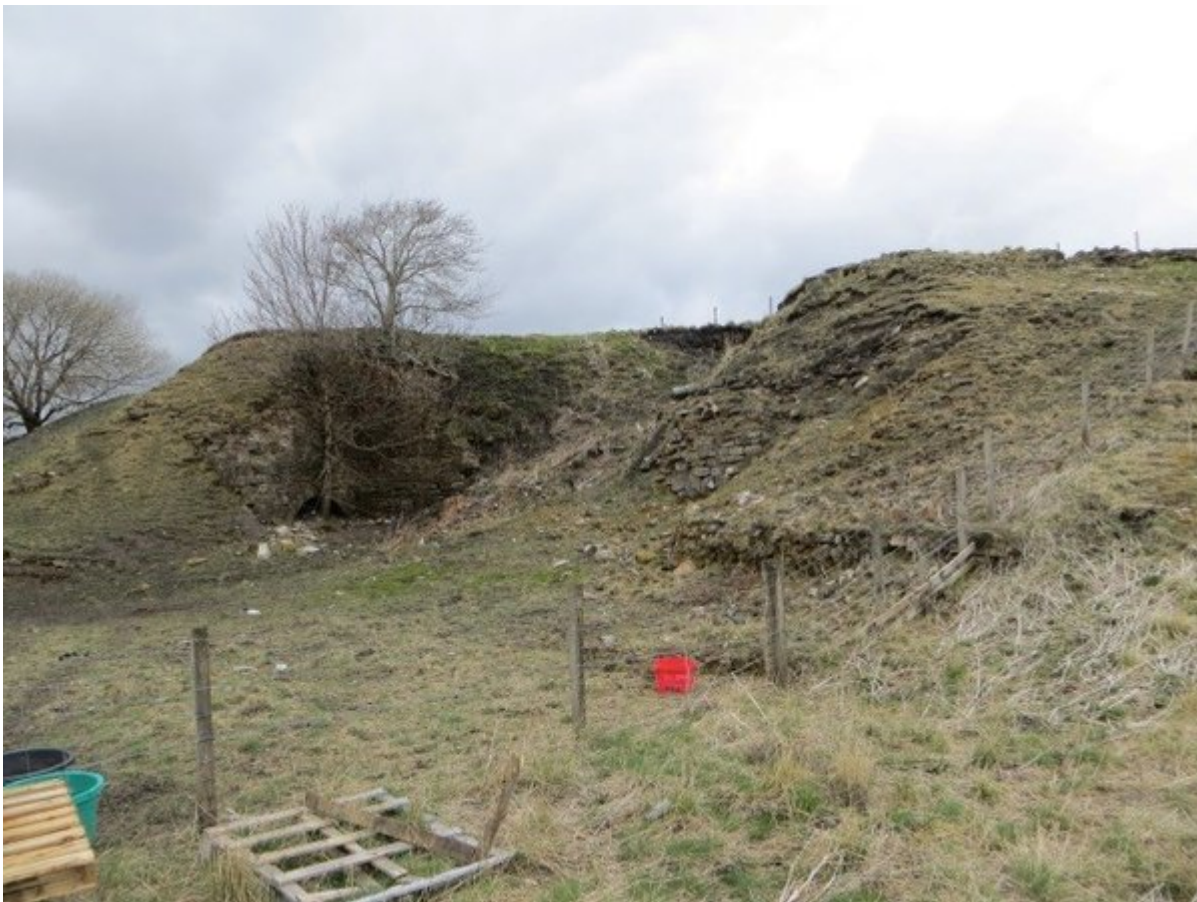
(Figure 9) The ruins of the Glenbuck Ironworks Furnace are visible at the base of the tree in the centre left of the photo. The furnace has been buried by later generations of mine waste. Photo copyright Mike Browne.

(Figure 9) The ruins of the Glenbuck Ironworks Furnace are visible at the base of the tree in the centre left of the photo. The furnace has been buried by later generations of mine waste. Photo copyright Mike Browne.
