The built environment

Materials used in the built environment of County Durham

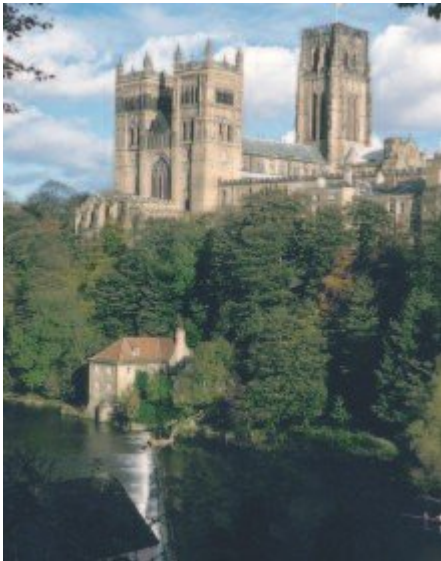
(Photo 82) Durham Cathedral. A striking example of the use of Coal Measures sandstone (the Low Main Post) as a building stone. B Young, BGS, ©NERC, 2004.

For more significant buildings stone of a more consistent quality and appearance was normally required. The county possesses several sandstones capable of supplying significant quantities of stone of consistent quality. A prominent early example of such a use of stone was in the building of Durham Cathedral. Here sandstone from the Low Main Post, a sandstone above the Low Main Coal of the Coal Measures, was employed. Over the succeeding centuries a variety of other Carboniferous sandstones became favoured as good quality building stones. The county abounds in examples of their use. Significant quantities of such sandstone are still quarried today, with substantial quantities being employed in building and repair programmes throughout Great Britain. A notable example is the use of sandstone from Dunhouse Quarry, near Staindrop, for repair work in Edinburgh where sources of the original Scottish sandstones are no longer available.

(Photo 82) Durham Cathedral. A striking example of the use of Coal Measures sandstone (the Low Main Post) as a building stone. B Young, BGS, ©NERC, 2004.

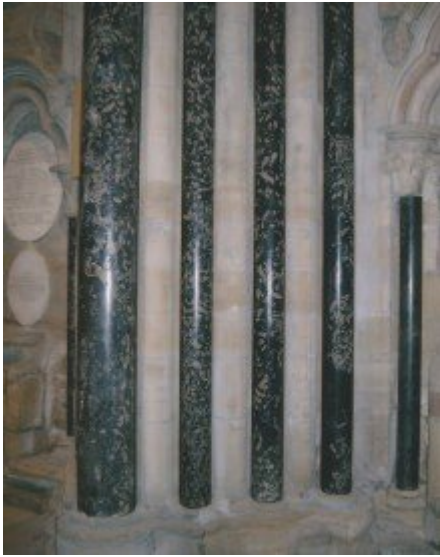
(Photo 83) Durham Cathedral. Polished columns of Frosterley Marble contrasting with Coal Measures Sandstone in the Chapel of the Nine Altars. B Young, BGS, ©NERC, 2004.

The unique coral-rich limestone, The 'Frosterley Marble', obtained from the Great Limestone, has been an important source of ornamental stone. It was used for pillars and flooring slabs in Durham Cathedral as early as the 14th century. In addition to its use in making internal ornamental pillars in churches, it has been much used in making fonts, tombs and even wash stand tops. Examples of its use within County Durham include:

- Frosterley Church (font)
- Stanhope Church (font, table-top tombs, coffin)
- Eastgate Church (font)
- Wolsingham Church (chancel floor) Auckland Palace Chapel
- Durham Cathedral (extensively used as pillars in Chapel of Nine Altars, Chancel, Rood Screen, Gallilee Chapel, flooring)

(Photo 83) Durham Cathedral. Polished columns of Frosterley Marble contrasting with Coal Measures Sandstone in the Chapel of the Nine Altars. B Young, BGS, ©NERC, 2004.

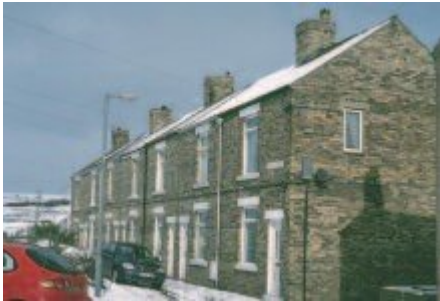
(Photo 84) Helmington Row, near Crook. Pale grey bricks produced from Coal Measures fireclay. B Young, BGS, ©NERC, 2004.

Bricks can be made from a comparatively wide variety of raw materials. Within County Durham bricks have traditionally been made from glacial clays, or from clay-rich rocks within the Coal Measures succession. It was common for several collieries to support a brickworks which employed otherwise waste shale from coal mining. Fireclay, also typically obtained as a by-product of coal mining, was commonly employed for brick making as well as the manufacture of refractory products. Distinctive pale cream fireclay bricks are a feature of several colliery settlements.

(Photo 84) Helmington Row, near Crook. Pale grey bricks produced from Coal Measures fireclay. B Young, BGS, ©NERC, 2004.

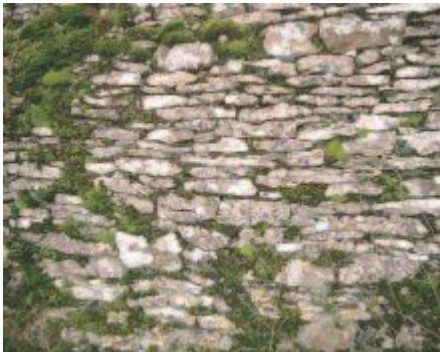
(Photo 85) Drystone wall built of limestone as host to a variety of lichens and mosses. God's Bridge, Bowes Moor. B Young, BGS, ©NERC, 2004.

Rocks in walls and buildings may provide important substrates for a variety of lower plants, including mosses and lichens.

(Photo 85) Drystone wall built of limestone as host to a variety of lichens and mosses. God's Bridge, Bowes Moor. B Young, BGS, ©NERC, 2004.
