A8 D11 Hazel Lane Quarry

Site information

Field surveyor: Scott Engering **Date:** 16/2/07

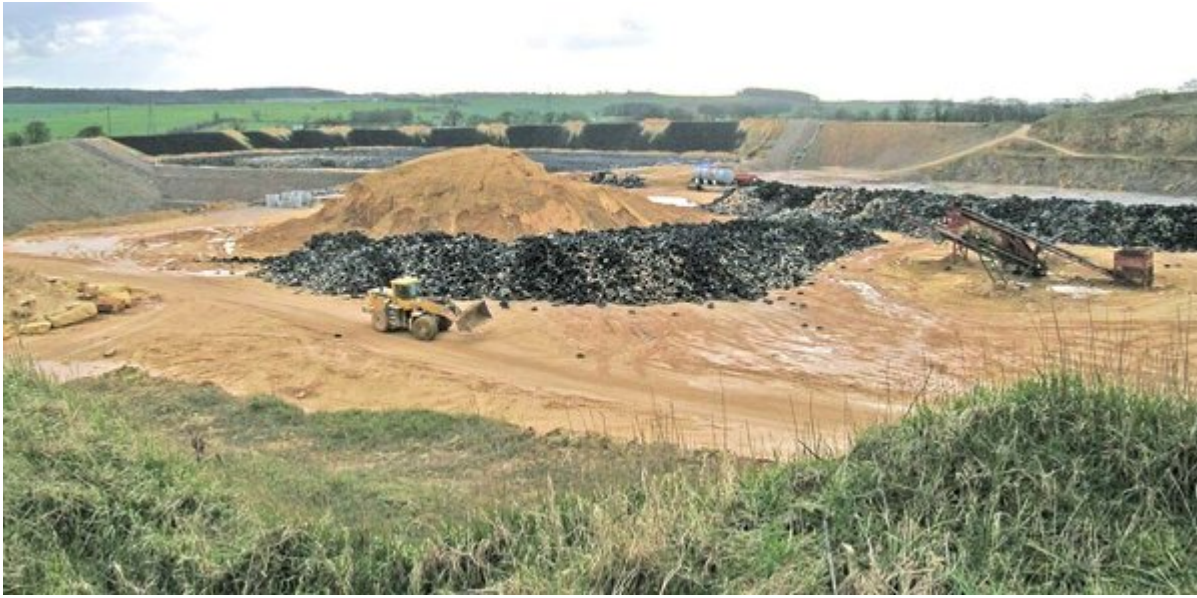
(Figure 41) General view to the south-west of landfill preparatory works. [SE 50063 11272].

The quarry has extended considerably in the last 10 years. Landfill preparation is well under way and the exposure of Coal Measures strata will soon be covered.

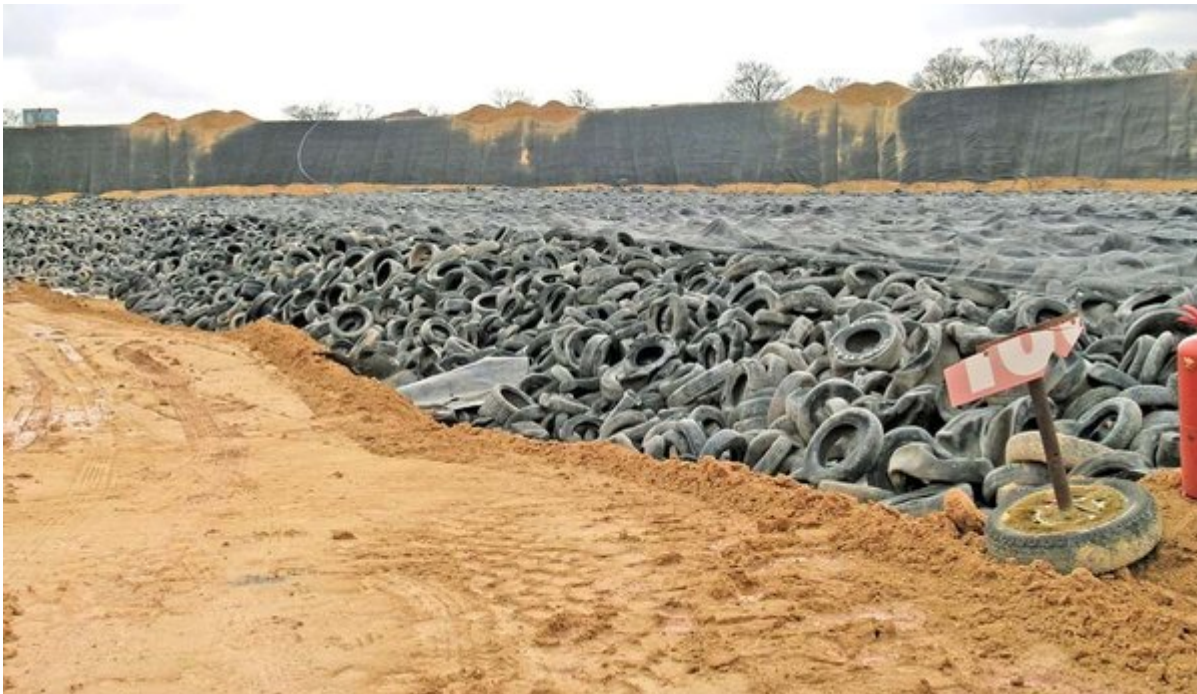
(Figure 42) Tyres from Hampole Lime Works Quarry used as drainage layer. [SE 49950 11050].

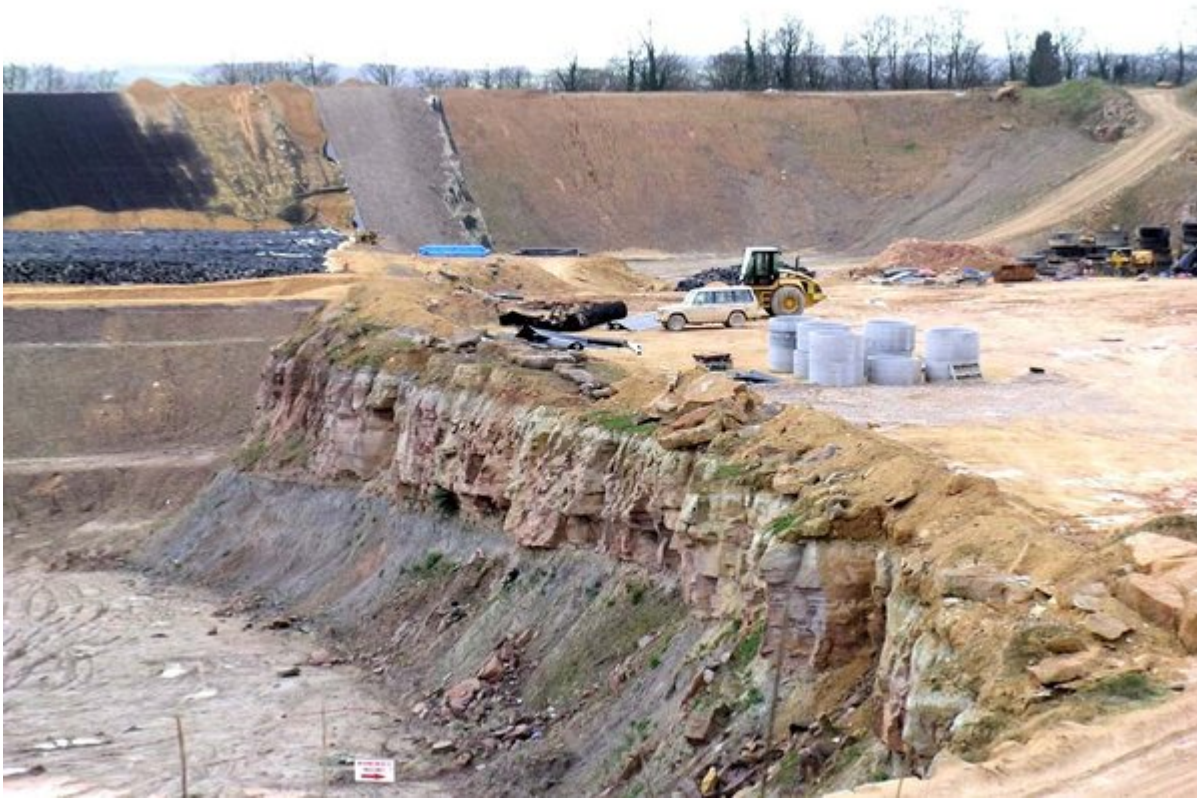
At the time of the RIGS survey in 1997, the site was notable for the excavation through the base of the Permian strata into the underlying Upper Coal Measures to produce an interesting exposure of reddened sandstone, siltstone and shale. Such exposures of Carboniferous strata are not often seen in the region. There are good examples of reddened shelly ooid-limestones (approximately 4 m) in the lower sections of many of the quarry faces, with well developed thin marls in places.

(Figure 43) Exposure of sandstones and shales of Upper Coal Measures in quarry floor. [SE 50174 11154].

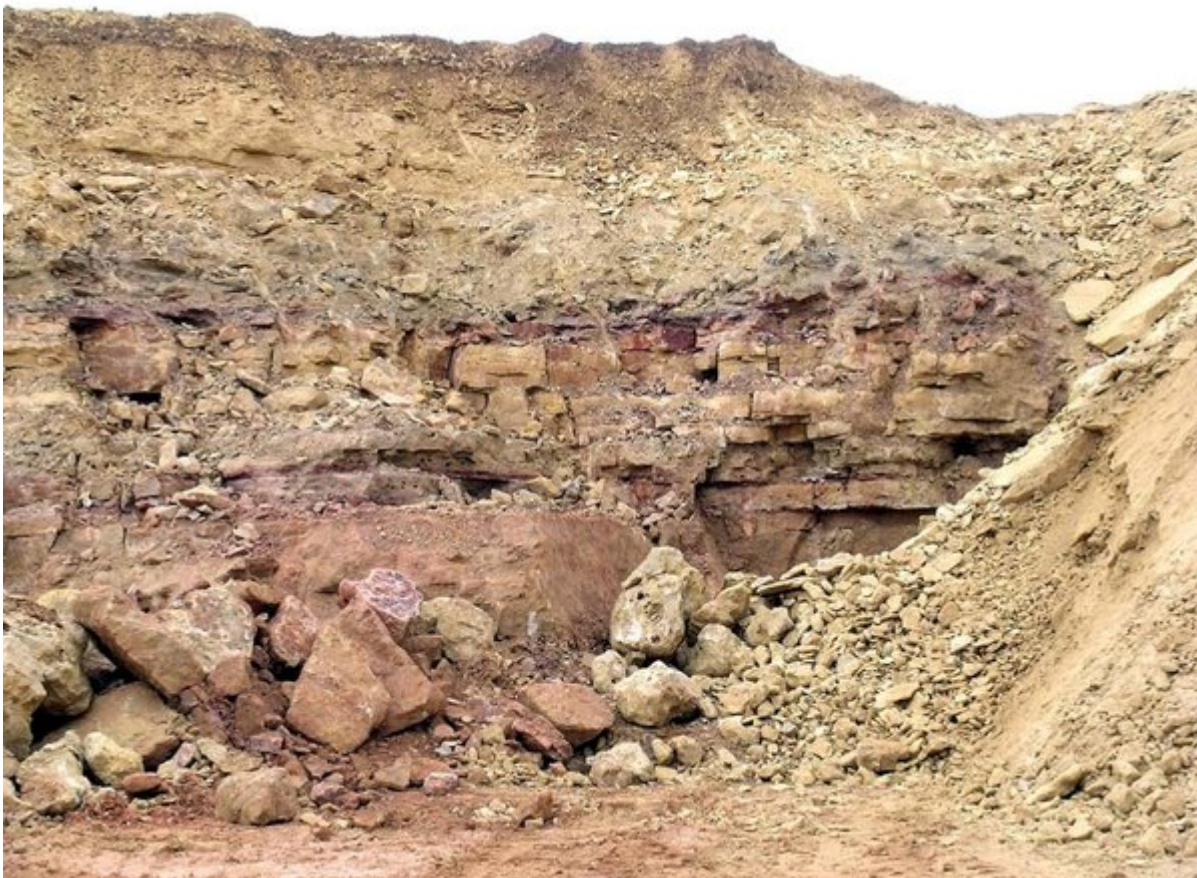
(Figure 44) Exposure of reddened limestones and red marl bands to north-east corner. [SE 49701 11567].
