# A34 D109 Hurst Plantation Quarry

## Site information

Doncaster GeodiversityAssessment

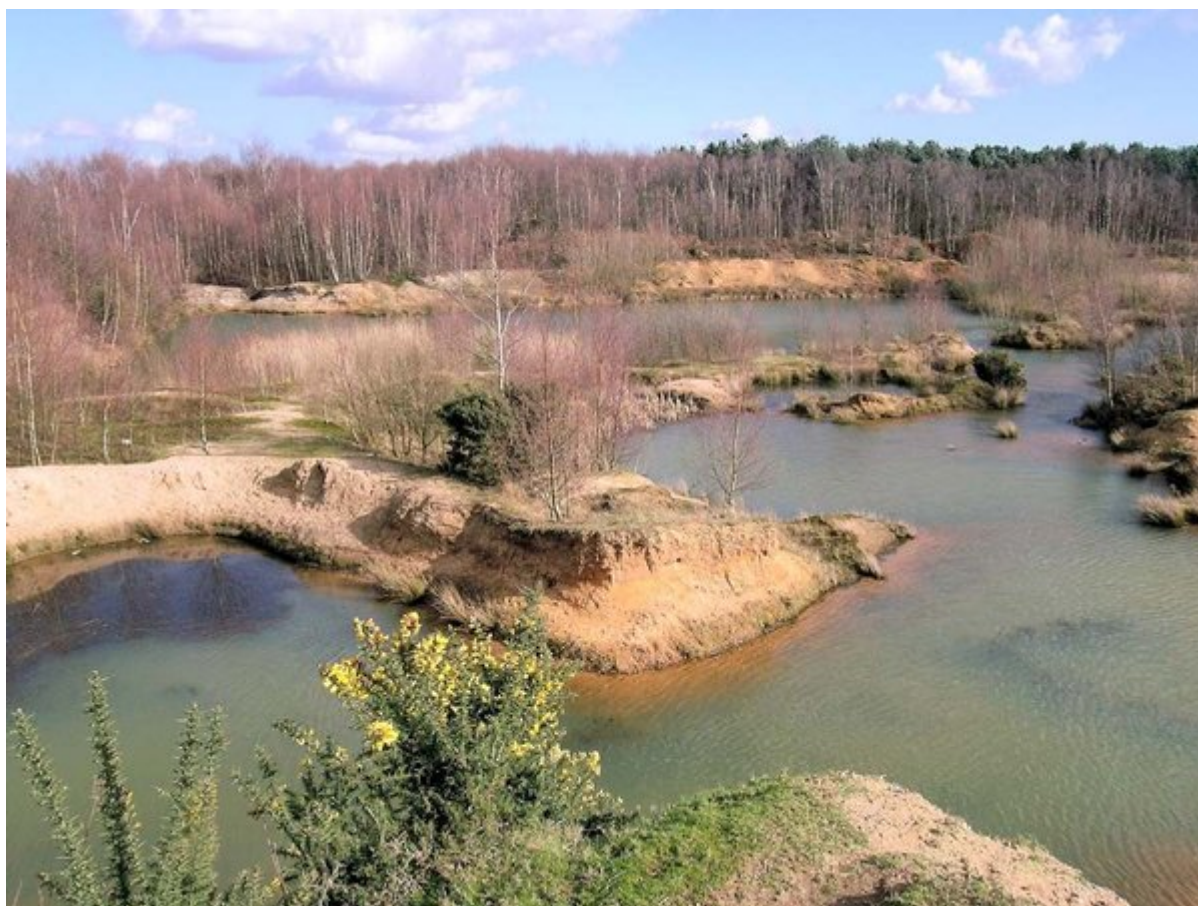
(Figure 161) General view of dormant sand and gravel quarry. [SK 63883 98977].

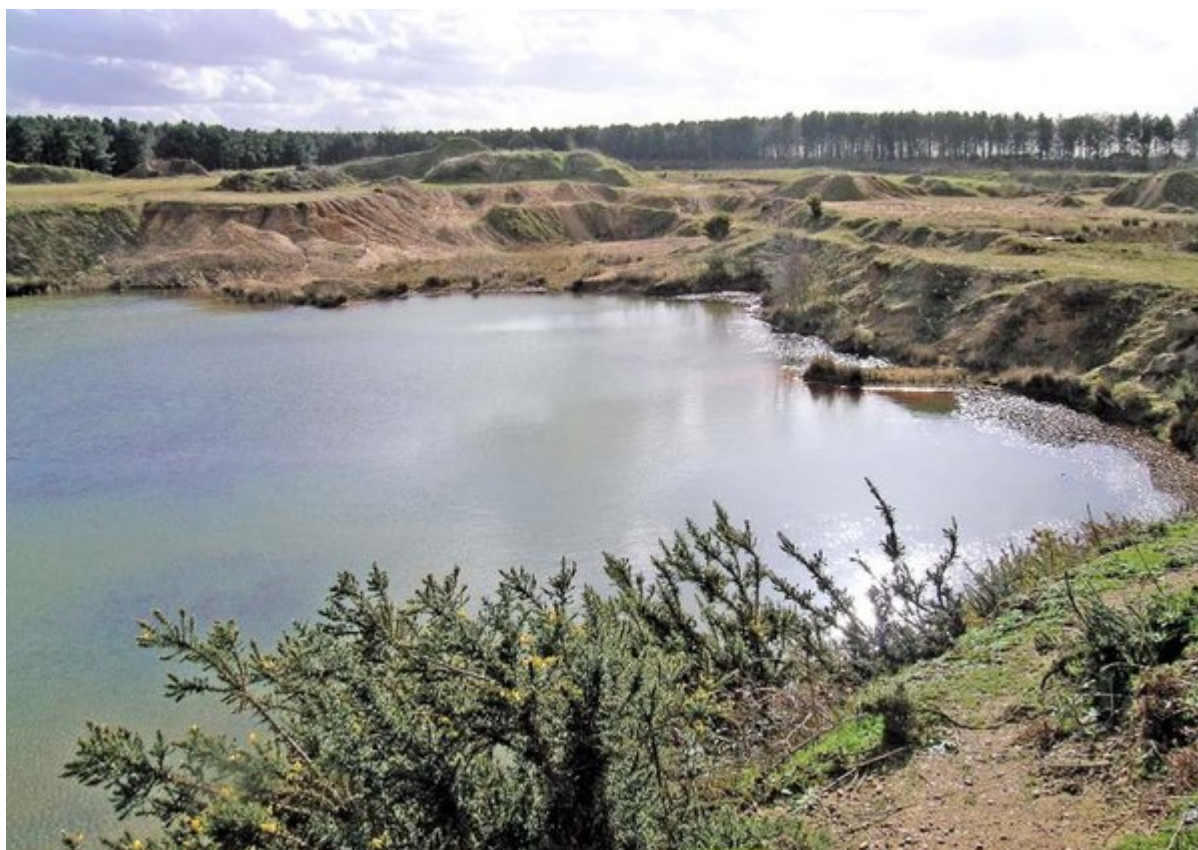
(Figure 162) General view of dormant sand and gravel quarry. [SK 63883 98977].

*(Figure 162) General view of dormant sand and gravel quarry. [SK 63883 98977].*

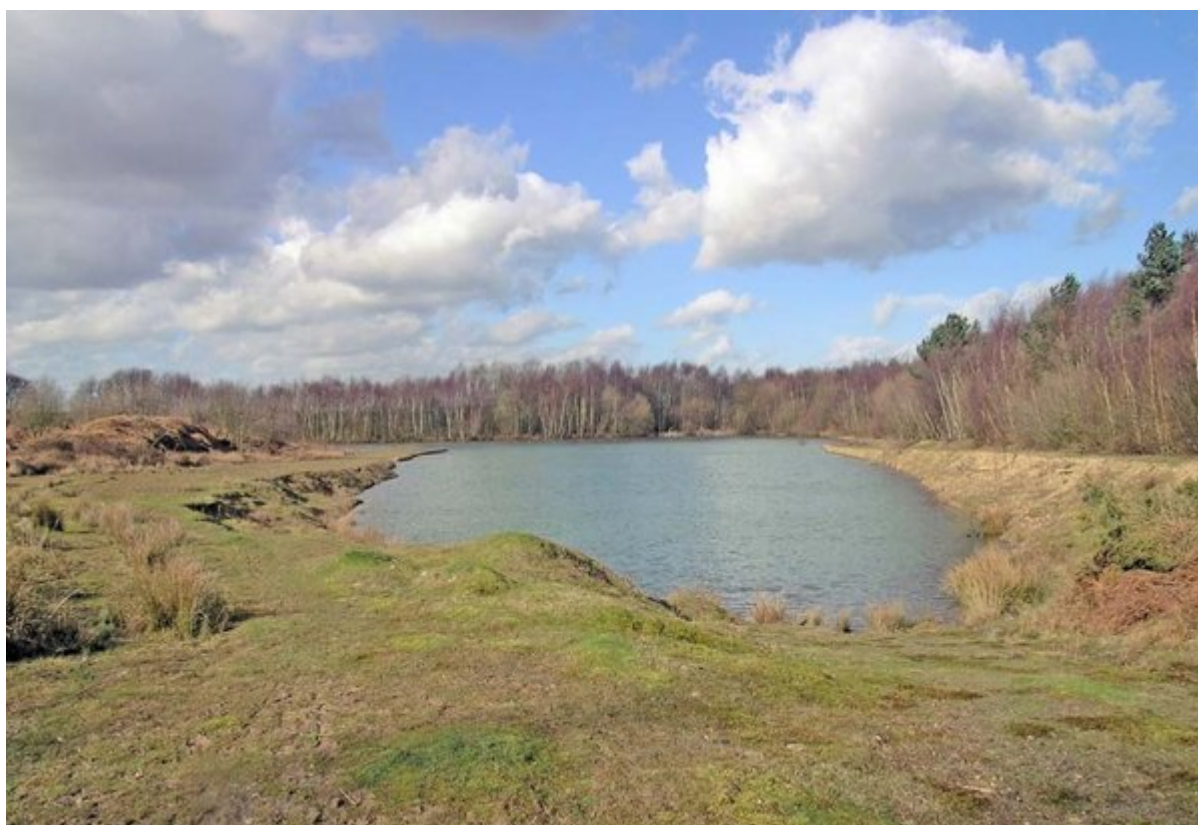
(Figure 163) General view of old clay workings. [SK 63639 99078].

*(Figure 163) General view of old clay workings. [SK 63639 99078].*
