Pant-y-llyn

Highlights

Pant-y-llyn is the only turlough in the Welsh karst, and is the only clearly defined example of a seasonal lake in Britain. It demonstrates the complex interaction between geological, geomorphological and hydrological controls on groundwater levels in a karst aquifer.

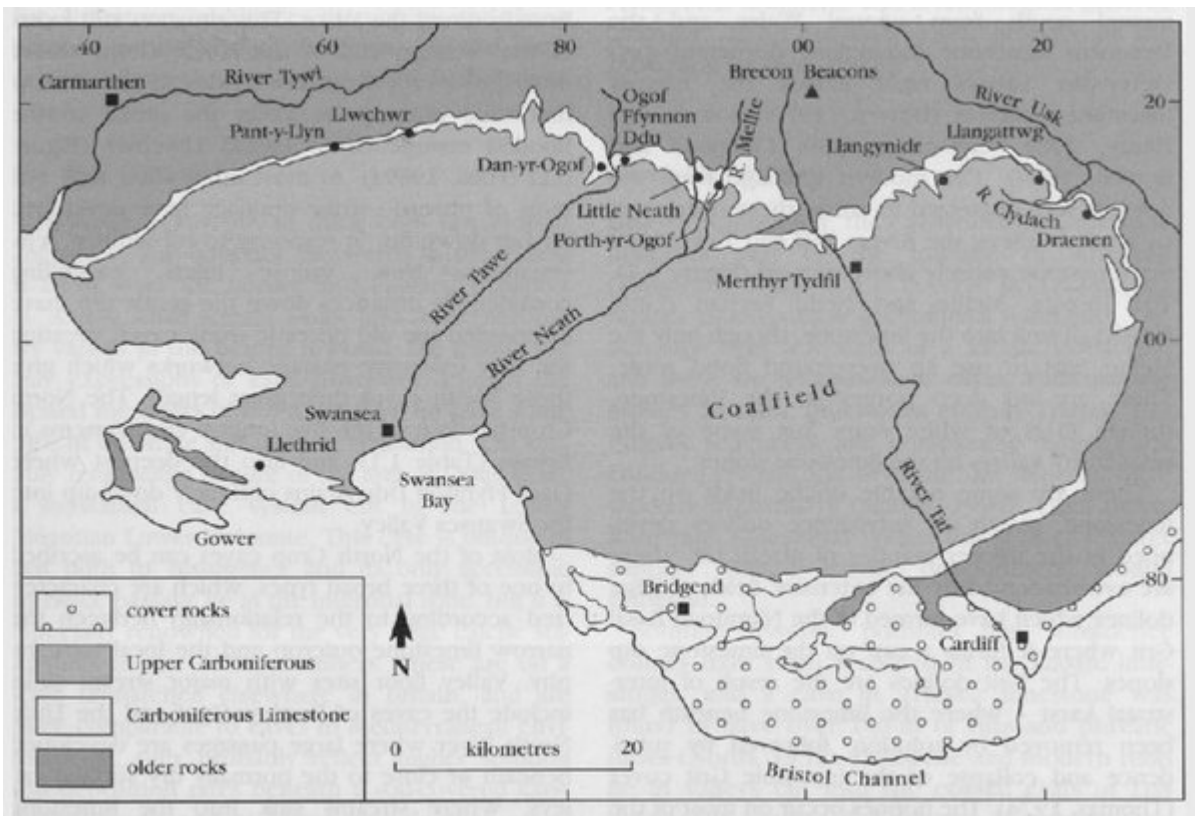
(Figure 6.1) Outline map of the karst areas around the perimeter of the South Wales coalfield, with locations referred to in the text. The cover rocks in the south are Triassic and Jurassic mudstones and thin limestones.

Pant-y-llyn lies on the northern margin of the South Wales coalfield syncline (Figure 6.1). The rocks in the area dip south at 20–40°, and include the Devonian Old Red Sandstone, the Dinantian Lower Limestone Shale, followed by about 200 m of limestone, and the Namurian Basal Grit. The turlough is underlain by the Bettws Fault, with an apparent downthrow to the west of about 200 m. This has brought the Dinantian Limestones into contact with the Devonian Sandstones; the eastern bank of the depression is cut into the sandstone, while the rest of the turlough lies on the limestone (Figure 6.22). The topography of the area consists of a low fragmented escarpment of Carboniferous Limestone, with a series of strike valleys running NE–SW, such as the Nant Gwenlais valley. The Bettws Fault zone appears to have offered a zone of weakness through the escarpment; during the Pleistocene, this was exploited either by ice moving south or by glacial meltwater (Bowen, 1965). More than 6 m of glacial till lies both north and south of the turlough, but is absent under the turlough site.

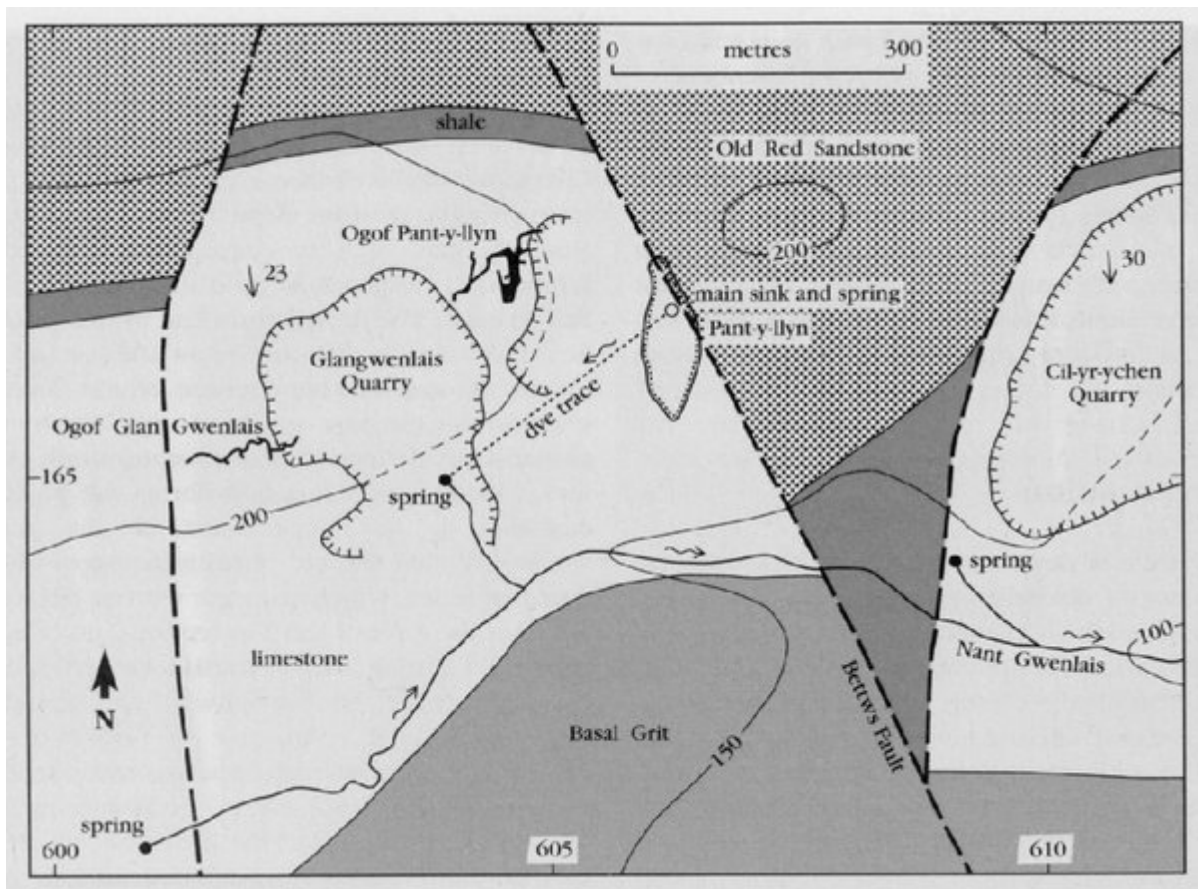
(Figure 6.22) Geological map of the area around Pant-y-llyn.

therefore impounded, and its water table fluctuates between levels of 155 m in summer and 160 m in winter. Sinks and springs at higher levels drain the limestone west of a minor fault west of Ogof Glan Gwenlais (Figure 6.22). About 50 m above the level of the turlough, Ogof Pant-y-llyn has 350 m of phreatic rifts and bedding cave passages. Ogof Glan Gwenlais has 200 m of old phreatic passage aligned on the strike at an elevation of about 165 m (Figure 6.22).
